A STUDY OF POLE TOP FIRES ON 22KV WOOD POLE POWER LINES IN KWAZULU - NATAL

**A postgraduate dissertation submitted to the Discipline of Electrical Engineering at
the University of KwaZulu - Natal in partial fulfillment for the requirements of
Master of Science in Electrical Engineering.**

Date: October 2007

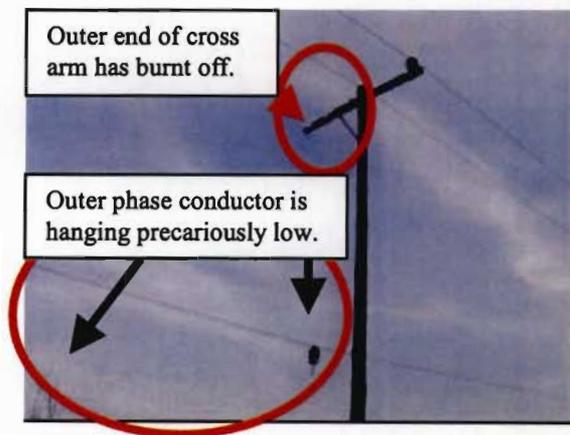
Figure 1 - 2: A burnt **cross arm** resulting in a low hanging conductor.

In Figure 1 – 2 above, the left of the cross arm has burned away resulting in the insulator and phase conductor hanging precariously low. Fig 1 – 3 highlights the extent of charring where the outer section of cross arms has completely burned away. This has resulted in that particular phase conductor either parting or hanging low which is of serious concern to Eskom.

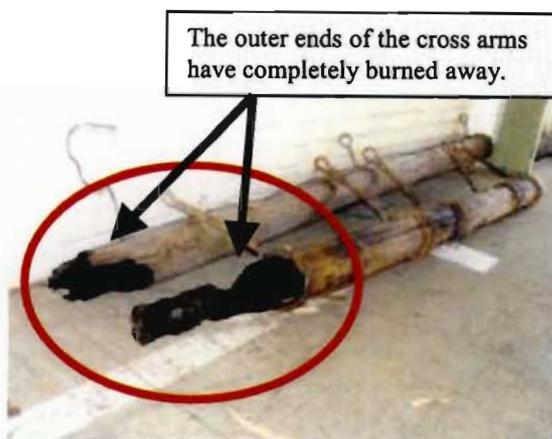
Figure 1 – 3: Extent of the damage (charring) at the ends of cross arms.

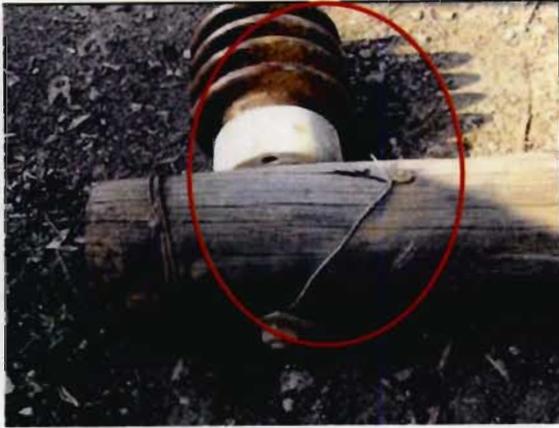
Other designs also included metal based post ceramic insulators (“capped”) of specific creepage 25mm/kV. Bonding of structures with these insulators was often via 1mm² solid copper wires. The copper wire was merely wrapped around the insulator spindles and secured onto the cross arm via washers and nails. This is illustrated in Fig 2 – 6 below. Once again, this application was not as per the requirements of the Engineering Instruction published and hence could be considered as poor bonding. Figure 2 – 7 shows the balance of the bonded cross arm that has burned away. The principle of bonding has again not been implemented correctly.

Figure 2 – 6: Illustration of solid 1mm² copper wire and method used for bonding in Stanger.

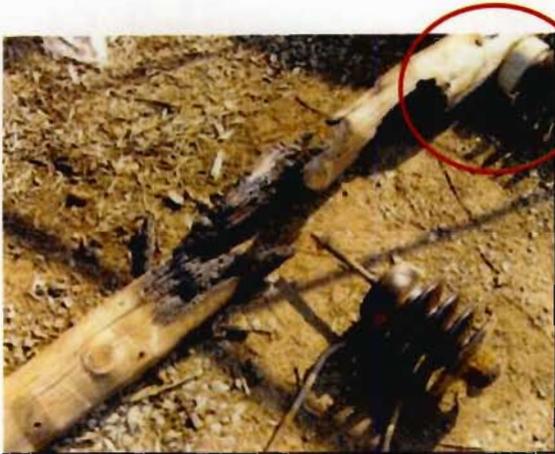
Figure 2 – 7: The balance of the cross arm that is illustrated in Fig 2 – 6 above.

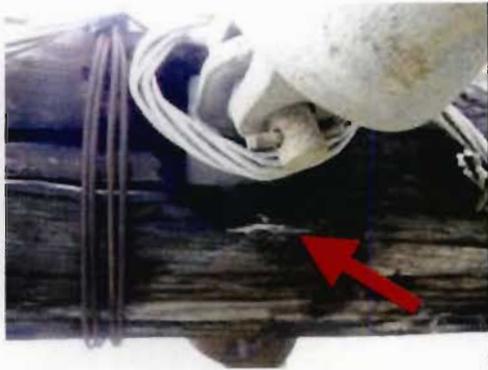
Further investigations by the researcher revealed the use of stranded aluminium conductor to bond wood cross arms in Mhlatuze just outside of Empangeni on the north coast of KZN. This area is severely affected by cross arm burns. On these structures, the stranded aluminium conductor was merely wrapped around the “dead” ends of the insulator eye – bolts and stapled at various positions onto the cross arm. No real effort was made to ensure proper electrical connections. The pictures below bear testimony to the loose connections and poor application.

Figure 2 – 8: Poor application of bonding leading to a severely burned hole of eye bolt.

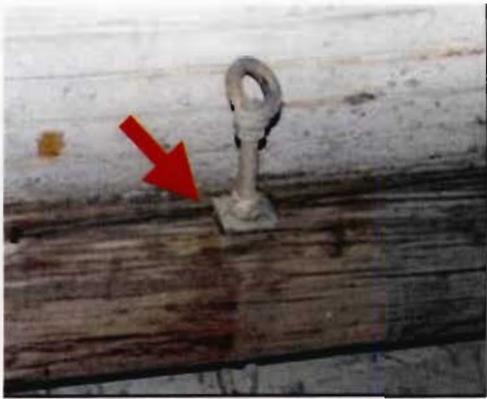
The method consisted of stranded copper wire pressed tightly against the wood cross arm surface via the curved washer and eye – bolt (Fig 2 – 9). The copper wire was also attached to copper bonding clips (Fig 2 – 10) at the steel galvanized threaded rods and merely passed over and adjacent to binding wires as in Fig 2 – 5. This practice led to another problem. Bi – metallic corrosion started to manifest between the copper clips and galvanized threaded rods. This jeopardized the electrical connection and hence the bonding of the structure. This is illustrated in Fig 2 – 10 below. Unfortunately many structures were built with this design. These are some reasons as to why bonded structures continued to burn. The cross arm was severely burned at one end (Fig 1 – 3). Hence this application did not work. This is illustrated below.

Figure 2 – 9: Bonding wire pressed against the cross arm surface.

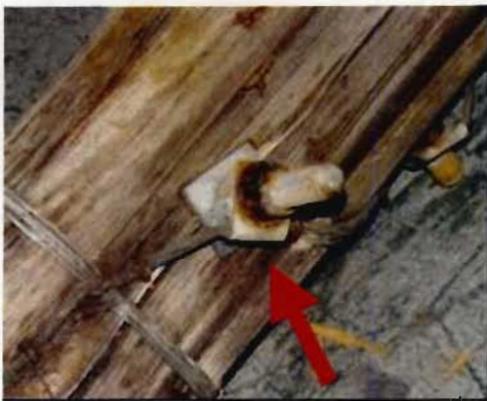
Figure 2 – 10: Galvanic corrosion between dissimilar metals.

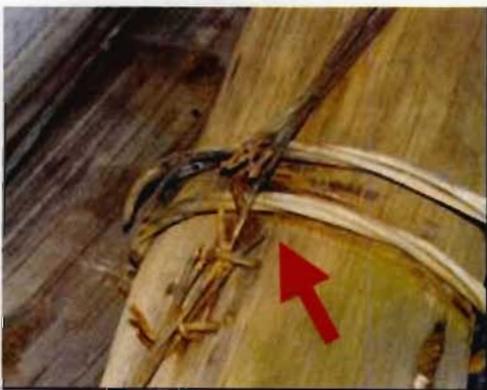
Figure 2 – 11: Broken strands of bonding wire.

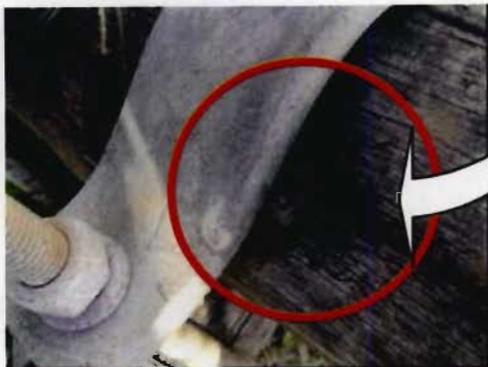
Figure 2 – 15: Magnified view of tracking adjacent to the U – bolt bracket

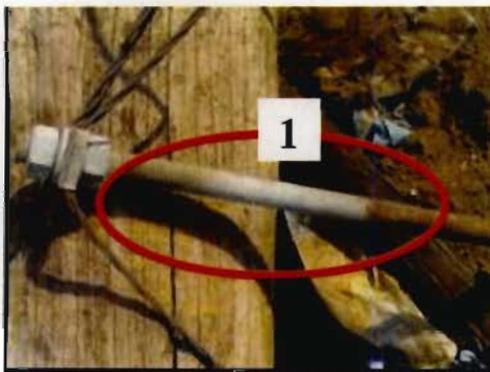
indicated that this bonding was part of a cross arm where the burning had started from the inside and had completely damaged the cross arm. The bonding installation was still intact. The copper bonding wire was still securely attached to the various threaded rods via clips and washers. The electrical connection was observed to be very good. Sufficient evidence existed to suggest that the burning did start from the inside of the cross arm. The threaded rods were severely burned along its shaft that traverses the cross arm. Once again, this is due to a phenomenon called neutral shift which is explained further in Appendix B. Many such samples were found in that same heap of scrap and some are illustrated below.

Figure 2 – 16: Burned section of threaded rod number 1.

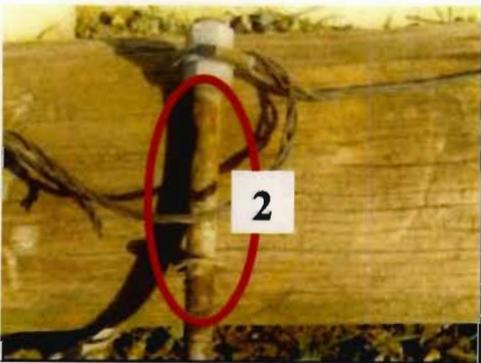
Figure 2 – 17: Burned section of threaded rod number 2.

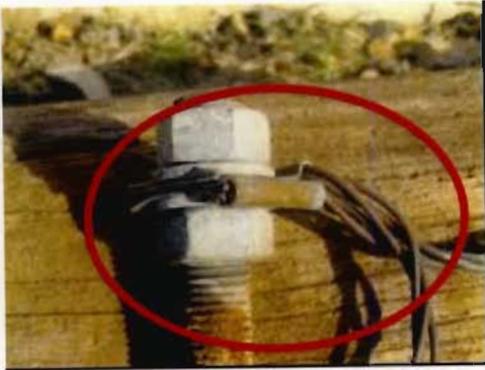
Figure 2 – 18: Good electrical connection maintained between bonding wire, clips, washers and nuts.

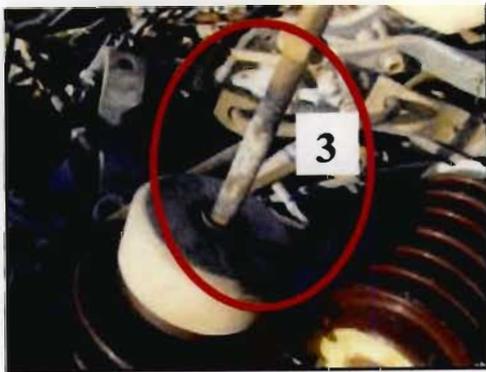
Figure 2 – 19: Burned section of spindle of a “capped” ceramic insulator.

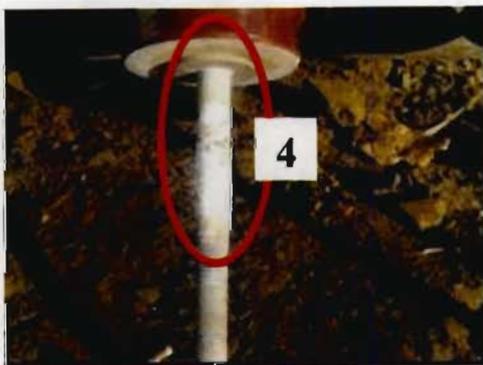
Figure 2 – 20: Severely burned spindle of another ceramic insulator.

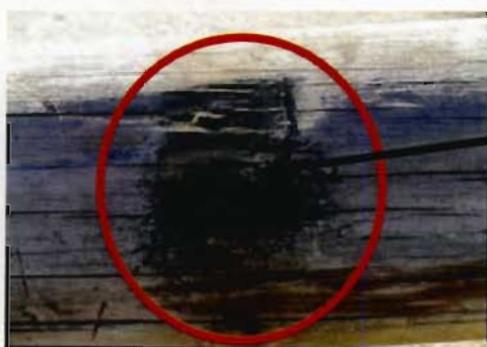
The following pictures were taken on structures in the Mtubatuba area, by the author. The areas highlighted in Figures 3 - 3 and 3 - 4 respectively show signs of early stages of burning. If these are un - detected, they will eventually lead to burns of the extent shown in Figures 3 - 5 and 1 - 3 respectively. These are serious problems as they lead to low hanging conductors of which pose a major safety risk to humans and animals.

Notice that a metal fitting was pressed against the surface of the cross arm.

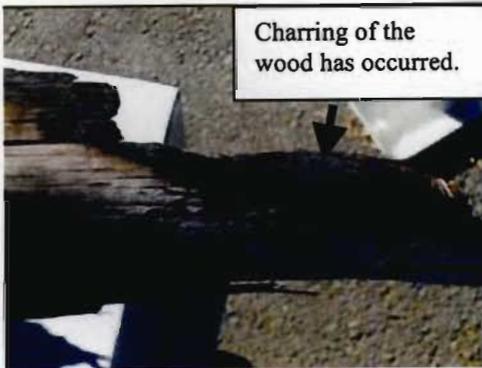
Figure 3 – 5: The wood surface suffered serious burns. The fire has damaged most of the cross arm.

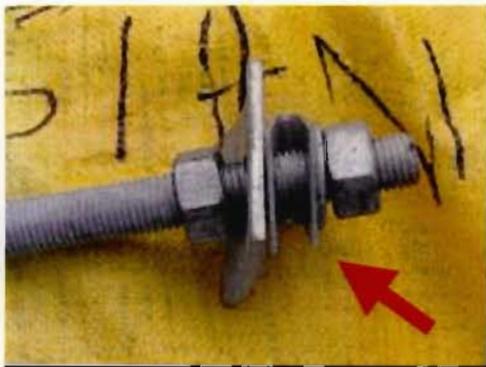
Figure 3 – 24: Inadequate materials supplied. A washer at the bonding clip was missing.

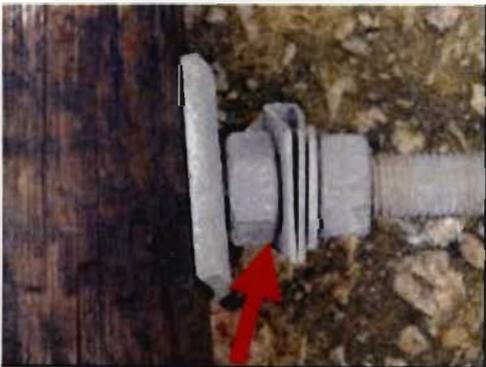
Figure 3 – 25: Linesmen failed to install the extra washer required to ensure a tight connection.

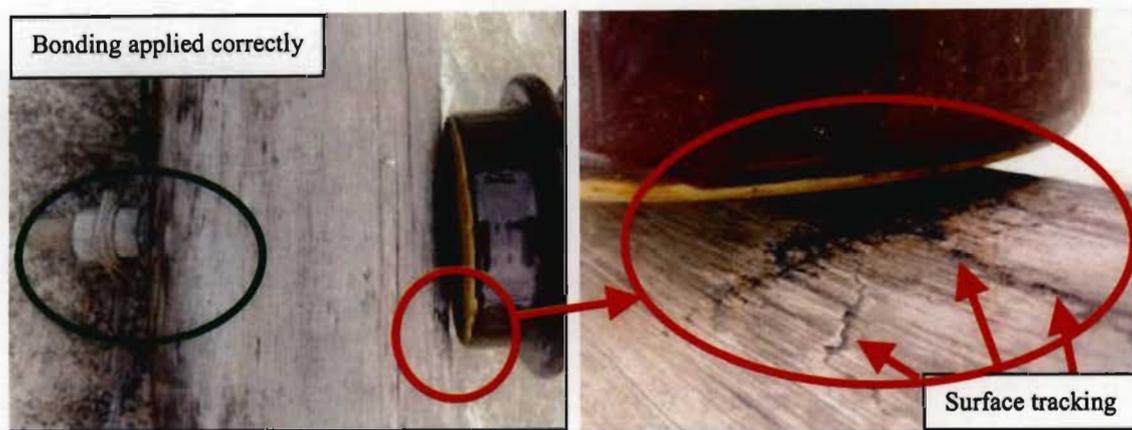
Figure 4 – 7: Early stages of tracking were observed between insulator base and wood surface.

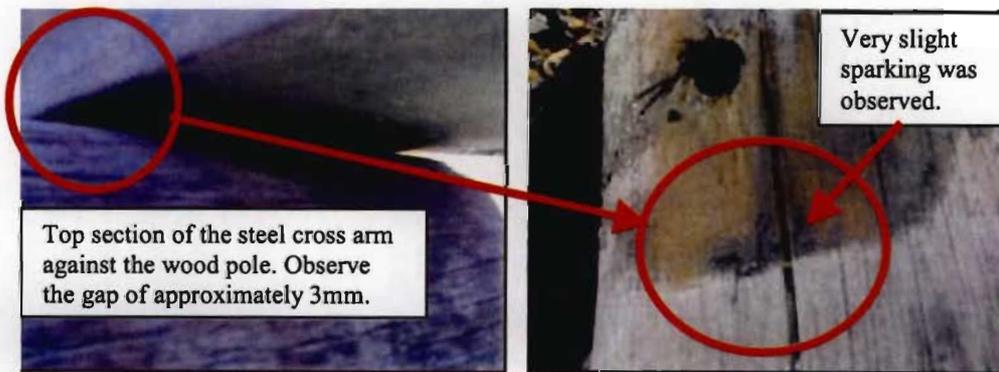
Figure 4 – 8: Illustration of tracking / sparking from steel cross arm to wood surface.

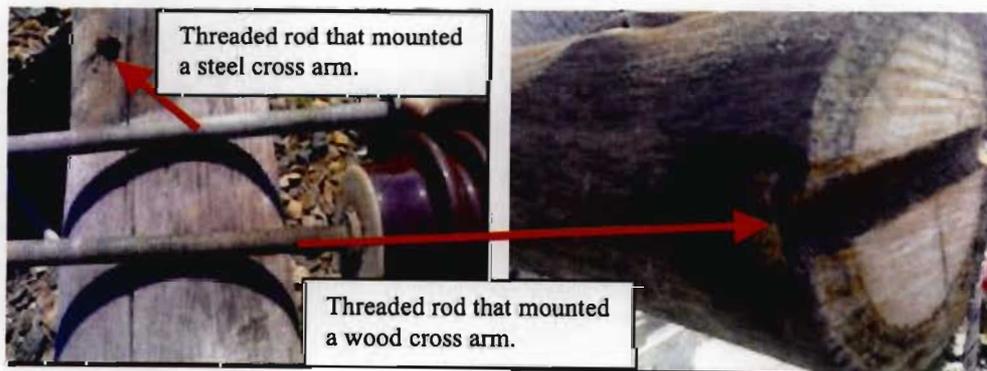
Figure 4 – 9: Comparison of threaded rods from different installations.

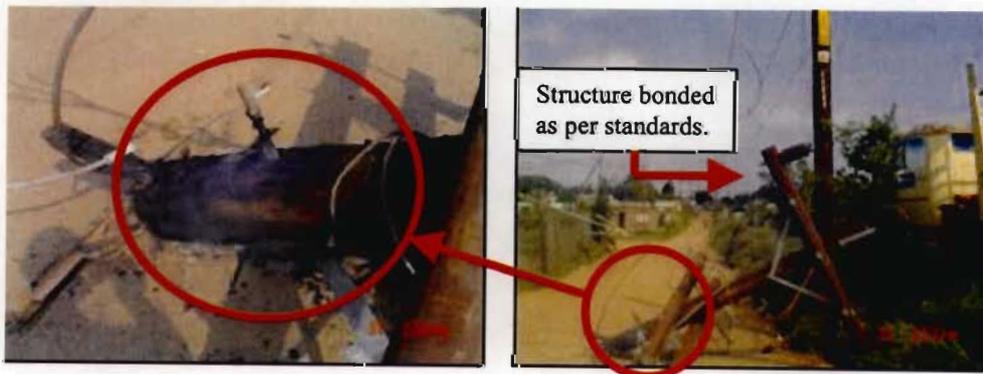
Figure 4 – 10: A burning bonded wood pole with smoke exiting a threaded rod hole.

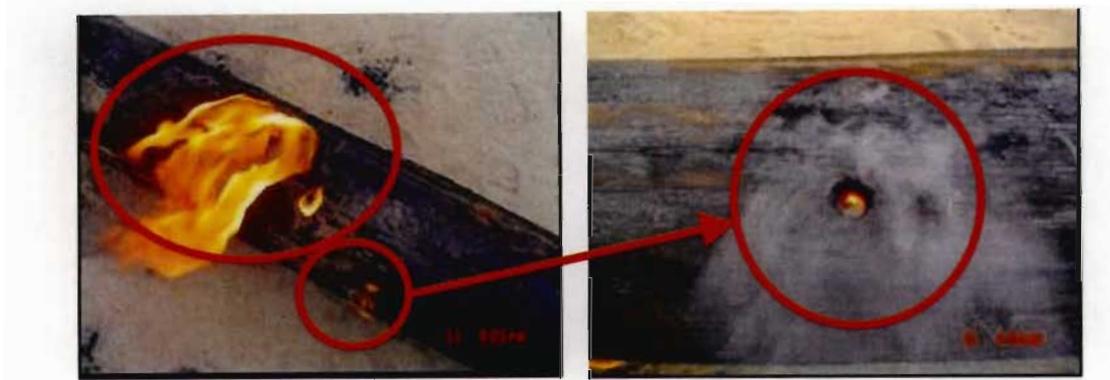
Figure 4 – 11: Flames exiting the threaded rod hole and at other crevices along the pole. Silicone link cut outs were closest to the affected area.

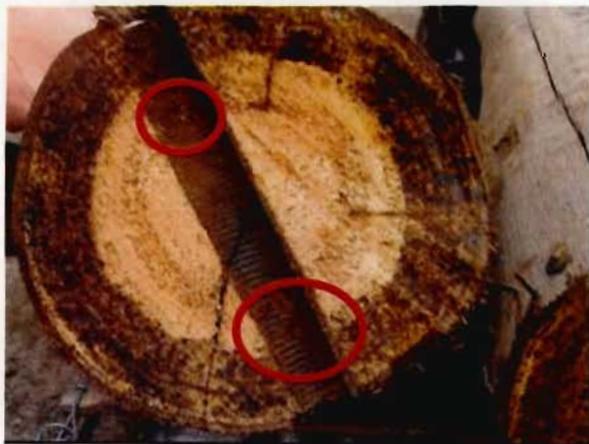
Figure 4 – 15: Illustration of cavities inside the wood cross arm.
