Investigation of the Directional Effect on Low Cost Houses Due to the 2014 Orkney Earthquake

Thando Nqasha

A dissertation submitted in fulfilment of the academic requirements for the
degree of Master of Science in Land Surveying

15 May 2020

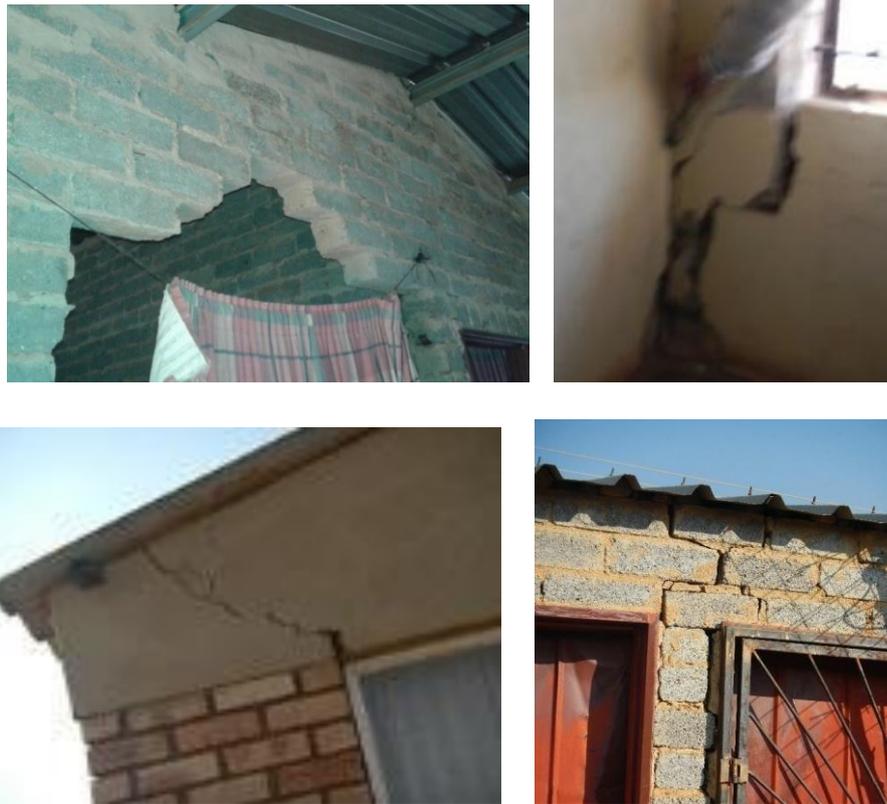
Jouberton was the least affected township, with a total of 7 homes damaged. The damage grade ranged from 20% (slight damage) to 60% (heavy damage) with an average damage grade of 30% (slight to moderate damage). Khoyratty (2016) observed a repeated pattern of damage to building weak points such as: corner cracks in houses, falling of plaster, hairline cracks, damage above windows and door openings (Figure 2-3)

Figure 2-3: Damages observed in low-cost homes during the 05 August 2014 Orkney earthquake (Khoiratty, 2016).

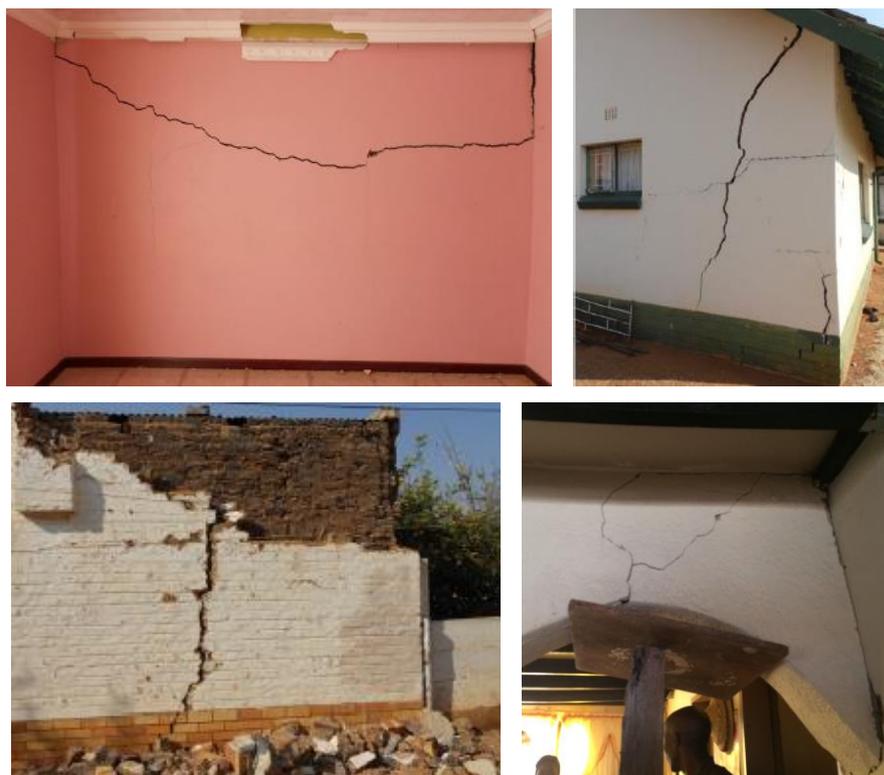
Figure 2-4: Damages observed in RDP homes during the 05 August 2014 Orkney earthquake (Midzi et al., 2015).

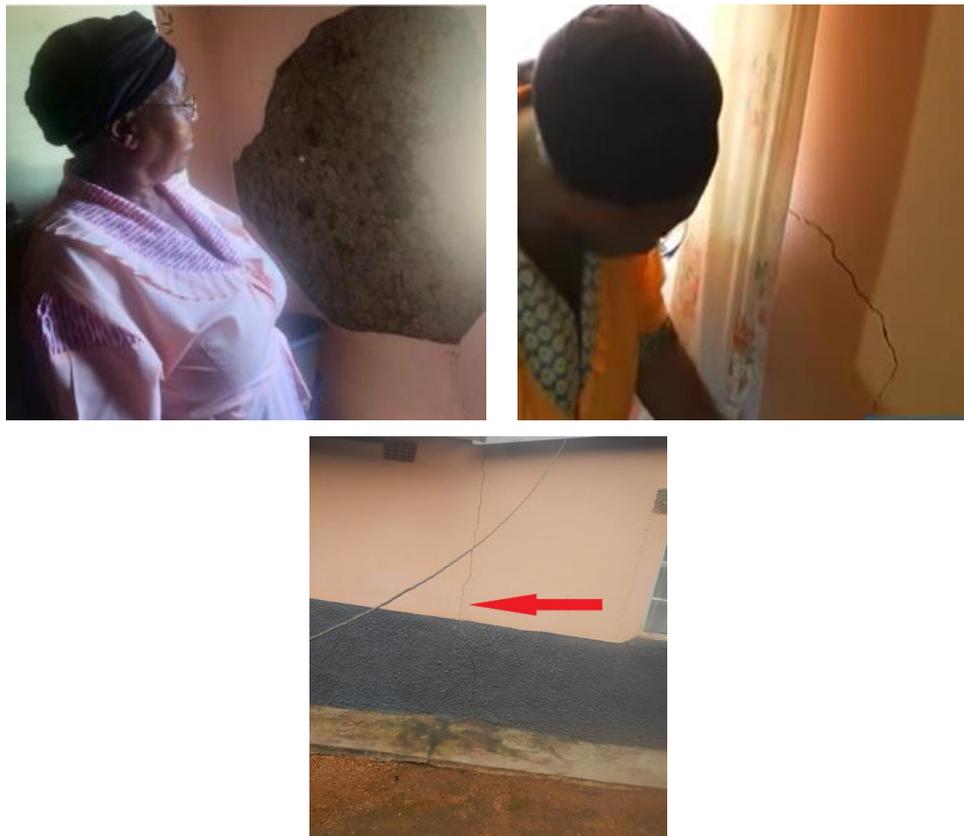
On 15th March 2018 more than 15 houses were damaged due to a tremor that took place in KwaXimba. This tremor was assumed to be caused by exfoliation of a granite dome (Ngubane, 2018; Vilakazi, 2018). Low-cost houses close to the source of the tremor could not withstand the slight seismic load produced (Ngubane, 2018; Vilakazi, 2018). Mrs Duma's house experienced the most damage, which included falling of plaster and hairline cracks on walls (Figure 2-8).

Figure 2-8: Damages sustained by Mrs Duma's house during the tremor

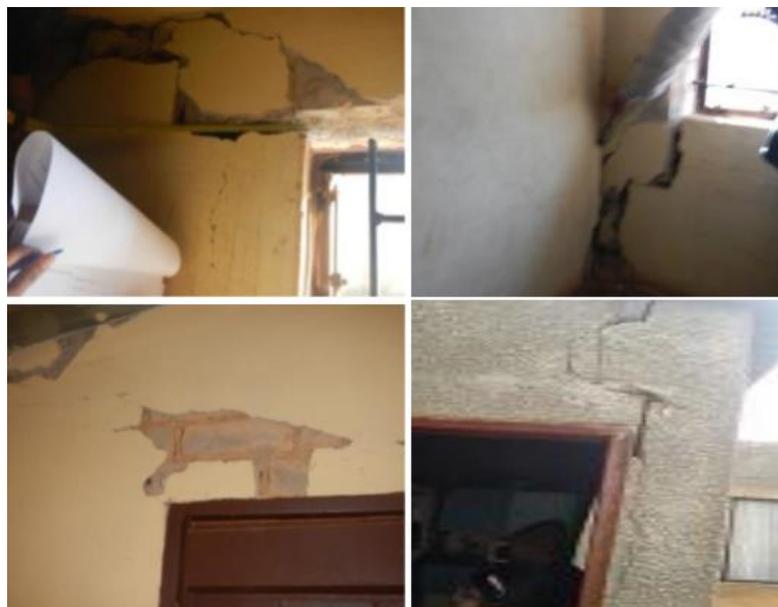
In a post-earthquake field assessment manual by Baggio et al. (2007), one of the key features that determined whether a building has been affected by an earthquake, were found to be cracks propagating from windows and door frames. In the post-earthquake field assessment conducted by Khoyratty (2016), a consistently repeated type of damage was seen where cracks propagated from the windows and door openings (Figure 2-10). A study by Martínez et al. (2006) in characterization of the seismic response of the Mallorca Cathedral, cracks propagating from windows and doors were observed when the building was exposed to earthquake acceleration.

Figure 2-10: Building damages observed in Orkney after the 2014 earthquake. Cracks propagated from windows and door frames (Khoyratty, 2016).
