**HYDRODYNAMICS OF TEMPORARY OPEN
ESTUARIES, WITH CASE STUDIES OF MHLANGA
AND MDLOTI**

Submitted in fulfilment of the requirements for the degree of
Master of Science in Engineering
in the
Civil Engineering Programme
University of Kwa-Zulu Natal

Date of Submission: 5 January 2004

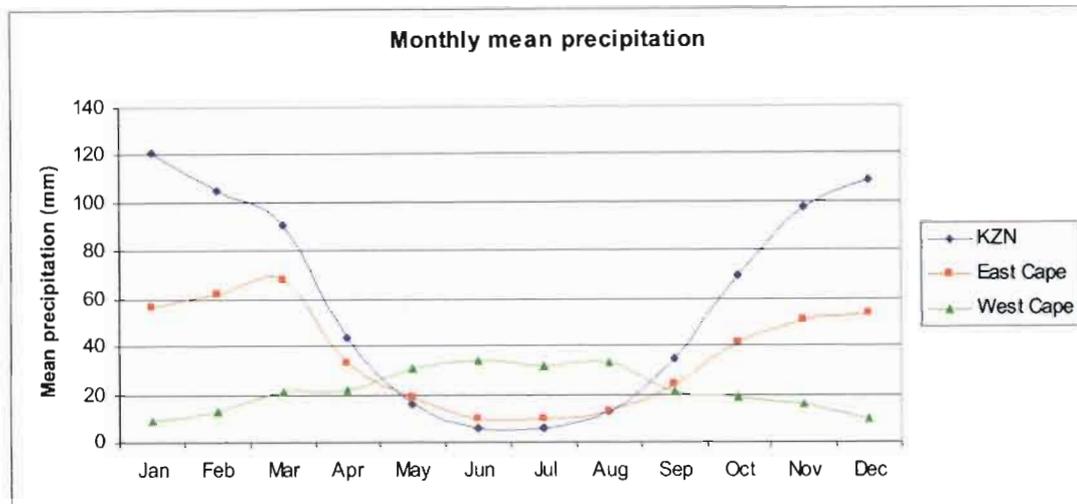
Figure 2-3: Mean monthly precipitation for KwaZulu Natal, Eastern Cape and Western Cape based on data obtained from Schulze (1997).

with peak rainfall in January (summer). The Western Cape differs from the other two provinces as the peak rainfall occurs in winter, and the rainfall pattern is less variable.

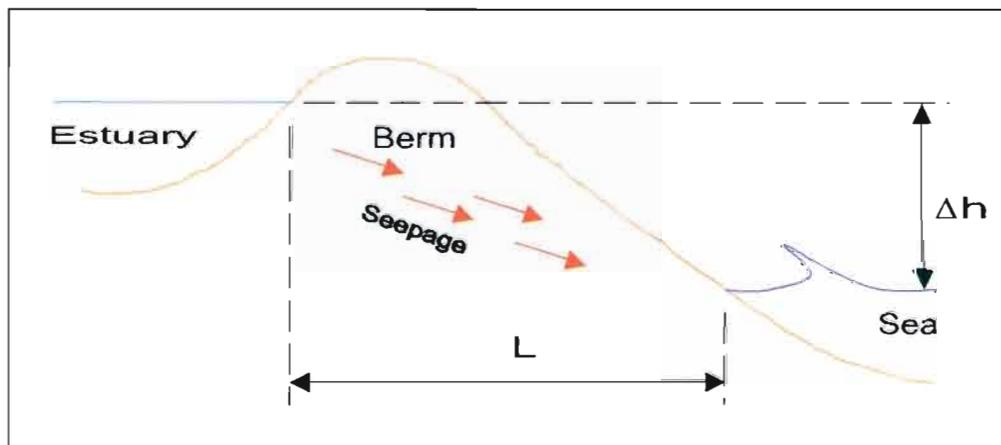
Figure 2-4: Schematic diagram showing the seepage and variables used in determining the hydraulic gradient.

where Δh is the head difference and L represents the length of flow over which head difference occurs. See figure 2-4 for visual interpretation of this relationship.

As the hydraulic gradient increases the rate of seepage through the berm increases until the point is reached at which soil stability is lost. In order for the failure condition to occur and breaching to result, a critical hydraulic gradient must be reached. Therefore an increase in Δh or a decrease in L would aid in reaching the critical value.

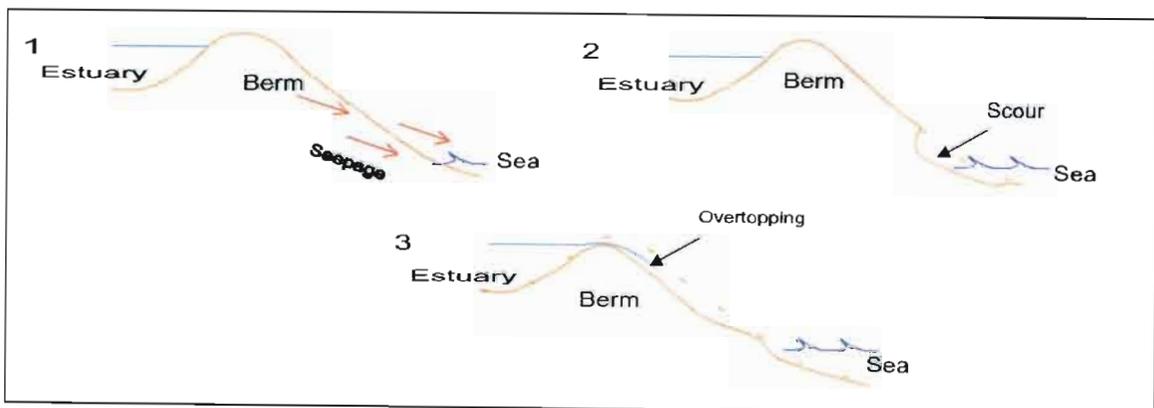
Figure 2-5: The affect of seepage on the breaching mechanism.

A possible mechanism of breaching is that as seepage increases and sand is removed, through sand piping (eg. Gillette, 2003), from the lower end of the sea facing berm it causes the sea slope to slump reducing the width of the berm at this point. Figure 2-5 depicts this form of failure. Step 1 shows seepage through the berm, which increases with increasing water levels until such time as the seepage scours the base of the berm on the seaward side, as shown in step 2. This scour leads to the berm slumping and thereby allowing water from the estuary to overtop the berm and scour the remainder of the mouth, as shown in step 3.

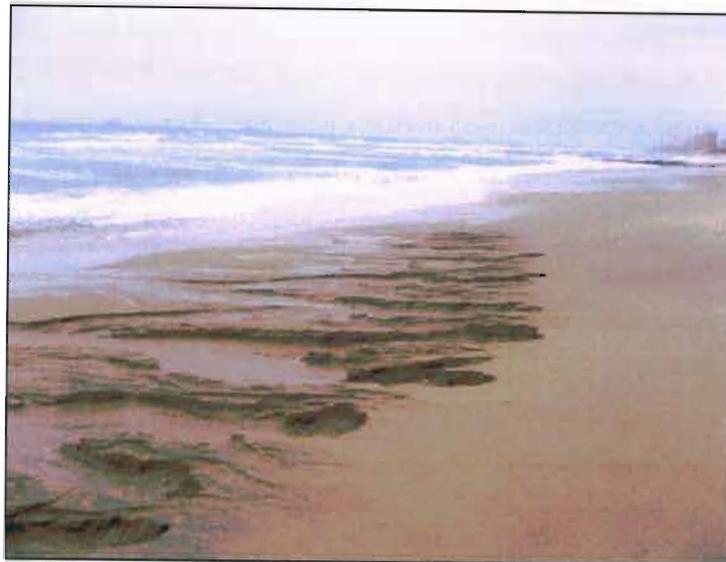
Plate 2-1: Seepage at Mhlanga Estuary.

The initial foundation for this model of breaching comes from observations at Mhlanga Estuary. Prior to two specific breaching events, extensive seepage was present. Plate 2-1 is an example of the seepage observed, with plate 2-2 showing failure of the berm. Unfortunately the actual

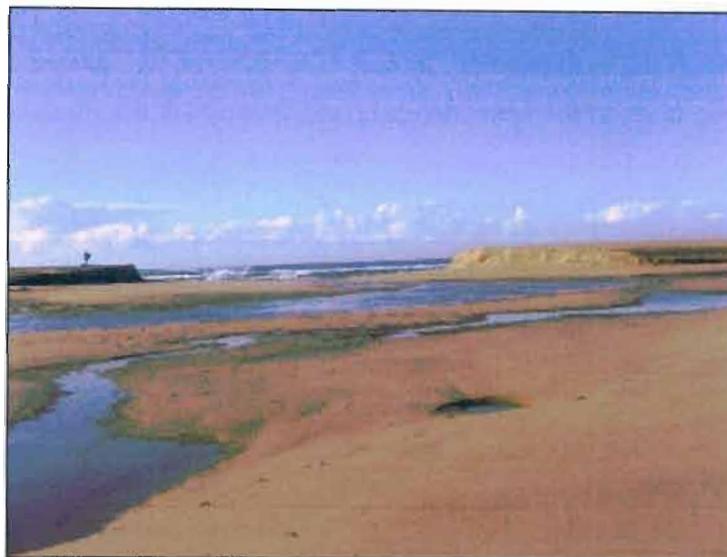
Plate 2-2: Mhlanga Estuary after breaching.

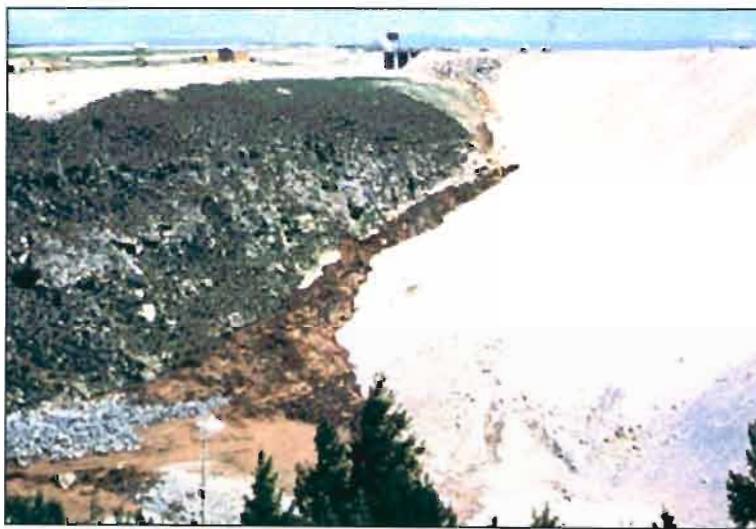
Plate 2-3: Teton Dam, Idaho, several hours after seepage began. (Olson, 1976).

It is interesting to note the similarities between the estuary breaching event and the failure of an earth dam. These similarities are seen in the initial photographs of seepage and the later pictures of the breached estuary and failed dam. The berm of an estuary can in essence be seen as a small earth dam and therefore the seepage and overtopping failure mechanisms of earth dams become applicable to estuaries.

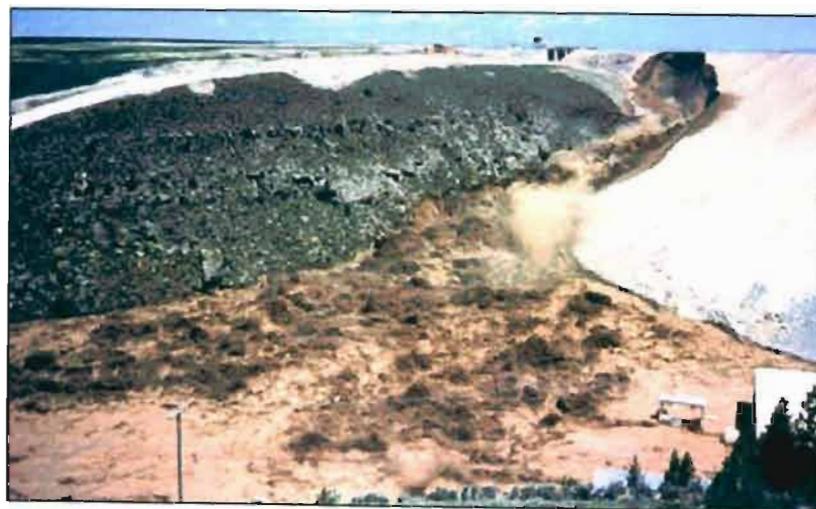
Plate 2-4: Seepage reaches crest of Teton Dam (Olson, 1976).

The estimated time for breaching to develop at Teton Dam was reported as being approximately 6 hours. Although there are several differences between the failure of an earth dam and the breaching of an estuary, the principle behind failure is the same. Some of the differences

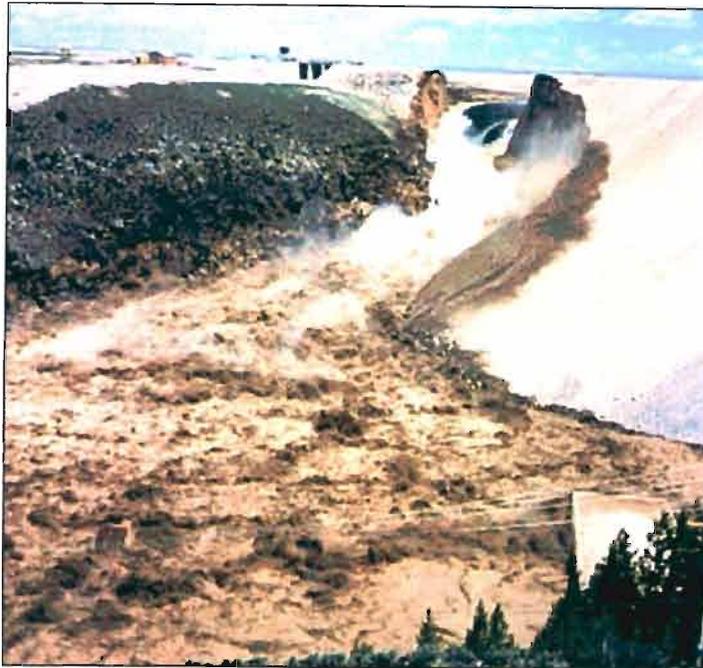
Plate 2-5: The failure of Teton Dam as breach widens (Olson, 1976).

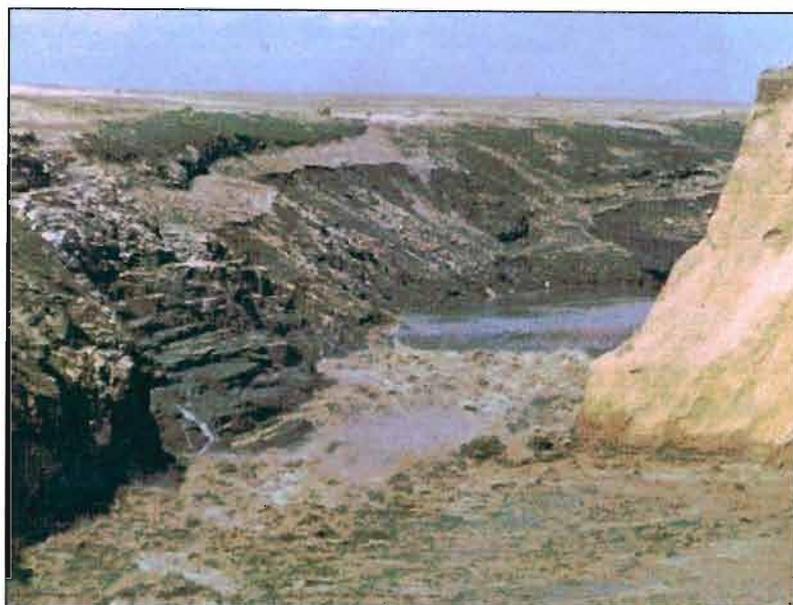
Plate 2-6: Several hours after breaching began, the dam is almost empty (Ponce, 1976)

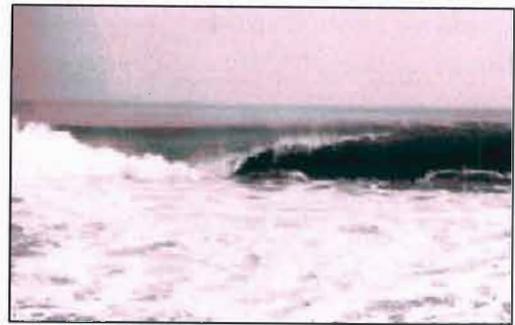
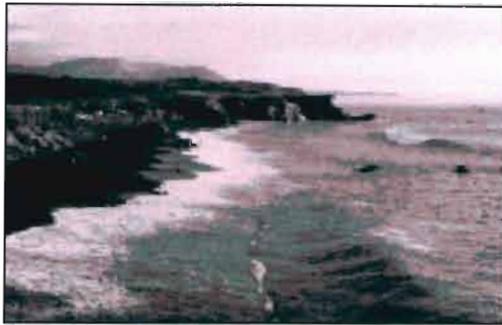
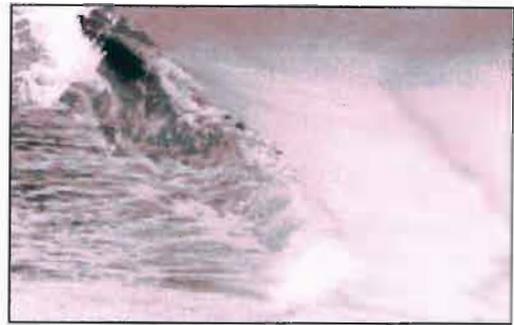
Plate 2-7: The different types of breaking waves are a) spilling, b) plunging, c) surging and d) collapsing (U.S. Army Corps of Engineers, 2002).

Spilling breakers commonly occur on gently sloped beaches, when the wave steepness is high, conversely surging and collapsing breakers tend to occur where low steepness waves come into contact with steep beach slopes. Plunging breakers occur when high steepness waves are combined with steep beach slopes. The plunging and to a lesser extent surging and collapsing breakers are more effective at suspending sediment and therefore cause higher erosion on the beach face, than spilling breakers. As the east coast of South Africa has steep beach slopes, the coast is susceptible to highly erosive breakers.

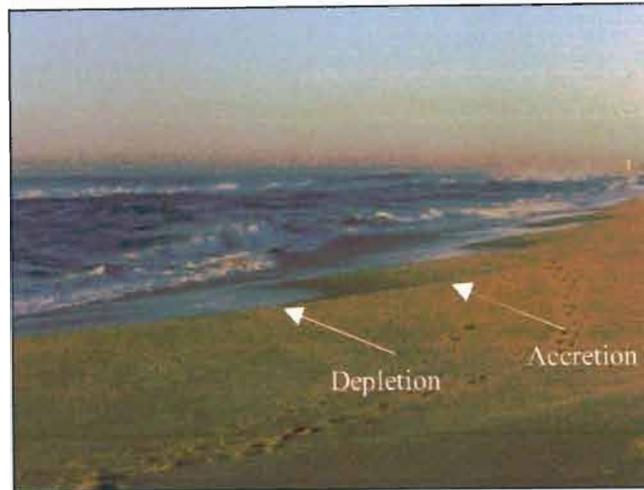
Plate 2-8: Depletion and accretion as observed on Mhlanga beach.

Wave action on the seaward side of the berm aids in reducing the width of the berm through depletion. The regular alongshore pattern of alternating depletion and accretion is shown in plate 2-8, caused by currents alternating between rip and shore bound as observed at Mhlanga Estuary prior to breaching at the end of July. Where the depletion was evident, seepage was visible along the southern portion of the estuary. The reduction in berm width through depletion results in an increase in hydraulic gradient thereby increasing the effects of seepage.

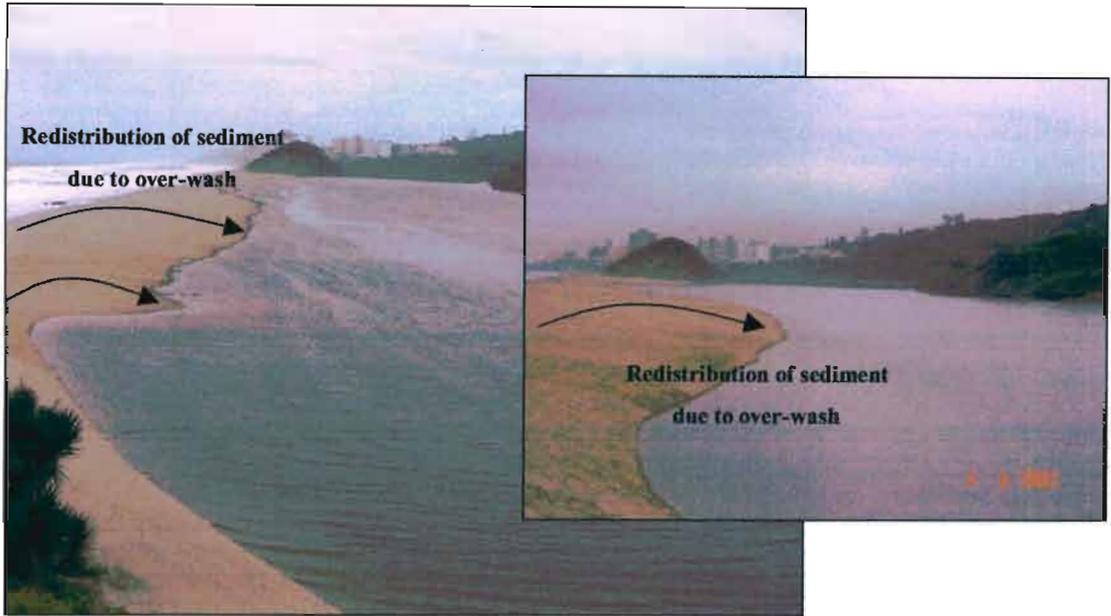
Plate 2-9: Over-wash has widened the berm at Mhlanga Estuary.

Over-wash can also cause an increase in berm width, thereby decreasing the hydraulic gradient and impeding failure through seepage. Plate 2-9 and 2-10 shows the widened berm at Mhlanga and Mdloti Estuaries due to over-wash. The affect of over-wash is visible in the patterns created by the over-washing waves entering the estuary.

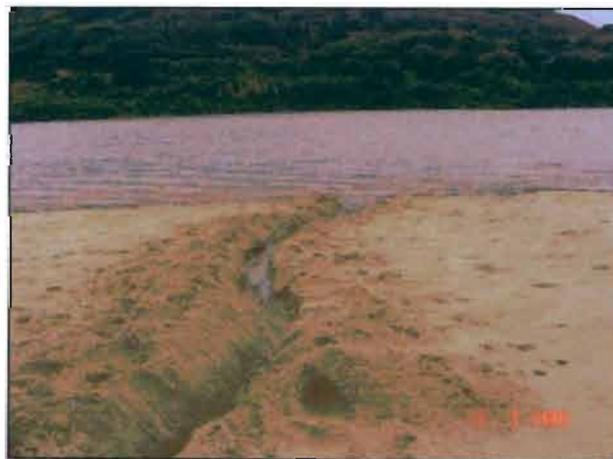
Plate 2-11: Hand dug channel from estuary to the sea.

The increased sedimentation within estuaries is a problem which perpetuates itself until only a large flood event (or dredging) can restore the estuary to health. Historically many of South Africa's estuaries were artificially breached (Begg 1978 & 1984). Plate 2-11 shows a small channel dug by hand by children on the beach at Mhlanga Estuary. The estuary was very full and close to breaching naturally, therefore breaching due to a small perturbation such as this is unlikely to adversely affect the estuary.

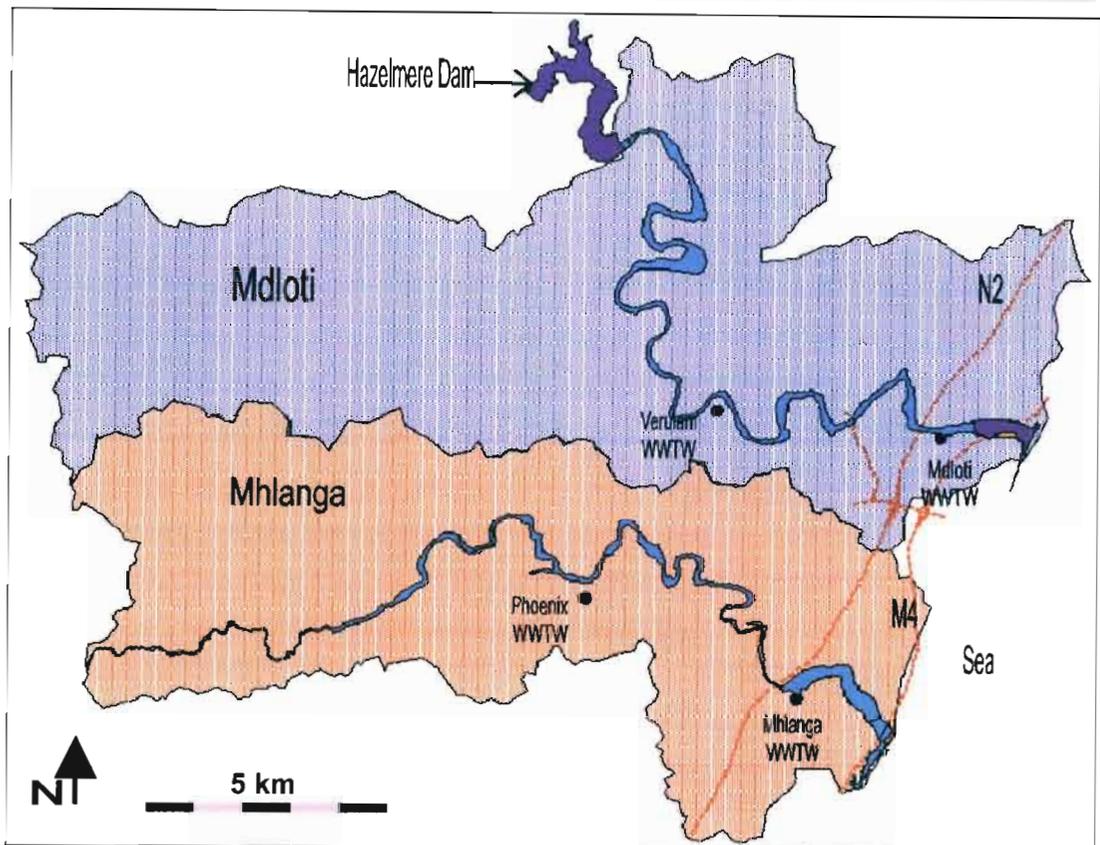
Figure 3-2: The catchment areas for Mdloti and Mhlanga Estuaries. The area shown for Mdloti Estuary is the portion below Hazelmere Dam.

The quaternary catchment area U30B consists of the catchment area for Mhlanga Estuary, the downstream portion of Mdloti Estuary catchment area and some catchment area providing runoff directly into the sea. Therefore the sum of the portions of catchment area for the two estuaries falling within the U30B area should sum to less than 221km². The sum of the two measured areas is 188km², with the remaining 33km² draining towards the coast.

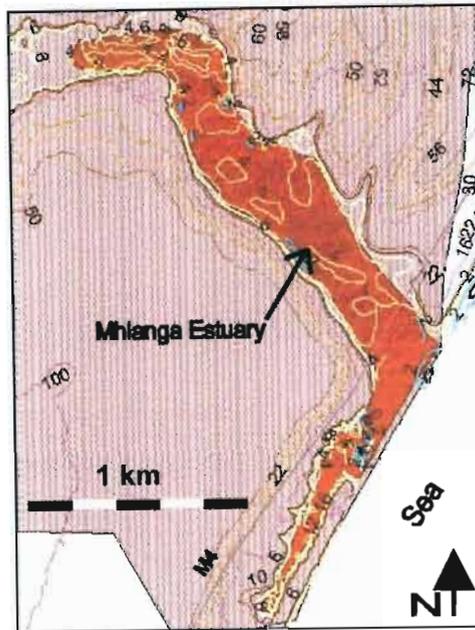
Figure 3-3: Map showing the extent of Mhlanga Estuary.

The area of the lagoon portion of each estuary was measured off a set of orthophotos dated 1992. Unfortunately the detail provided by the 5m contour interval on the orthophotos was not sufficient to determine the true head of the estuary. Therefore the head of the estuary was found by projecting the maximum water level, determined from fieldwork, upstream using the 2m contour data and mapping, dated 2003, supplied by the Durban City Engineers. Figures 3-3 and 3-4 show the Mhlanga and Mdloti lagoons as determined from the contours depicted. Not all of the contours are displayed in the figure as this would clutter the plot, therefore 2m contours are displayed up to 10m above MSL, and thereafter random contours are shown. Note that the values obtained for the surface areas of the estuaries are much larger than those defined by literature (e.g. Begg, 1984), this is probably linked to the definition of the estuary head.

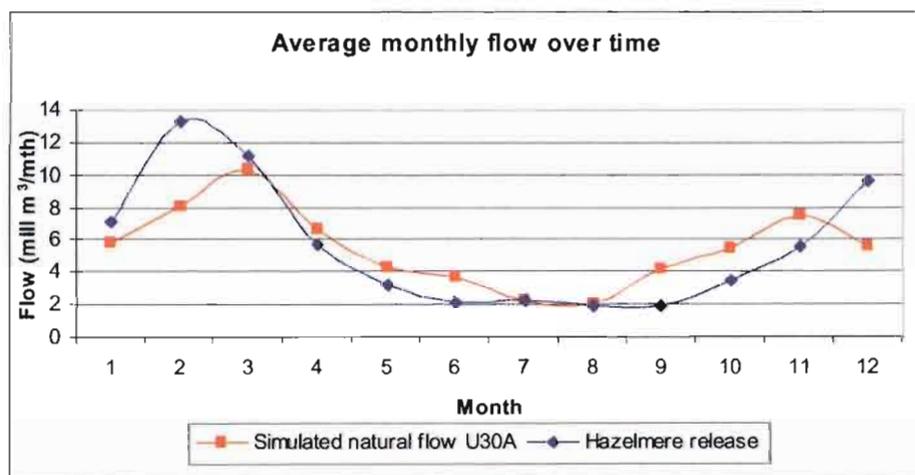
Figure 3-8: Plot of seasonal variations in flow, both simulated natural stream-flow and actual flow released from Hazelmere Dam.

the Hazelmere Dam. Hazelmere Dam was constructed in 1975 and has a net capacity of $23.2 \times 10^6 \text{ m}^3$, with a surface area of approximately 223.9 ha. The effect of the dam on the hydrodynamics is to attenuate flood flows, release less flow under drought conditions and to change the seasonal stream flow pattern. The quaternary area U30A, is the portion of the Mdloti catchment area upstream of Hazelmere Dam. The average monthly stream-flow from the Hazelmere Dam is shown in figure 3-8 together with the simulated natural stream flow for the U30A catchment obtained from Midgley, et al. (1997). It was expected that the flow released from Hazelmere Dam would be lower than the simulated natural stream-flow, however this is not the case. Either the simulated data underestimates the natural stream-flow for the catchment or there is an overestimation of the flows released from Hazelmere Dam creating this inconsistency.

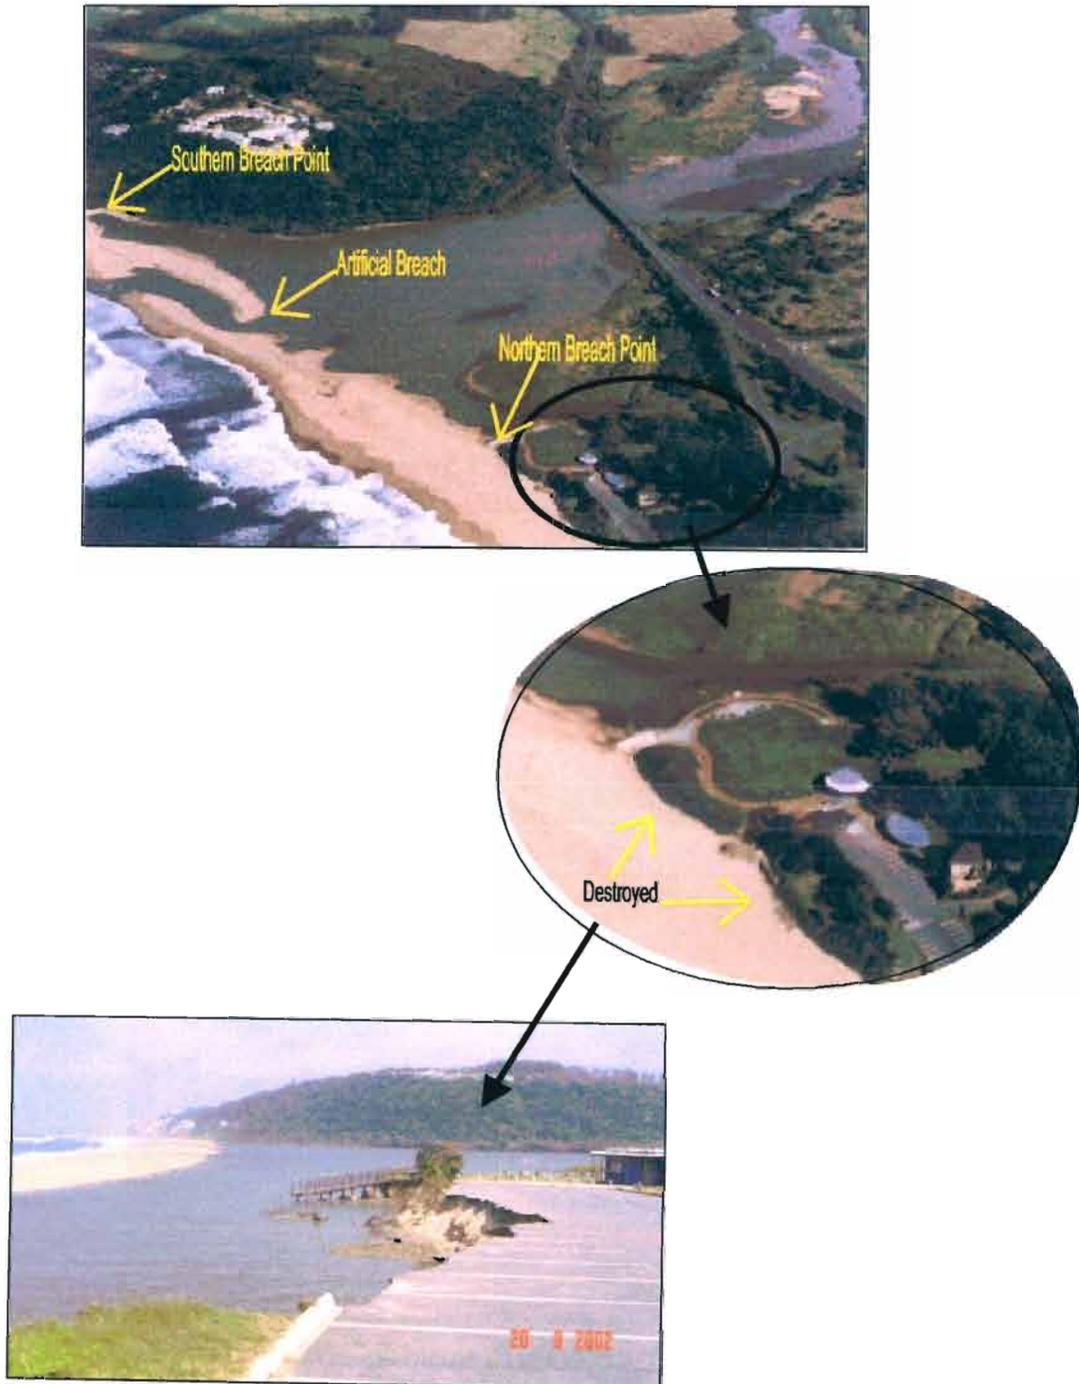
Plate 3-1: The change in position of breaching at Mdloti Estuary and the destruction caused by the recreational centre.

Human influence has also had an impact on the breaching position of the estuary. Plate 3-1 shows the different locations at which the estuary breaches.

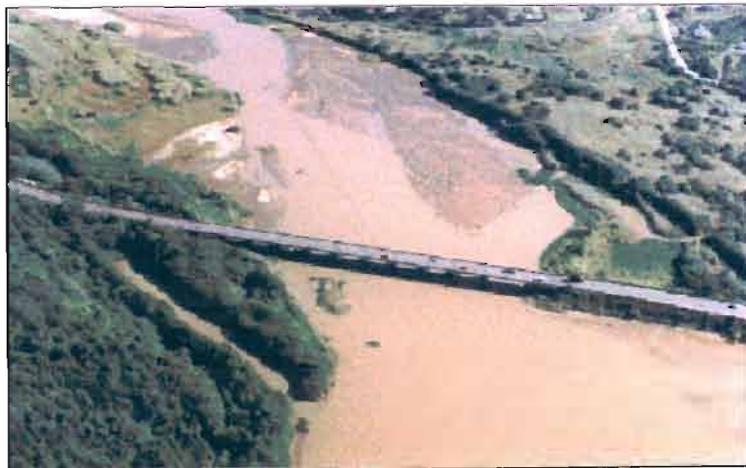
Plate 3-2: The effect of the construction of the M4 bridge.

Other direct human impacts on the estuary include the construction of the M4 bridge across the estuary. In order to build this bridge, embankments were required and these embankments resulted in the loss of the old flood channel on both the northern and southern banks, as seen in plate 3-2. The bridge and embankments would therefore also have altered the flow and sedimentation patterns.

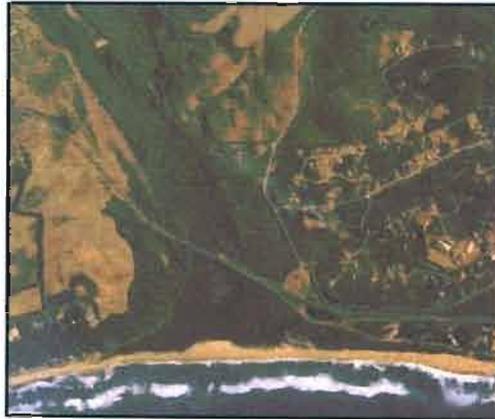
Plate 3-3: An aerial photograph taken in 1985, showing pre-flood conditions.
(Perry, 1989)

The flood of 1987 led to a much wider mouth eliminating the majority of the berm. Plate 3-3 was taken prior to the flood and the contrasting flood conditions are shown in plate 3-4. The flood also resulted in the failure of the bridge across the estuary.

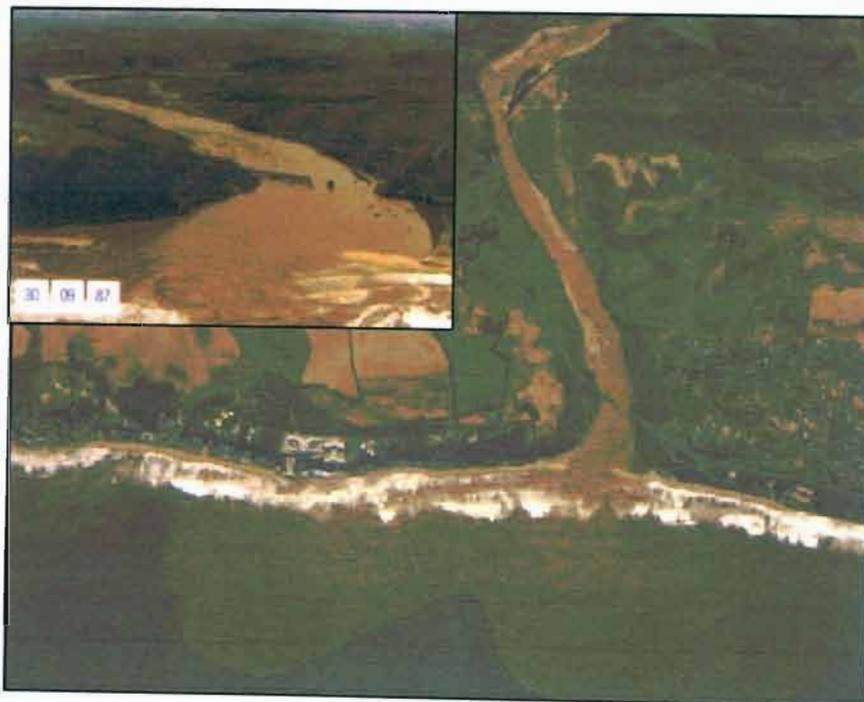
Plate 3-4: The affect of the 1987 flood on the sand berm of Mdloti Estuary. (Perry, 1989)

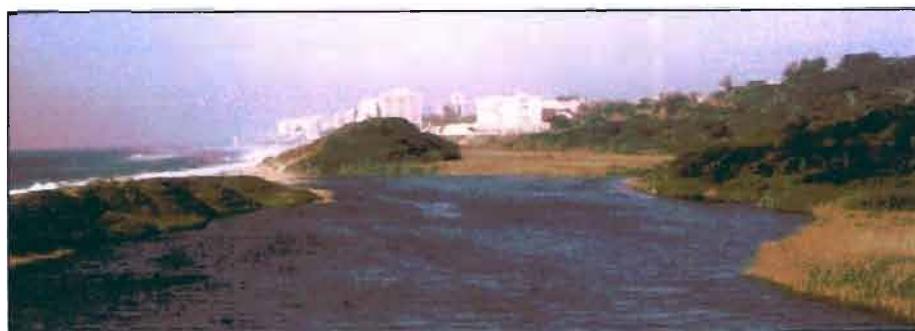
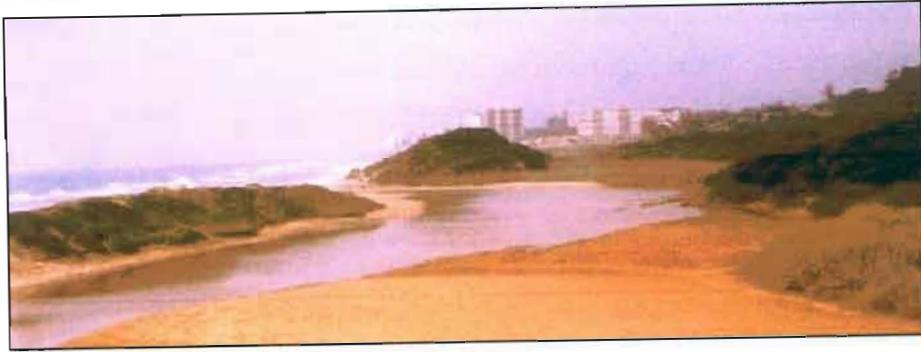
Plate 3-5: Plates a) & b) show the estuary in the open and closed state before the loss of the vegetated dune (Whitfield, Bate, Colloty and Taylor, www.upe.ac.za).

The sand bar separating Mhlanga Estuary from the sea was historically a vegetated sand dune, as shown in plate 3-5. Begg (1984) reported the loss of vegetation to the north due to trampling. As a result of the loss of vegetation, wind erosion affected this section of the berm lowering it and allowing for over-wash. This weakened this part of the berm and in 1980 a small flood broke through, altering the natural position of the mouth. It is possible that the combination of trampling of vegetation and a large flood resulted in the loss of the rest of the vegetation on the dune. The lack of vegetation means the berm has lost some of its protection as the plant coverage helps to keep the sand intact. The present state of the berm is shown in plate 3-6.

The mouth of the estuary is generally located to the south, as seen in the plates; this phenomenon has not changed despite the loss of vegetation of the dune, and possible reduction in berm height. The southern portion of the estuary has a reef within the onshore zone, which could influence the position of the breach.

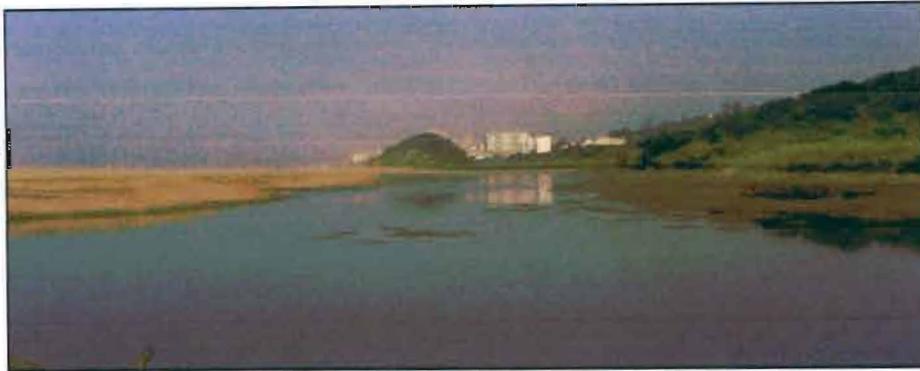
Plate 3-6: Plates a) & b) show the present state of the estuary in both the closed (a) and open (b) states.

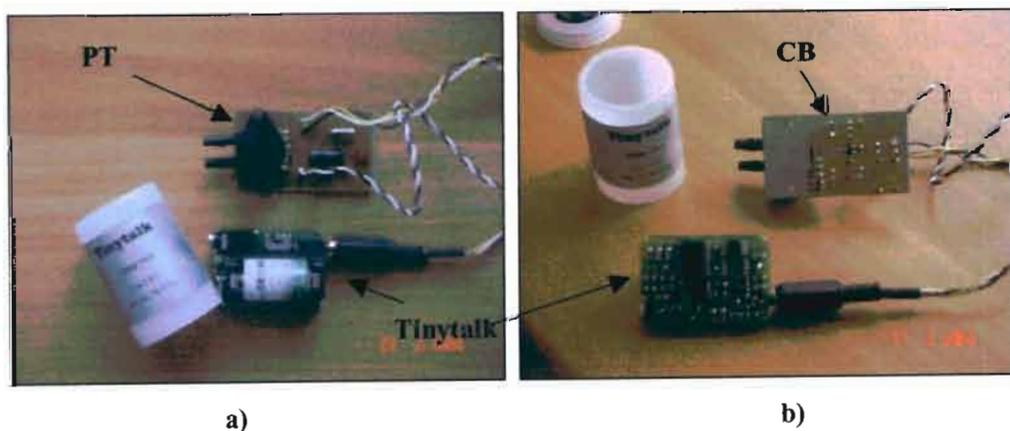
Plate 4-3: Different views of the Tynytalk data logger and the pressure transducer mounted on a circuit board along with the microprocessor, are shown in a) and b).

A problem arose with the initial design of the water level monitor as the sensing signal generated by the logger only allows for a 150 millisecond warm up period, whilst the pressure transducer requires 15 seconds to warm up. To overcome this problem a PIC microcontroller was incorporated with the technical assistance of Mr R Van Zyl, from the University of Natal Pietermaritzburg (UNP). This microcontroller was programmed to continuously monitor the time between sensing signals and used this time to turn on the voltage regulator for the required 15 second warm up period prior to sampling. Plate 4-3 shows a Tynytalk data logger and the pressure transducer mounted on a printed circuit board designed and built by Mr R van Zyl of UNP and incorporating the PIC microcontroller. The circuitry for the board, the component list and costs are given in appendix D.

The Tynytalk TK0702 has an eight bit resolution; therefore it has 256 levels (from 0 to 255) to measure a 5 meter column of water giving an accuracy of approximately 20 millimetres. Compensation for changes in atmospheric pressure is required as variations of 200 mm can occur over extended time periods. The manufacturer's specifications are included in appendix E.

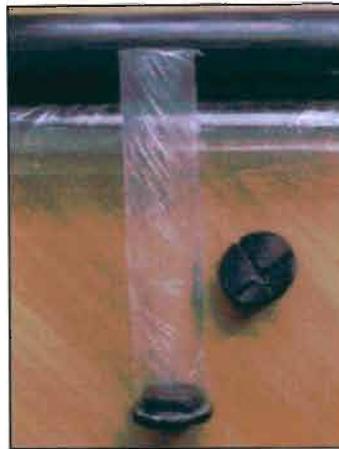
Plate 4-4: The materials for the capsule comprising of perspex tubing and HDPE end plugs.

Electronic equipment requires a dry environment in which to function, therefore the water level meter needed to be housed in a water tight capsule. A clear Perspex tube was used with an inner diameter of 34mm and a 40mm outer diameter. The end plugs were constructed on a lathe from a 50mm diameter high density polyethylene (HDPE) rod. The casing and raw materials are shown in plate 4-4. O-Rings and silicone grease were used to create the seal between the plugs and the tube. One plug was drilled in order to accommodate the pressure sensor, the exposed surface was countersunk and recessed grooves were machined as a precaution to prevent false readings when using a bladder, described below. A bleed hole was created in the other cap by drilling and tapping a hole, with a screw as a bleed cap and a greased o-ring to ensure no leaks. Both the electronics and the casing were tested under laboratory conditions before placing the water level monitors in the field. The test cell shown in plate 4-5 was used to test the water level monitors.

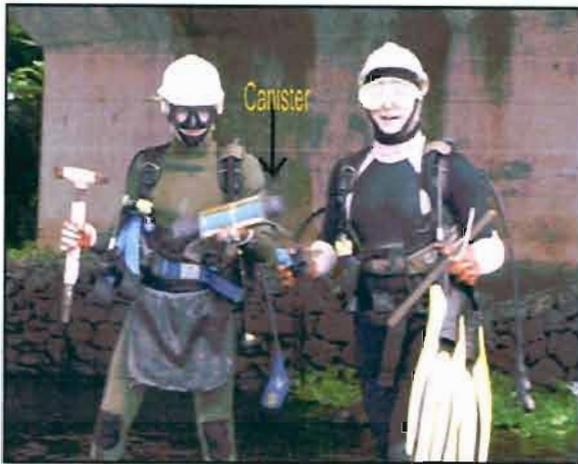
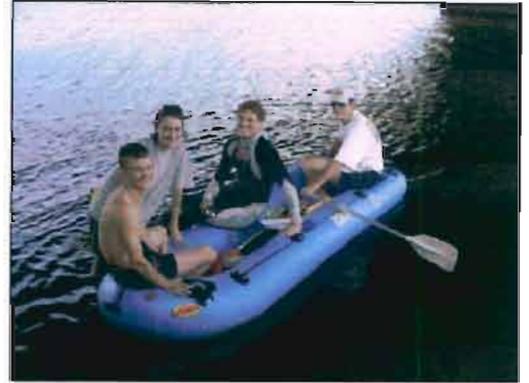
Plate 4-9: Installing the water level monitors using the boat and divers. The plate on the left shows the divers holding the canister before installation.

In order to ensure the water level monitor was always placed in the same place and could not float away a perforated container was fixed in the estuary. The initial canister design was a section of steel pipe sealed on one end with a lid on the other attached to a steel stake about 1 meter in length. The idea behind the design was that the stake would be driven into the floor of the estuary near the M4 bridge, however this did not work in practice as it was not easy to drive the stake into the ground underwater. The second design consisted of PVC pipe with an end cap on one side and a lid on the other. This canister was attached to the piles underneath the bridge pile caps using stainless steel brackets, rope and stainless steel wire. Scuba divers, shown in plate 4-9, were used to place the containers under the pile caps. The position of the canisters at Mdloti and Mhlanga Estuaries are shown in plate 4-7 and 4-8 respectively.

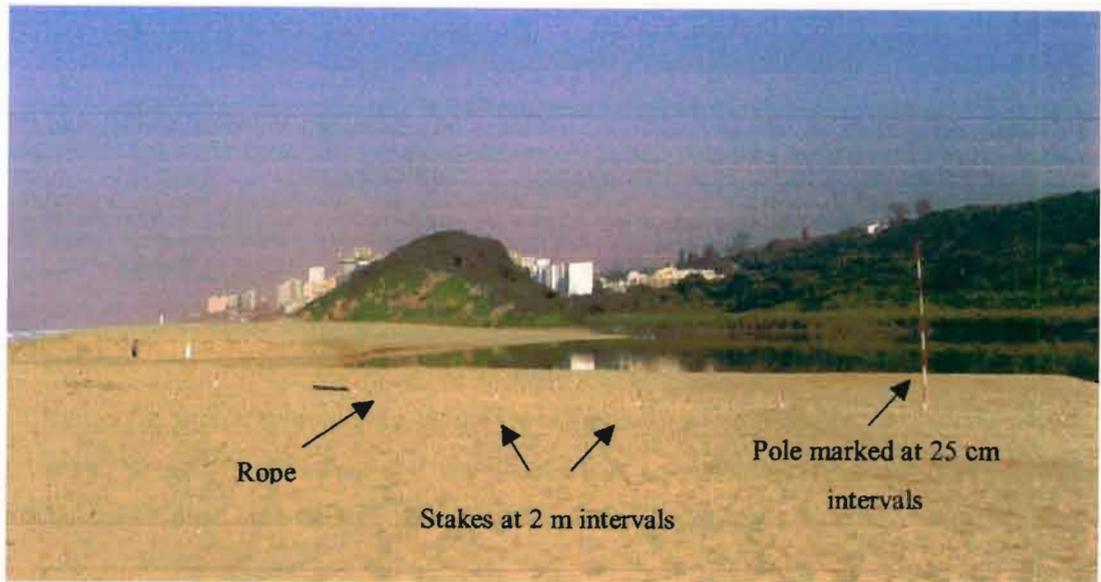
Plate 4-10: Example of photographs used in the determination of beach profile.

Poles, marked at 25 centimetre intervals, were placed at the edge of the estuary and edge of the sea, with a rope between the two. The rope had two meter markings on it and at each two meter point a stake was driven into the sand. Photographs of the beach were taken using a digital camera fixed to a levelled tripod. The poles were used to provide a vertical scale for the picture while the stakes provided a horizontal scale. Levelling the tripod on sand was not always very accurate as sand is not a stable surface on which to work, therefore the horizon was used during post processing to ensure the data obtained was level. Plate 4-10 is an example of the photographs used in determining the beach profiles.

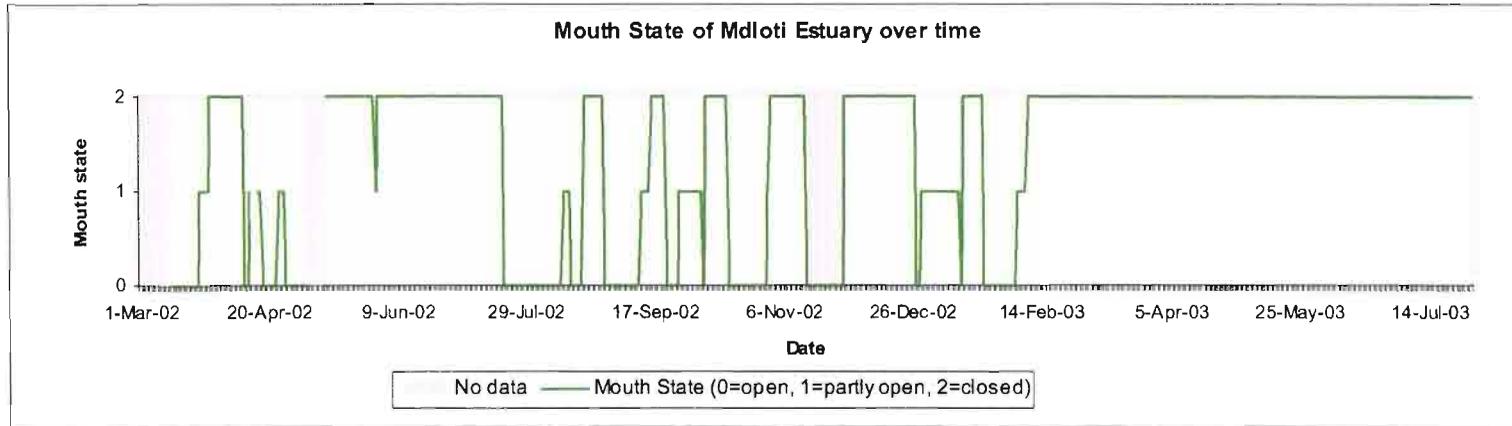
Figure 5-4: The mouth state at Mdloti Estuary over the observation period.

Ramm et al. (1986) stated that Mhlanga Estuary is typically closed 96% of the time, while Mdloti Estuary is closed 64% of the time. CSIR, 2002 reports that Mhlanga and Mdloti Estuaries are closed/semi-closed 75% and 73% of the time respectively, under present conditions. It was therefore expected that Mdloti Estuary would breach more frequently than

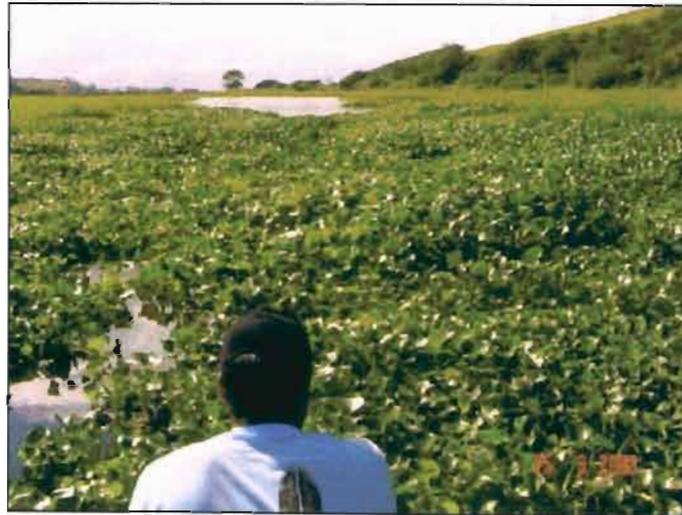
Plate 5-1: Water hyacinth preventing flow measurements upstream of Mdloti estuary.

No flow measurements were made for Mdloti Estuary between February and June 2003, due to accessibility problems encountered upstream of the estuary, as seen in plate 5-1.

The abundance of water hyacinth upstream of Mdloti Estuary made it very difficult to gain access to the head of the estuary by boat. After travelling as far as the hyacinth would permit attempts to measure the flow were unsuccessful as there was no measurable flow. While the estuary remained closed the water hyacinth remained a problem upstream. Eventually alternative access to Mdloti River via a small bridge near Mt. Moreland, upstream of the hyacinth problem, was found suitable for taking readings.

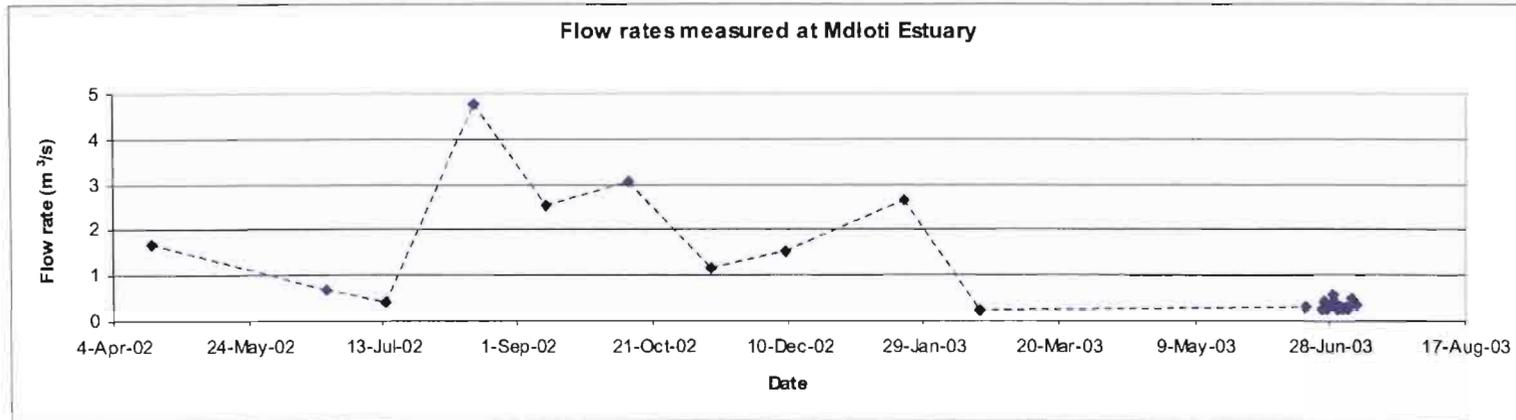
Figure 5-6: Spot flow data measured at Mdloti Estuary over the observation period. (Points joined by dotted line for clarity).

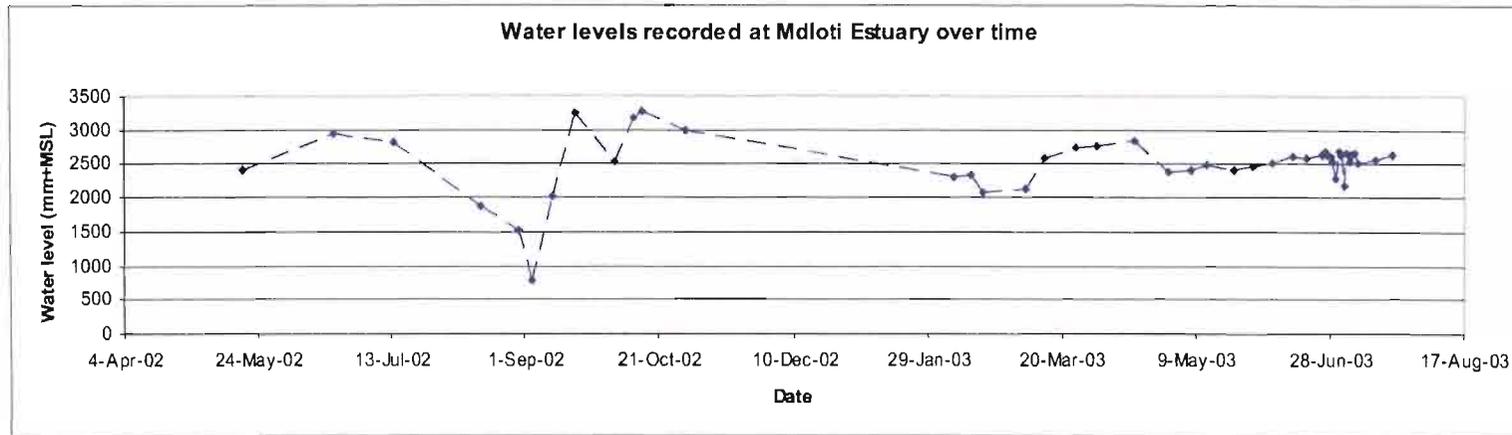
Figure 5-8: Spot water level data measured at Mdloti Estuary over the observation period. (Points joined by dotted line for clarity).

The water level data was as expected lower when the estuary was open and shortly after closing than when it had been closed for a period of time. From the water level data for Mdloti Estuary figure 5-8 was produced. Figures 5-9, 5-10 and 5-11 represent the water level data for Mhlanga Estuary. Appendix G contains the water level data obtained from photographs of the bridges as well as an example of the data captured by the water level monitors.

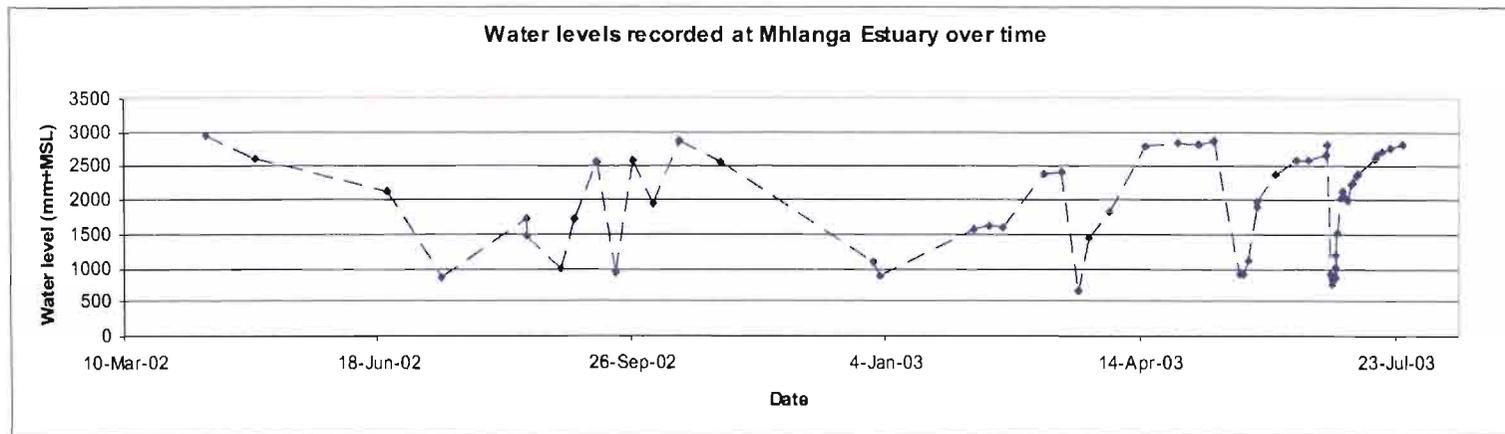
Figure 5-9: Spot water level measurements at Mhlanga Estuary over the observation period. (Points joined by dotted line for clarity).

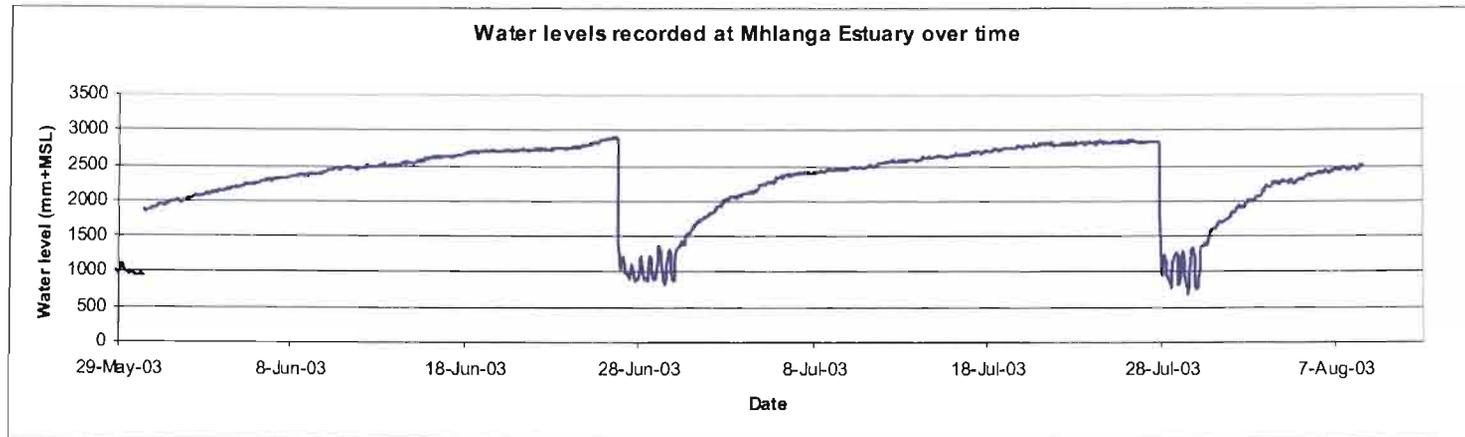
Figure 5-11: Continuous water level data measured, using water level monitors, between March 2003 and August 2003.

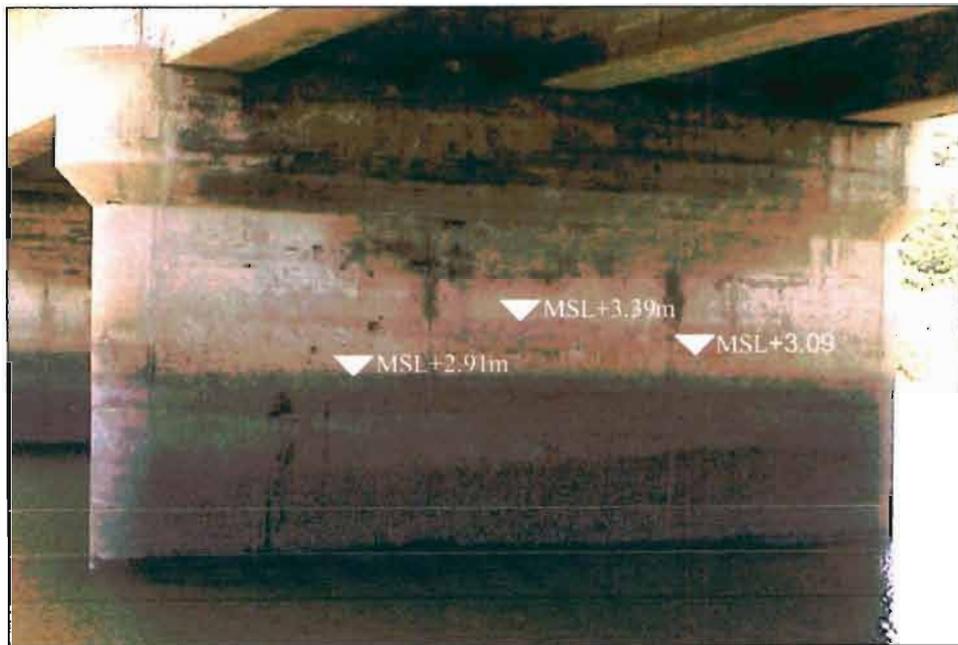
Plate 5-2: The high water mark on the M4 bridge over the Mhlanga Estuary.

From plate 5-2 and 5-3 of the M4 bridges over the two estuaries, distinct high water marks are visible. The various water marks indicate the different breaching levels attained by the estuaries.

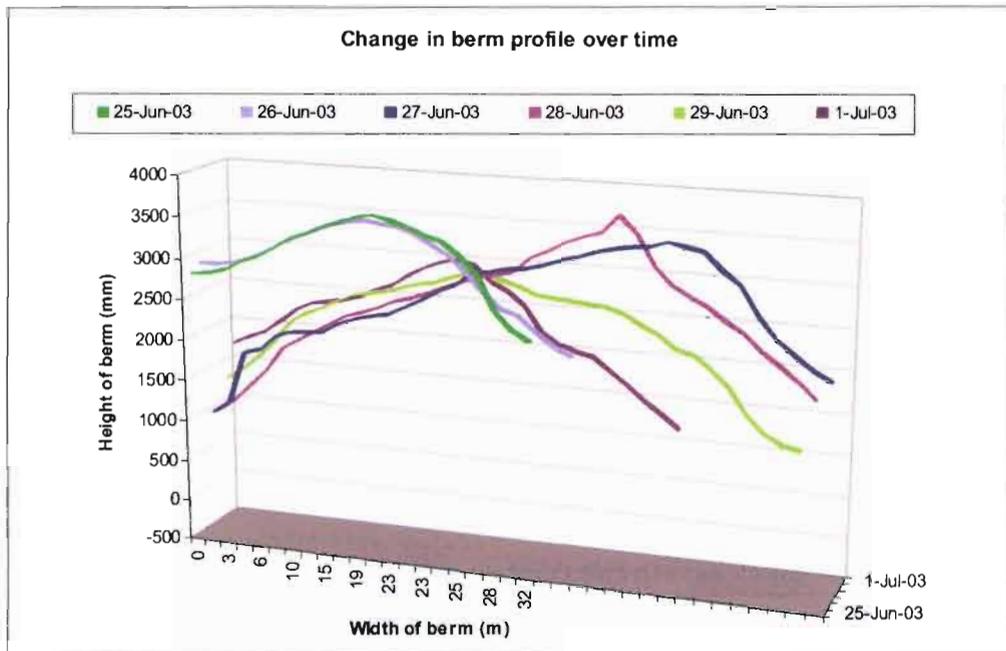
Figure 5-12: Ribbon plots of selective beach profiles measured at Mhlanga Estuary.
