**HYDRODYNAMICS OF TEMPORARY OPEN
ESTUARIES, WITH CASE STUDIES OF MHLANGA
AND MDLOTI**

Submitted in fulfilment of the requirements for the degree of
Master of Science in Engineering
in the
Civil Engineering Programme
University of Kwa-Zulu Natal

Date of Submission: 5 January 2004

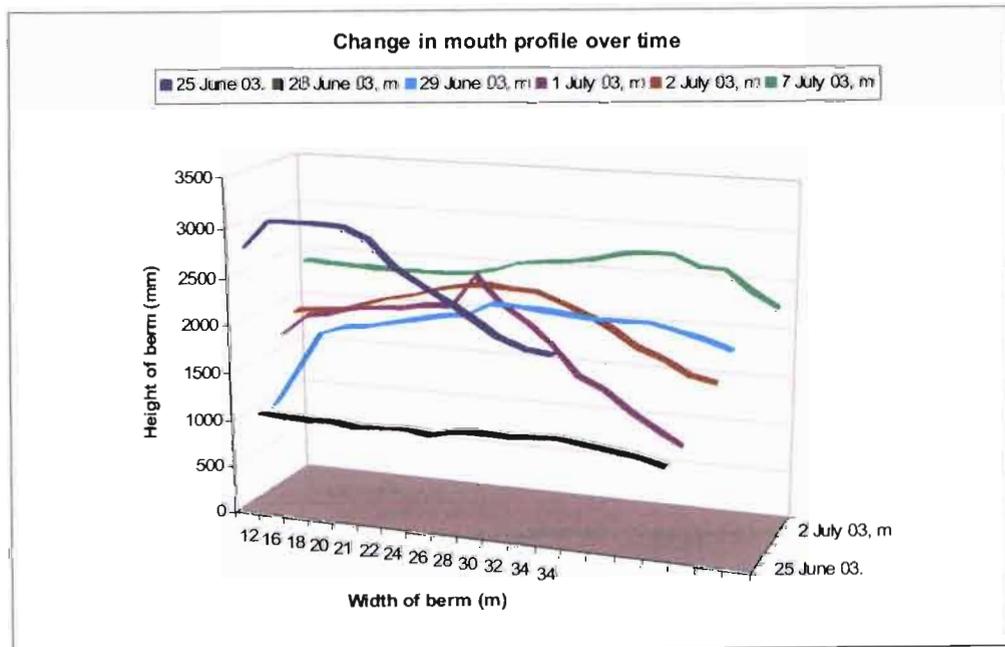
Figure 5-13: Ribbon plots of selective mouth profiles measured at Mhlanga Estuary.

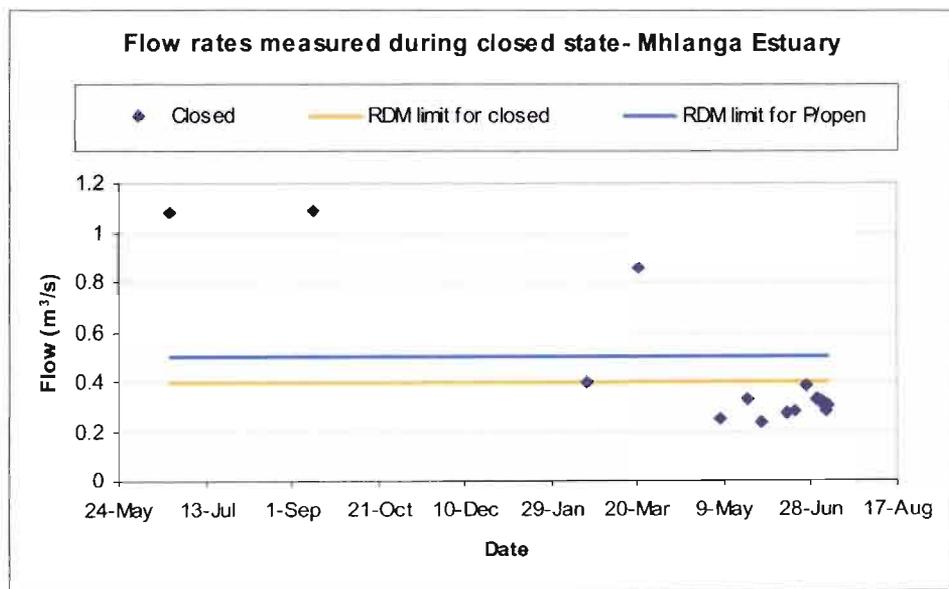
Figure 5-18: Comparison of the flow rates obtained during the closed state at Mhlanga Estuary with RDM thresholds.

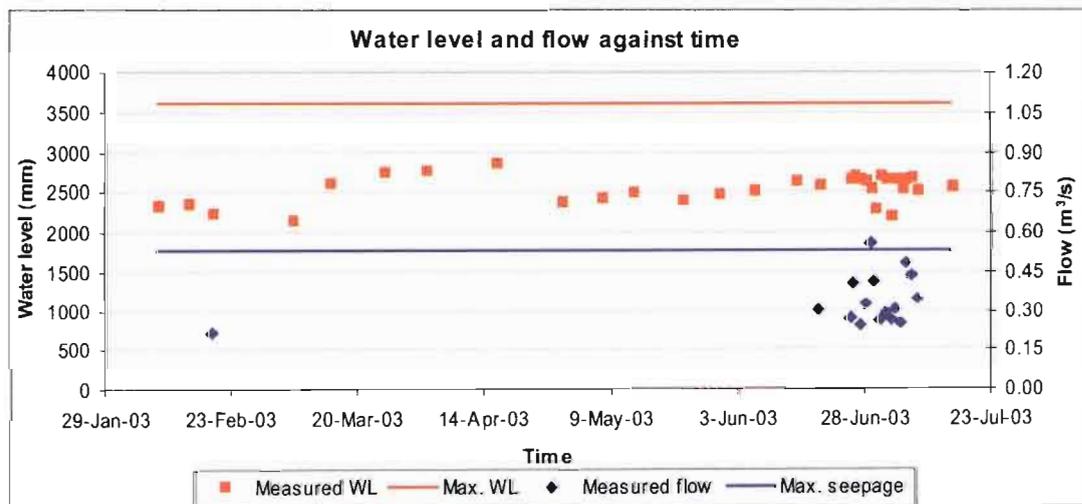
Figure 5-20: Water levels and flow rates over time for Mdloti Estuary, with an indication of the maximum water level and maximum seepage.

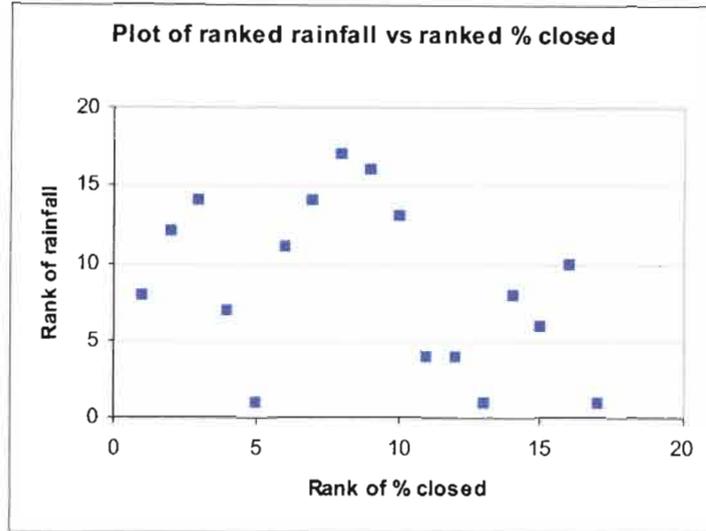
Figure 5-23: Ranks of monthly rainfall and percentage of time in the corresponding month that the estuary mouth was closed.

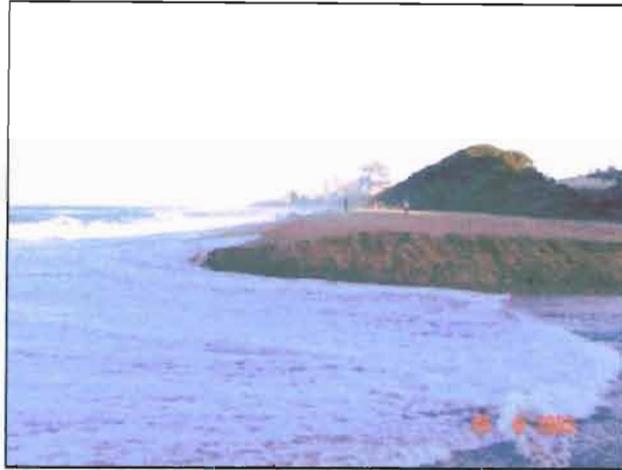
Plate 5-4: High tide pushing in through the entire width of the mouth.

Visual observations provided an explanation for the flood dominated tidal exchanges at Mhlanga Estuary. At high tide, water washing into the estuary uses the entire width of the mouth, as seen in plate 5-4, however when the water leaves the estuary, it flows out of a small channel in the middle of the mouth as shown in plate 5-5, thus causing the estuary to fill quicker than it empties.

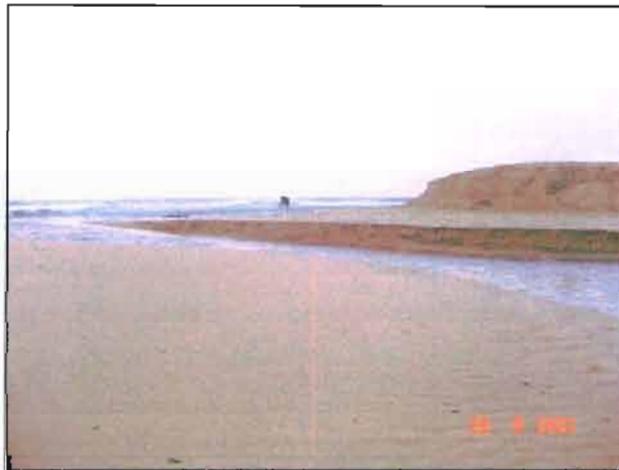
Plate 5-5: A channel within the mouth of Mhlanga Estuary.

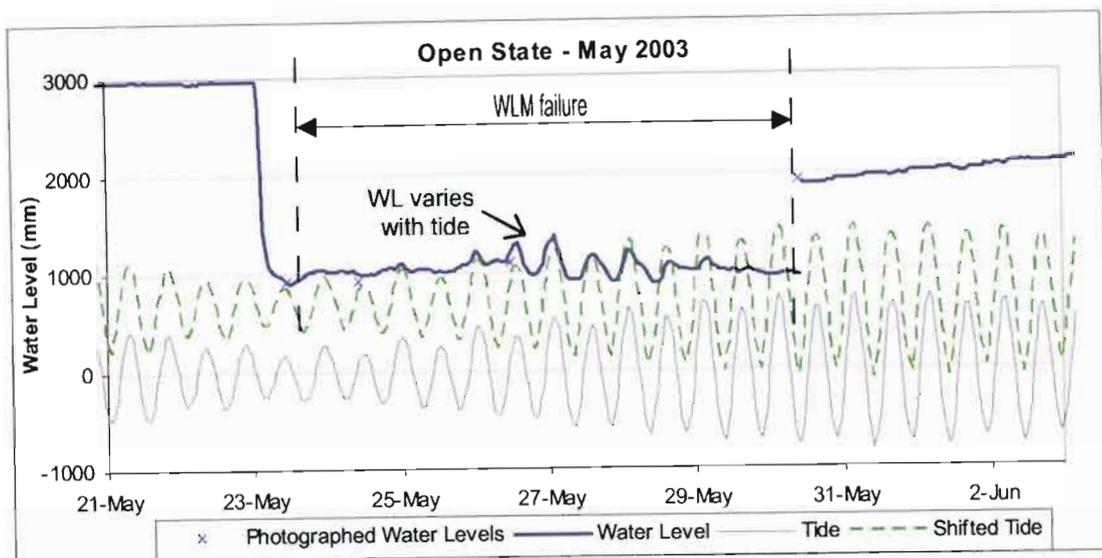
Figure 5-29: The data collected over the open phase during May 2003.

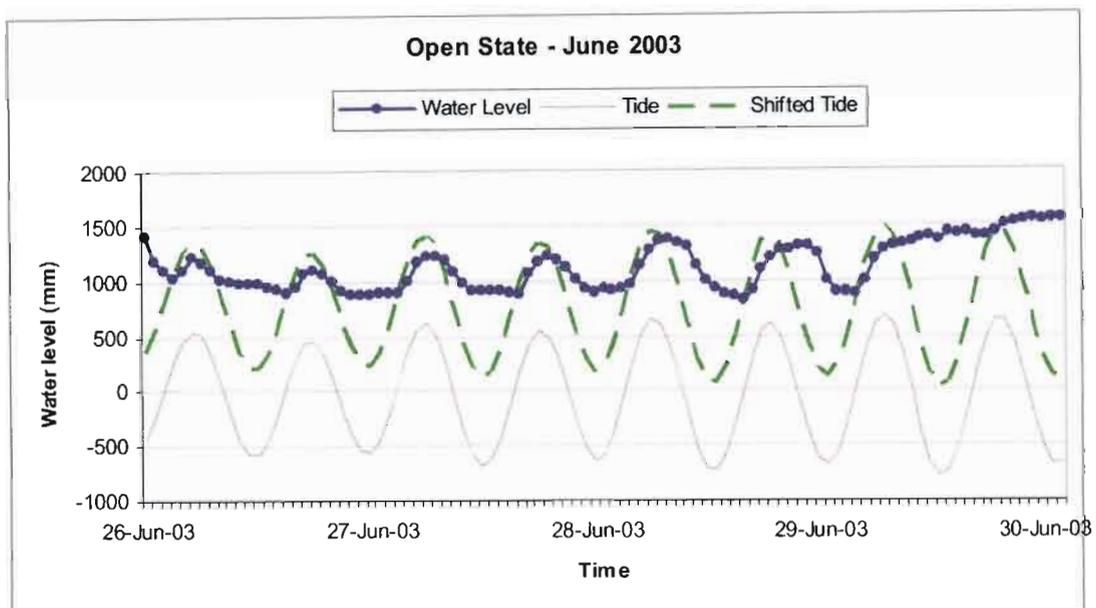
Figure 5-30: The open state captured by the water level monitor during June 2003.

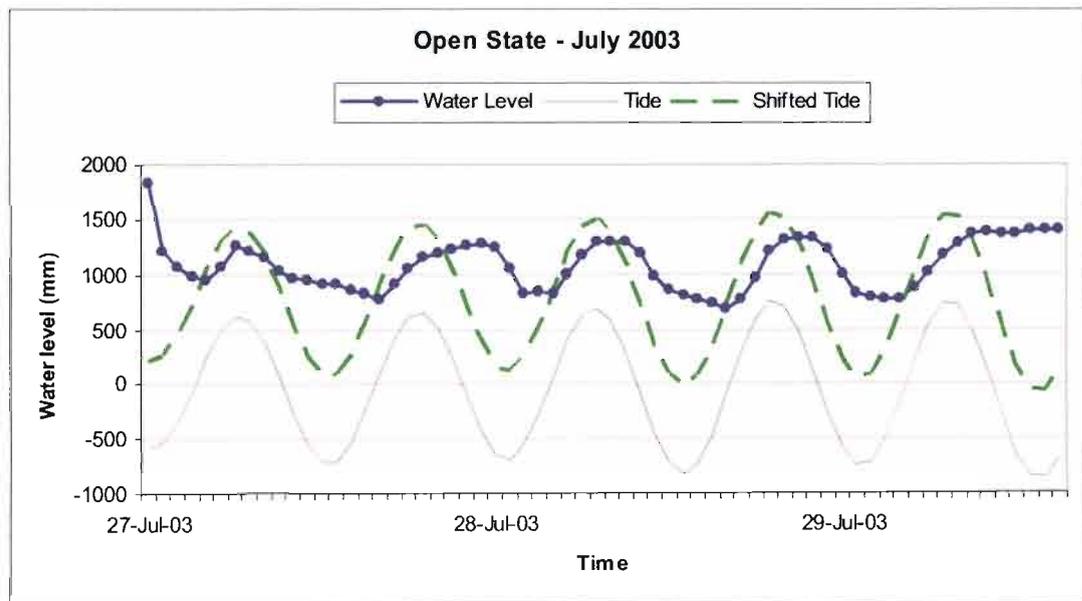
Figure 5-31: The open state at Mhlanga Estuary during July 2003.

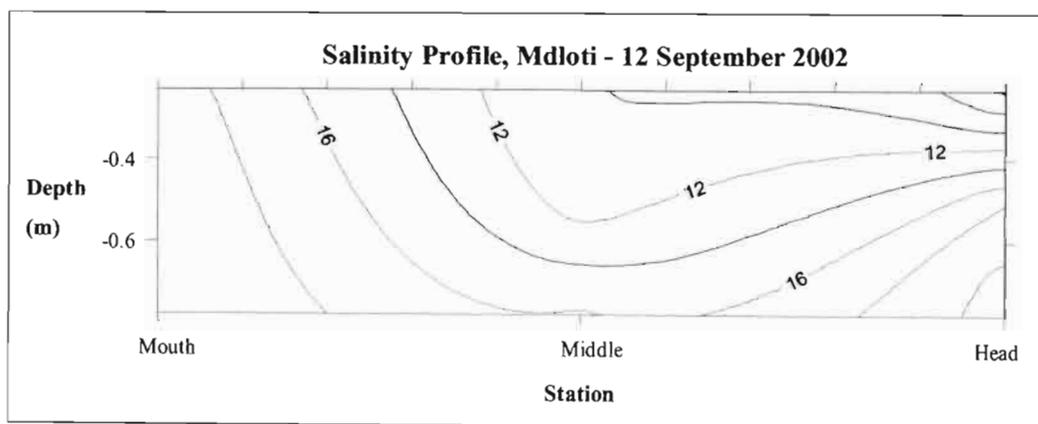
Figure 5-32: Salinity profile at Mdloti Estuary under partly open conditions.

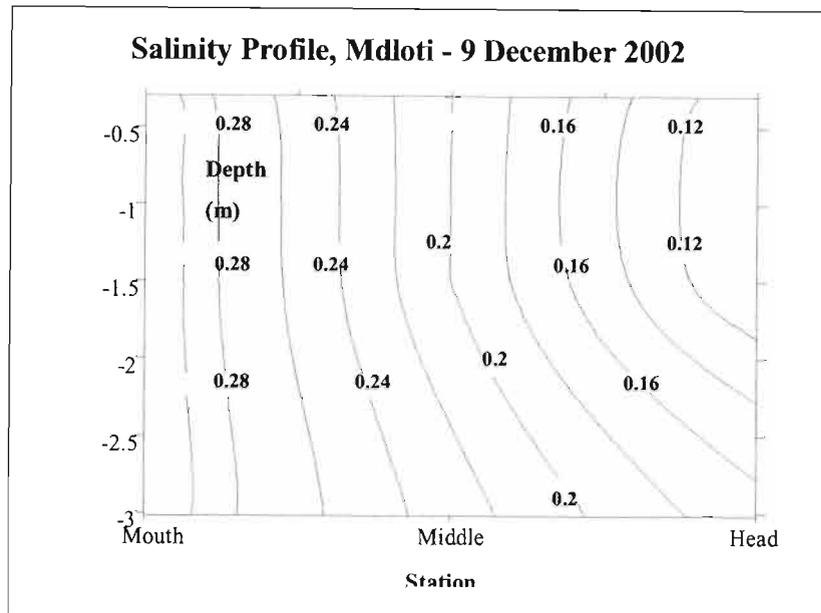
Figure 5-33: Salinity profile at Mdloti Estuary after it had been closed for 15 days.

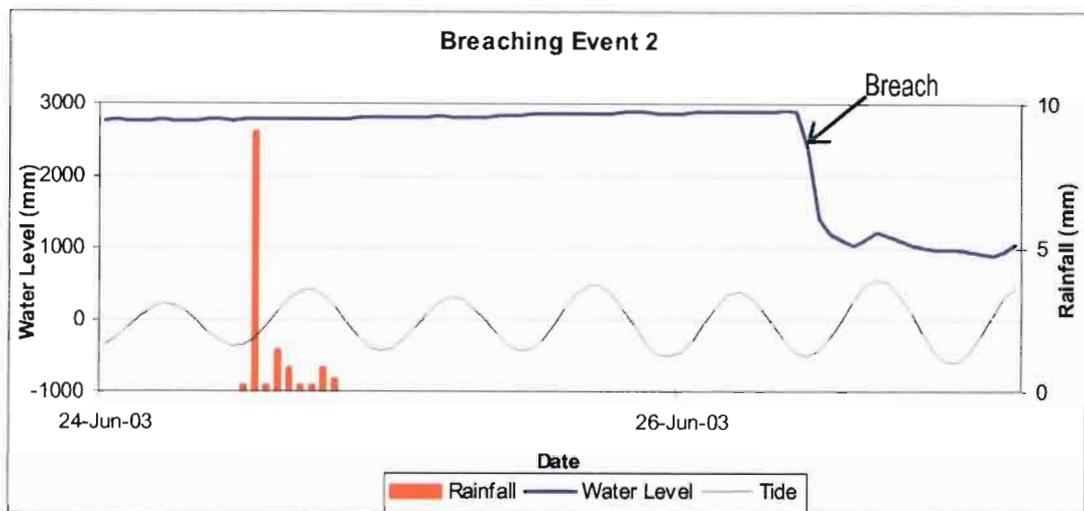
Figure 5-35: Breaching event on 26 June 2003.

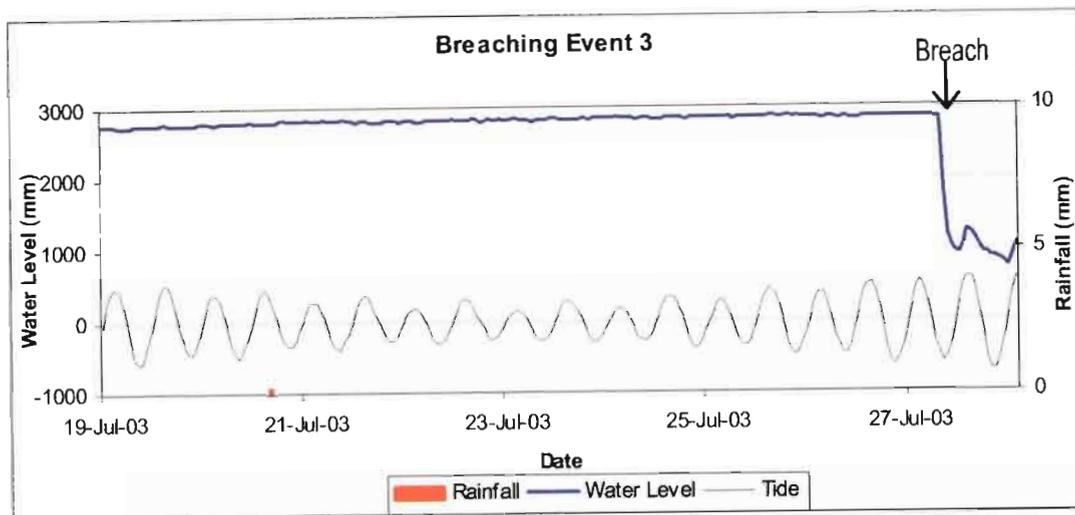
Figure 5-36: On the 27 July 2003 the Mhlanga Estuary breached for the third time since the installation of the water level monitor.

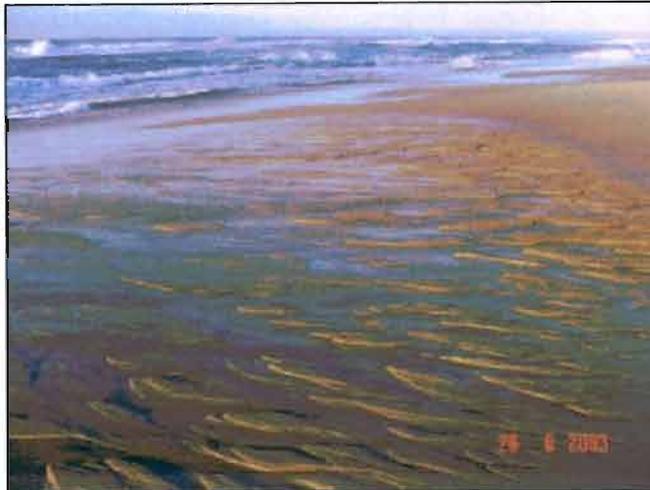
Plate 5-6: Seepage at the southern end of Mhlanga Estuary on the 26 June 2003.

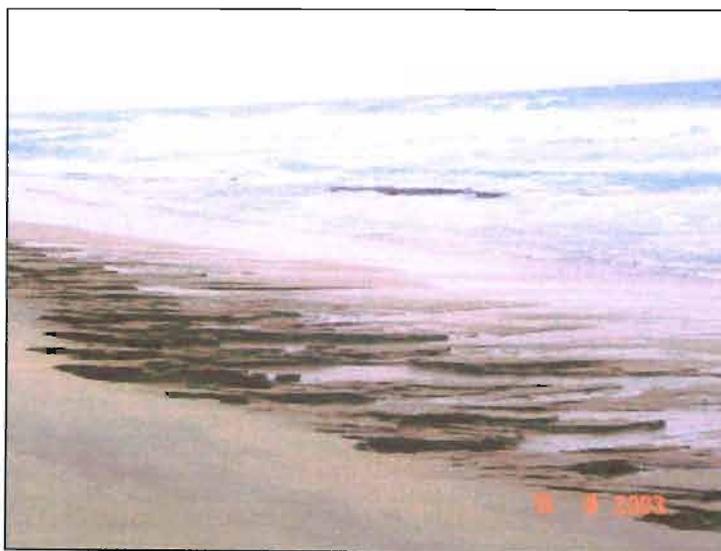
Plate 5-7: Seepage observed at Mhlanga Estuary on the 15 September 2003.

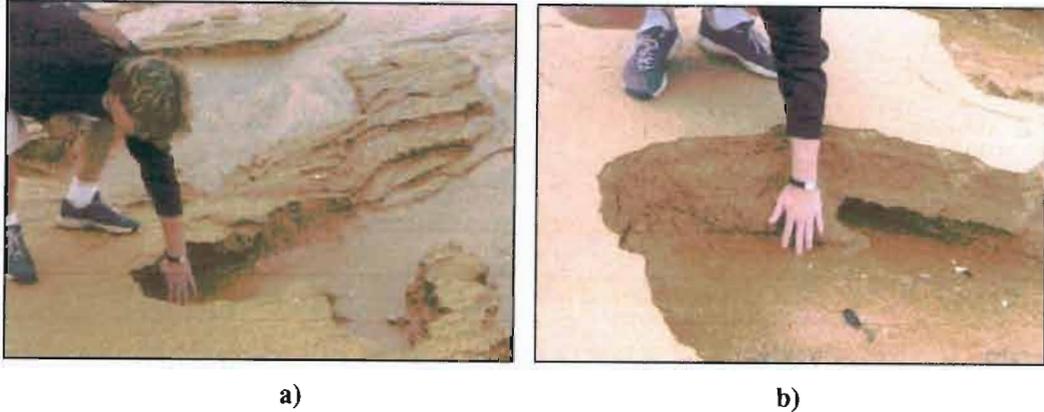
Plate 5-8: Depth of scour observed at a) 11:19 and b) 12:32.

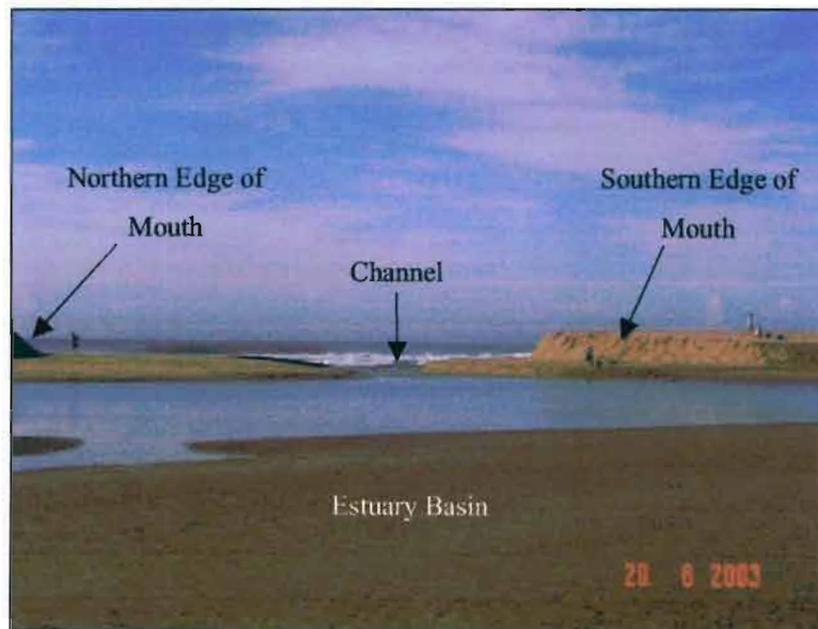
Plate 5-9: The characteristics of the mouth.

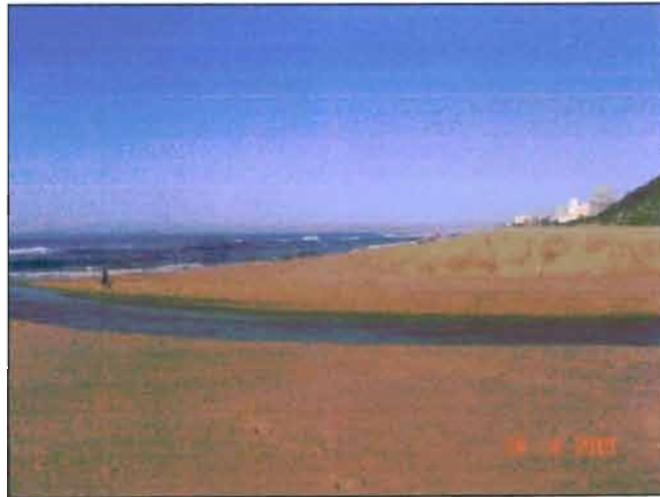
Plate 5-11: Defined central channel on the morning of closure.

which had formed down the centre of the mouth. Plate 5-11 shows the substantial channel connected to the sea, while plate 5-12 taken 6.5 hours later shows the channel narrowing on the seaward side. By low tide the following morning the estuary had partially closed with only a small trickle connecting the estuary to the sea.

An interesting aspect of the mouth closure is that it occurs at high tide trapping a large volume of saline water in the estuary. The water depth at the time of closure is approximately 1400 millimetres above MSL, as opposed to the level of 690 millimetres above MSL when open at low tide.

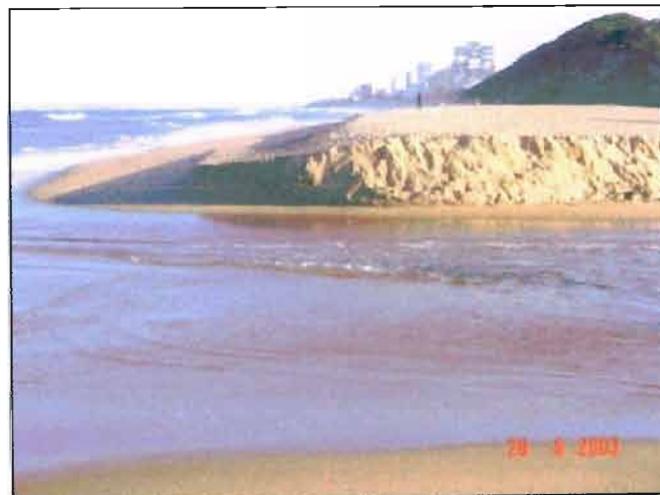
Plate 5-12: Channel becoming narrow on the seaward side, as the estuary closes.

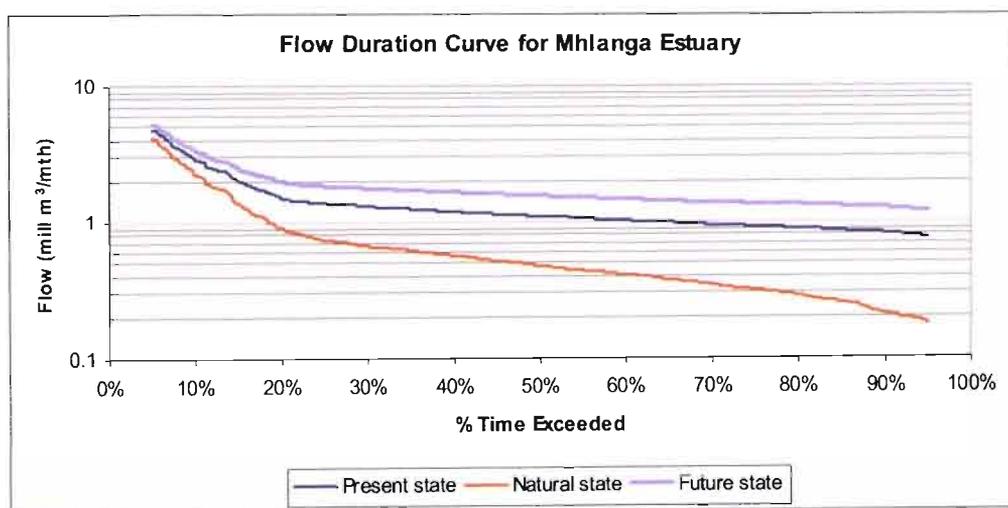
Figure 5-37: A 1-month annual flow duration curve of both the natural state and the present day conditions at Mhlanga estuary.

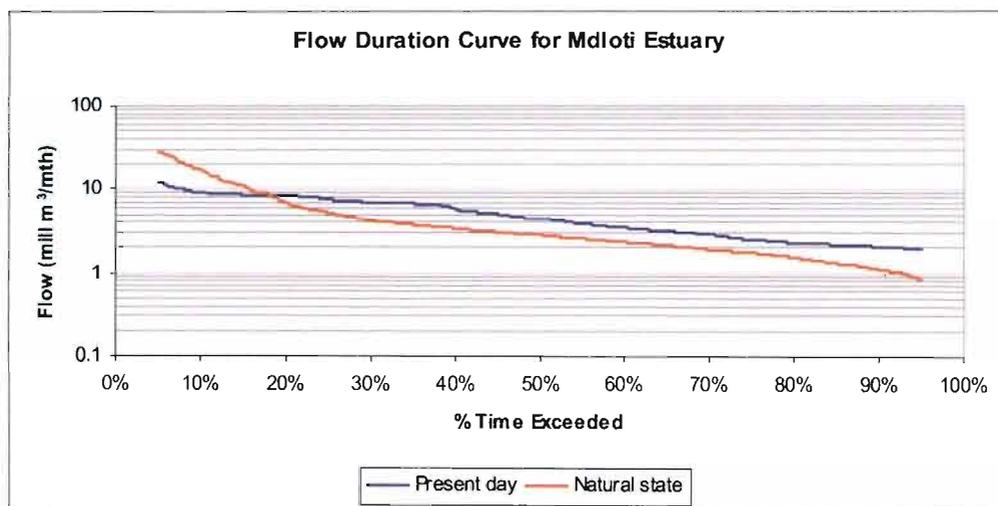
Figure 5-38: A 1-month annual flow duration curve of both the natural state and the present day conditions at Mdloti Estuary.

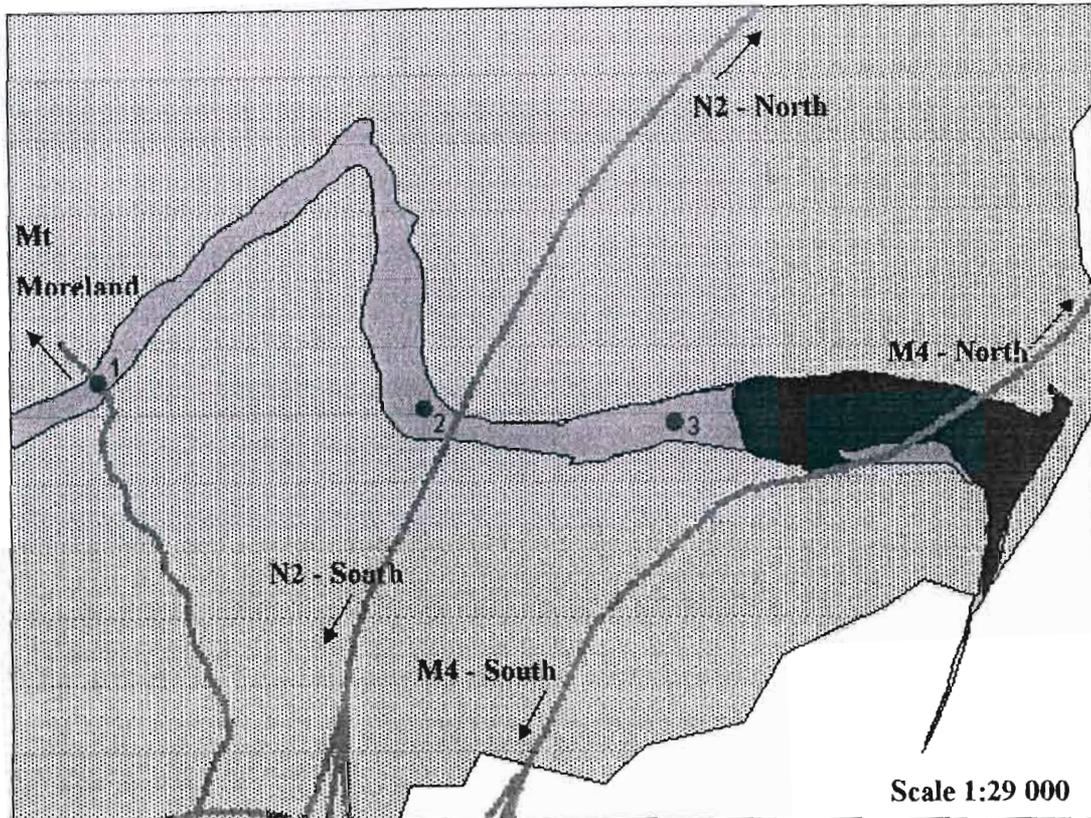
Figure showing the location of flow readings taken at Mdloti Estuary.

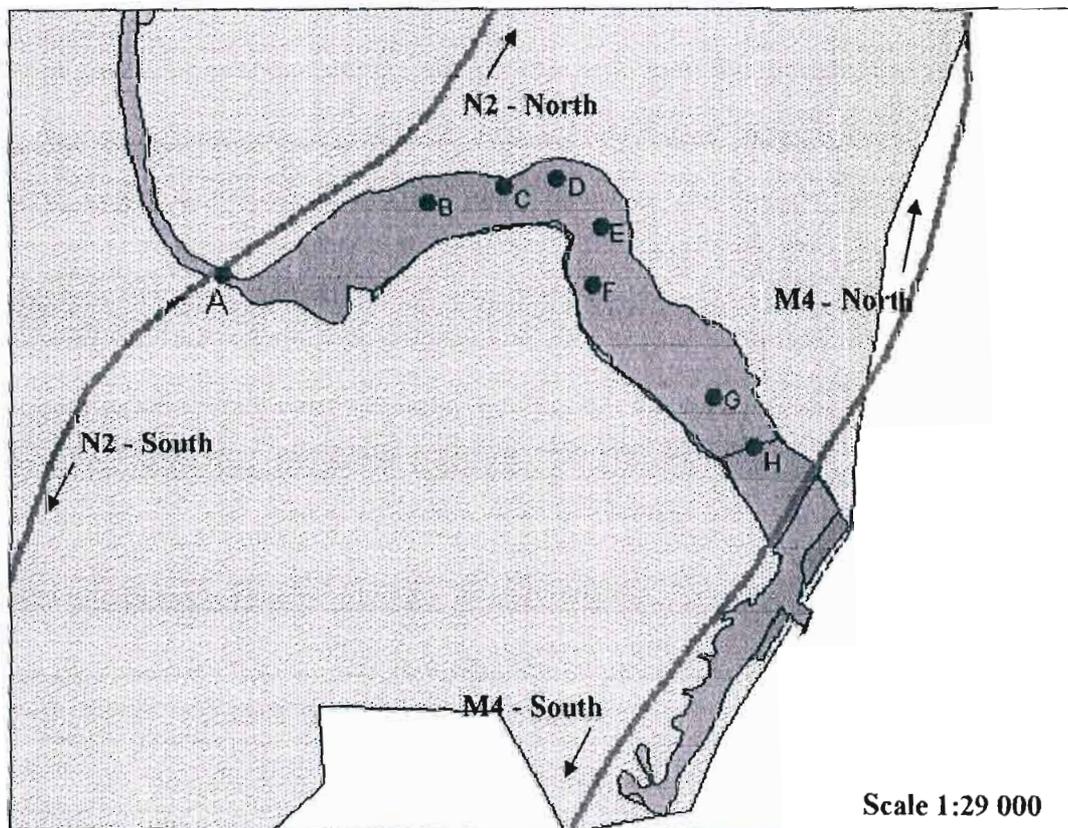
Figure showing the location of flow readings taken at Mhlanga Estuary.

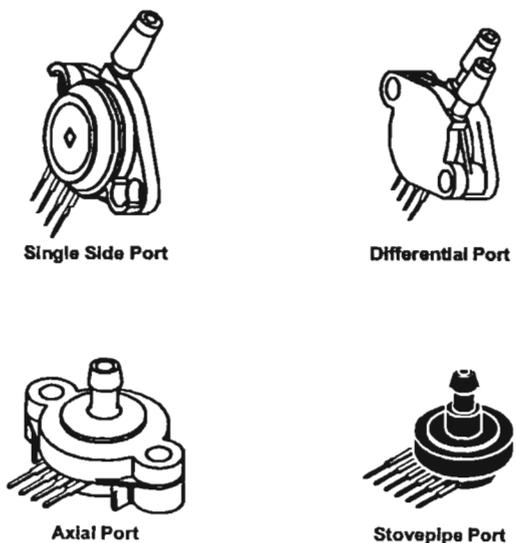
Figure 1. MPX Pressure Sensors with Ported Packages
