An Analysis of the Potential Erosional Changes in the KwaZulu-Natal Coastline due  
to the Effects of Sea Level Rise and Associated Storm Surges

Submitted in fulfilment of the requirements of the MSc degree

University of KwaZulu – Natal

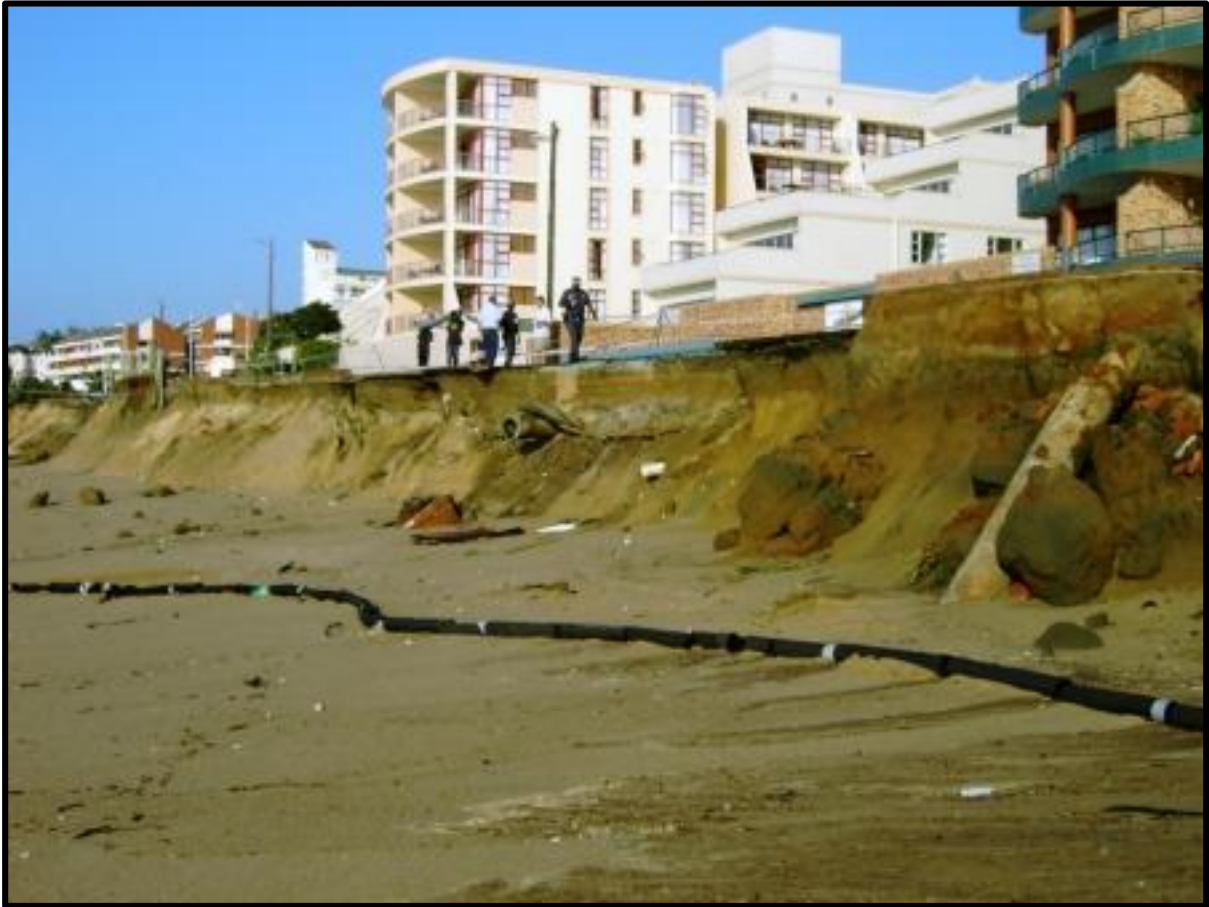
Figure 1.1: Destruction that was created by the 2007 storm. (Source: Umdloti, 2007; Accessed 29 January 2015)

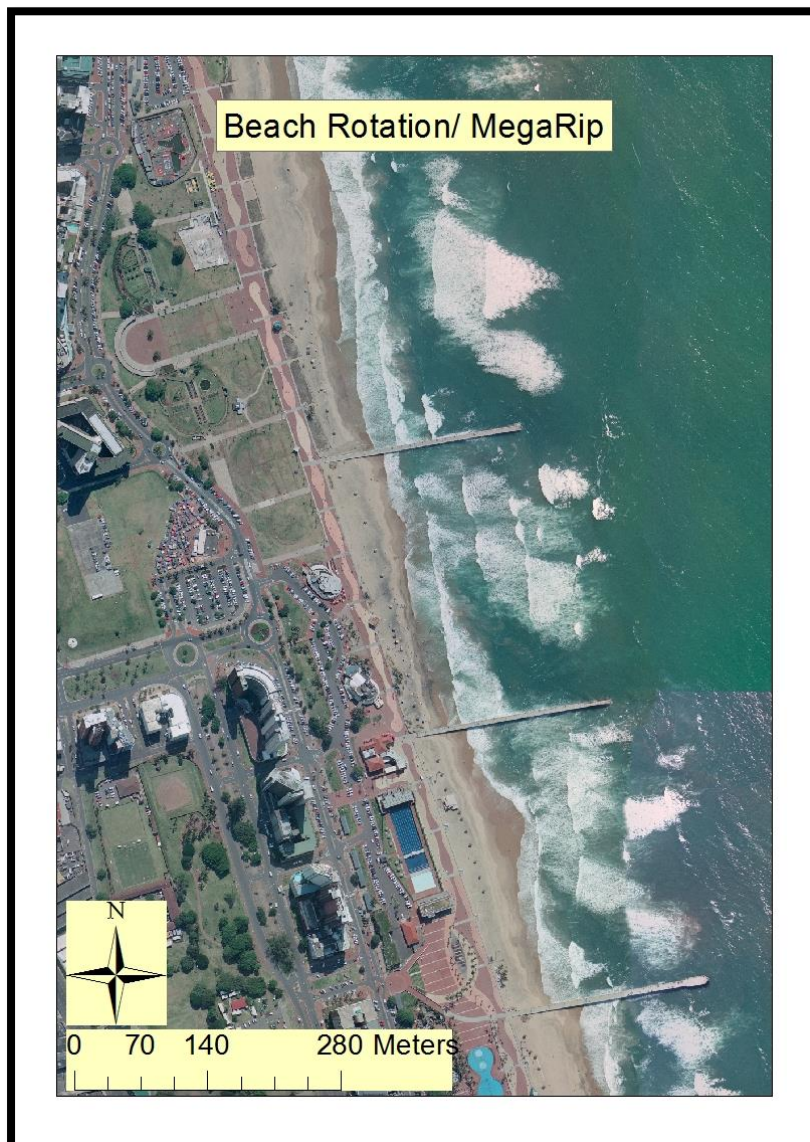
Figure 2.3: Durban beach front experiencing thinning of coastline in the south and thickening in the north within the 2 piers

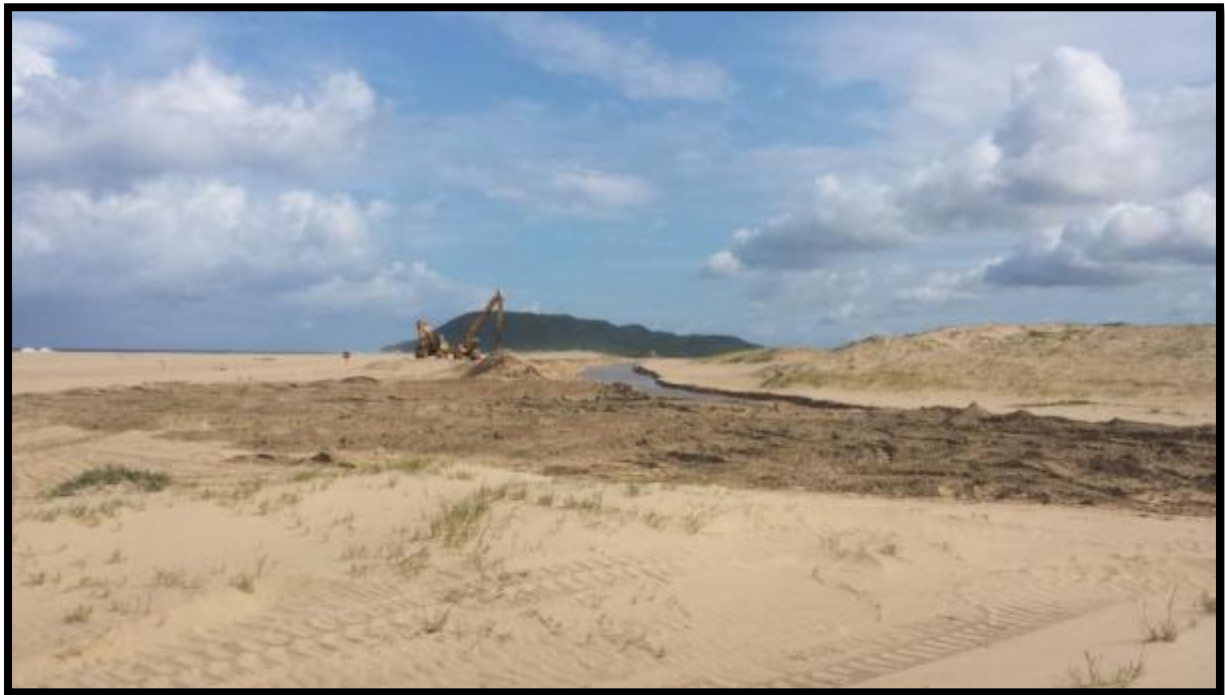
Figure 4.10: The process of connecting the Mfolozi River to the St Lucia estuary to add water to the St Lucia estuary.

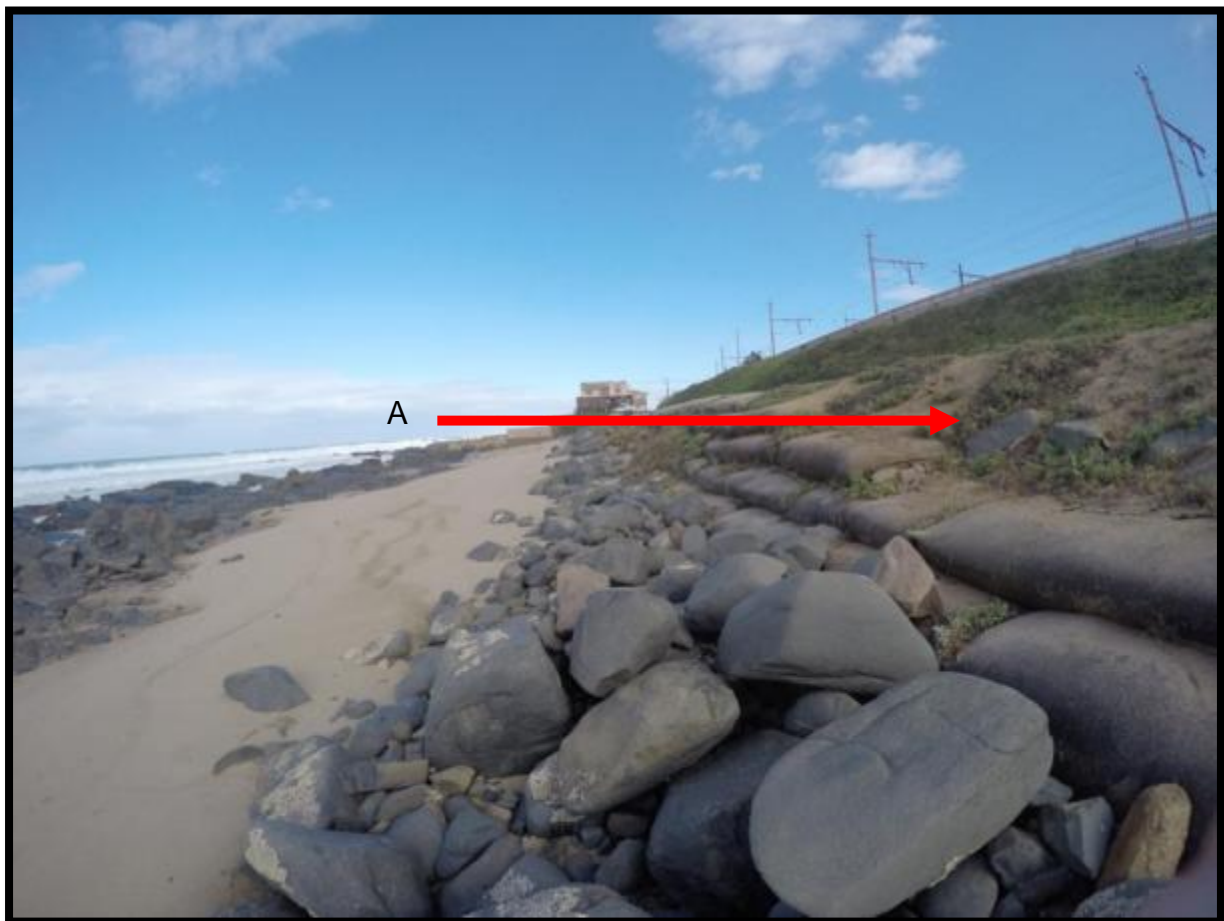
Figure 4.11: Sand bags and rocks placed at the base of the road (at A) to prevent the effects of coastal erosion

Umkomaas has a lot of infrastructure in close proximity to the ocean. There are buildings, roads, railways and bridges which all have the potential of being affected by sea level rise and storm surge. This area has already placed sand bags and rocks in to help prevent the coastline from being eroded (Figure 4.11).

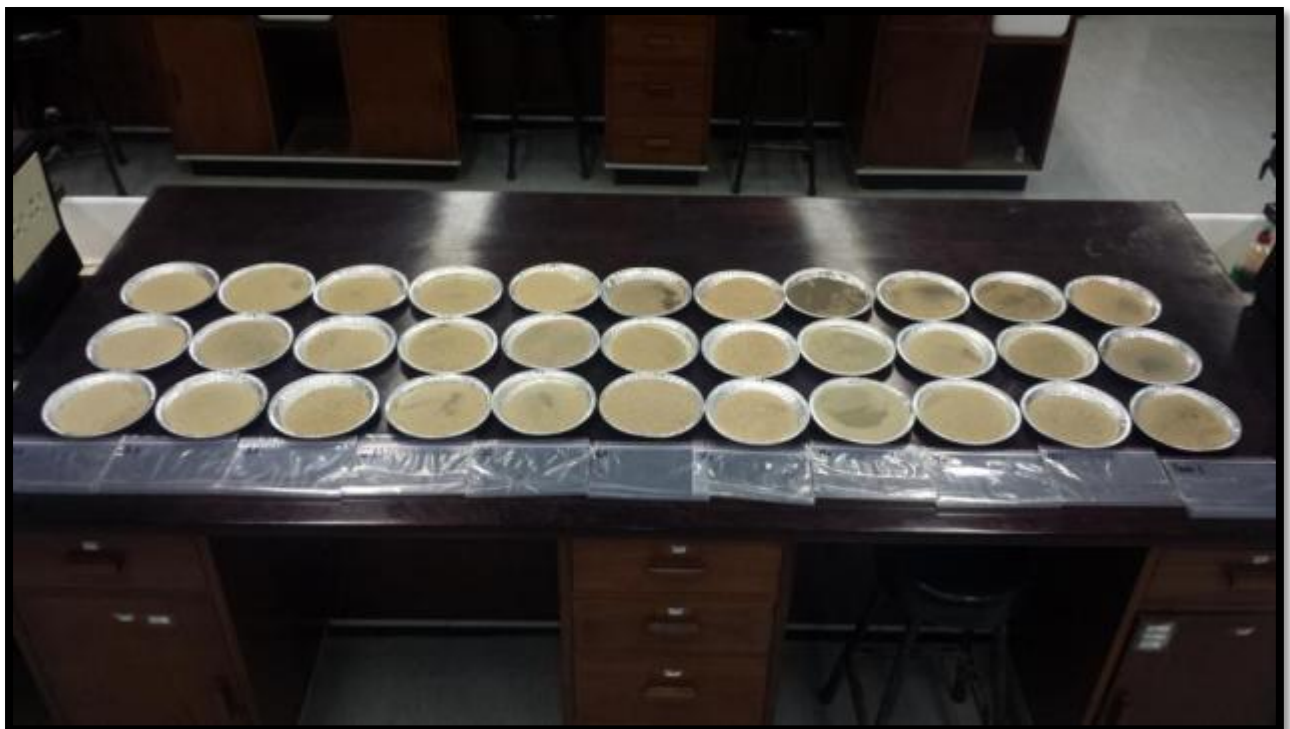
Figure 4.12: Representation of all samples after they have been analysed and now sorted according to their sample number with 1.1 in the top left working right through each sample site.

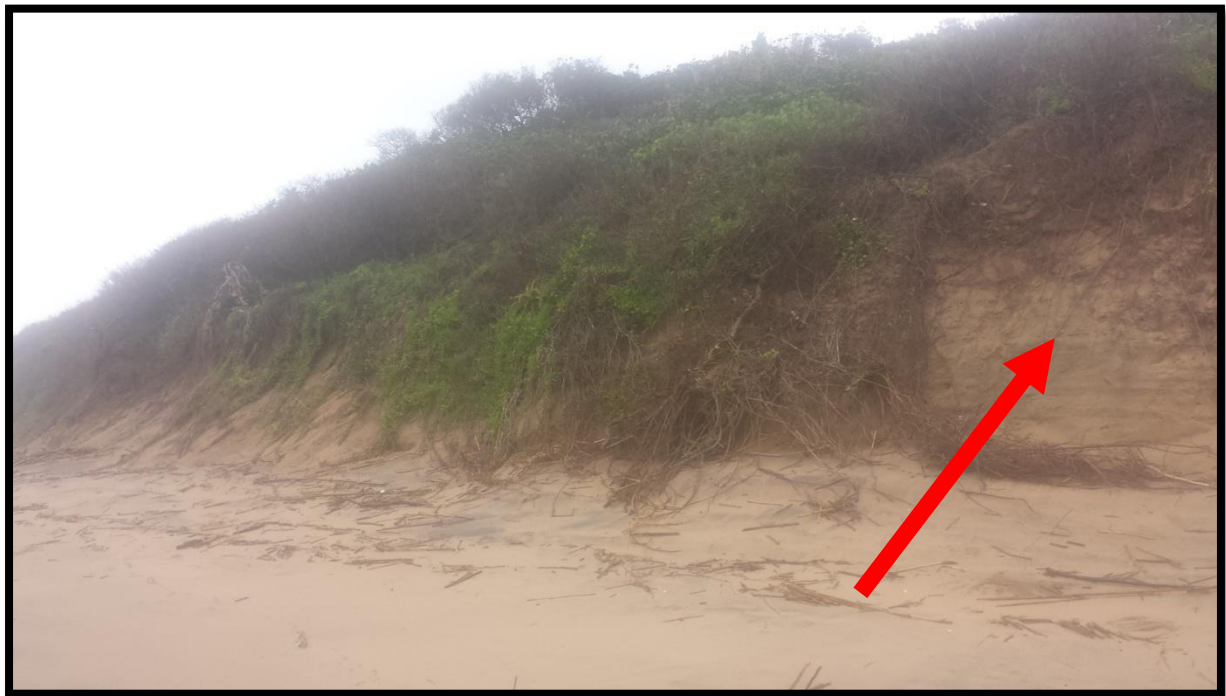
Figure 5.1: Erosion of the dune that has had vegetation growing over the eroded areas

infrastructure is built on top of the coastal dunes, with a light house on top of the hill. This area is a mixture of rock and sediment with natural vegetation on the dunes. The coastal system had signs of erosion within the dune system during the time of the site visit (figure 5.1). The vegetation has grown over the eroded section on the left of the picture but on the right, the arrow points to uncovered signs of erosion. The date of this erosion event is unknown.

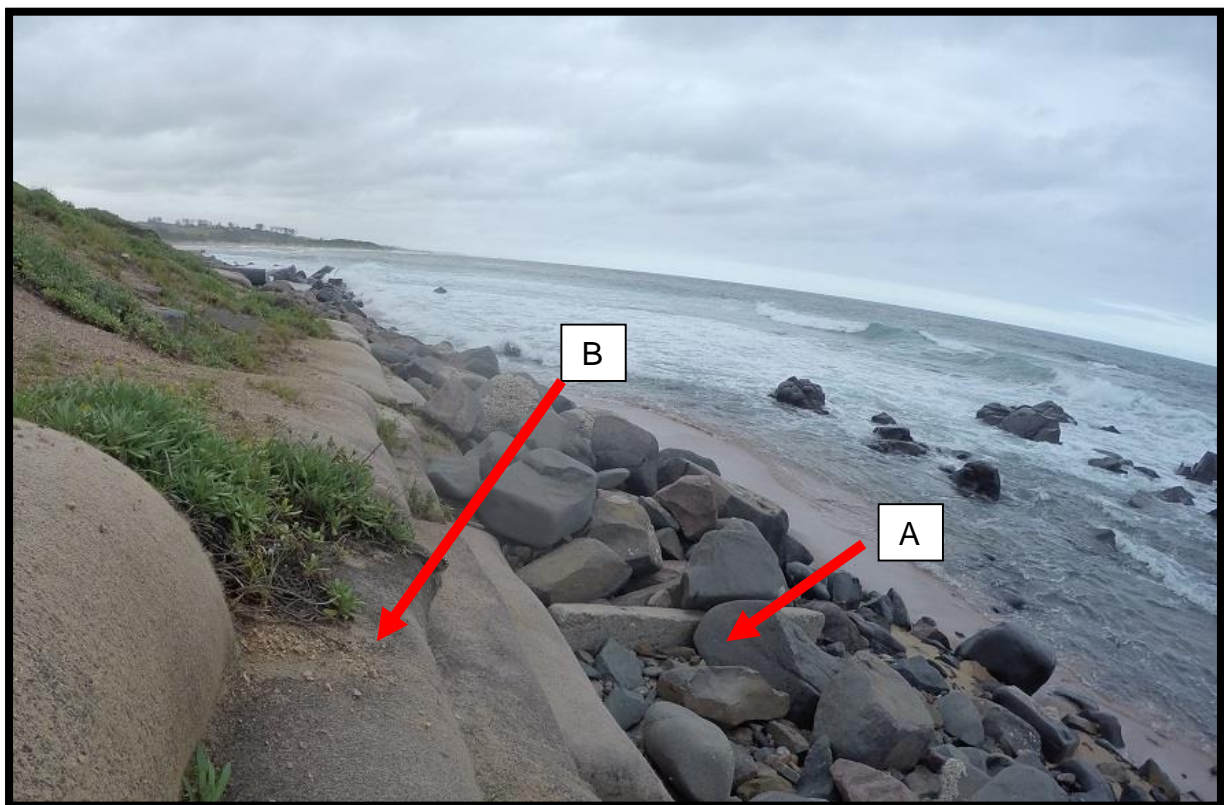
Figure 5.2: Waves washing up and coming into contact with the rocks (A) at the base of the sand bags (B)

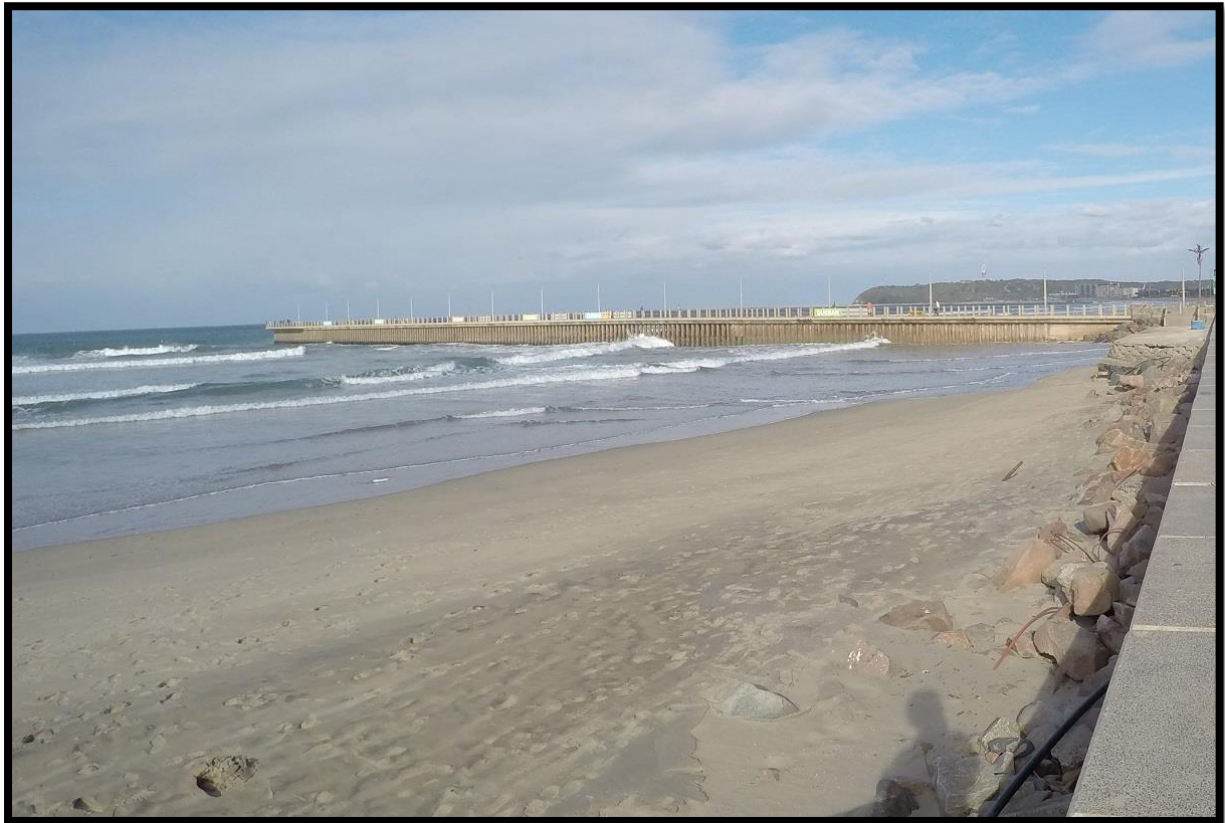
Figure 5.3: The wash up from a high swell period as removed the sediments from the edge of promenade at New Pier Beach, Durban.

As one can see from Figure 5.3, the wash up has removed the majority of the sediments along this stretch of beach exposing the rocks below the undermining of the structure of the promenade.

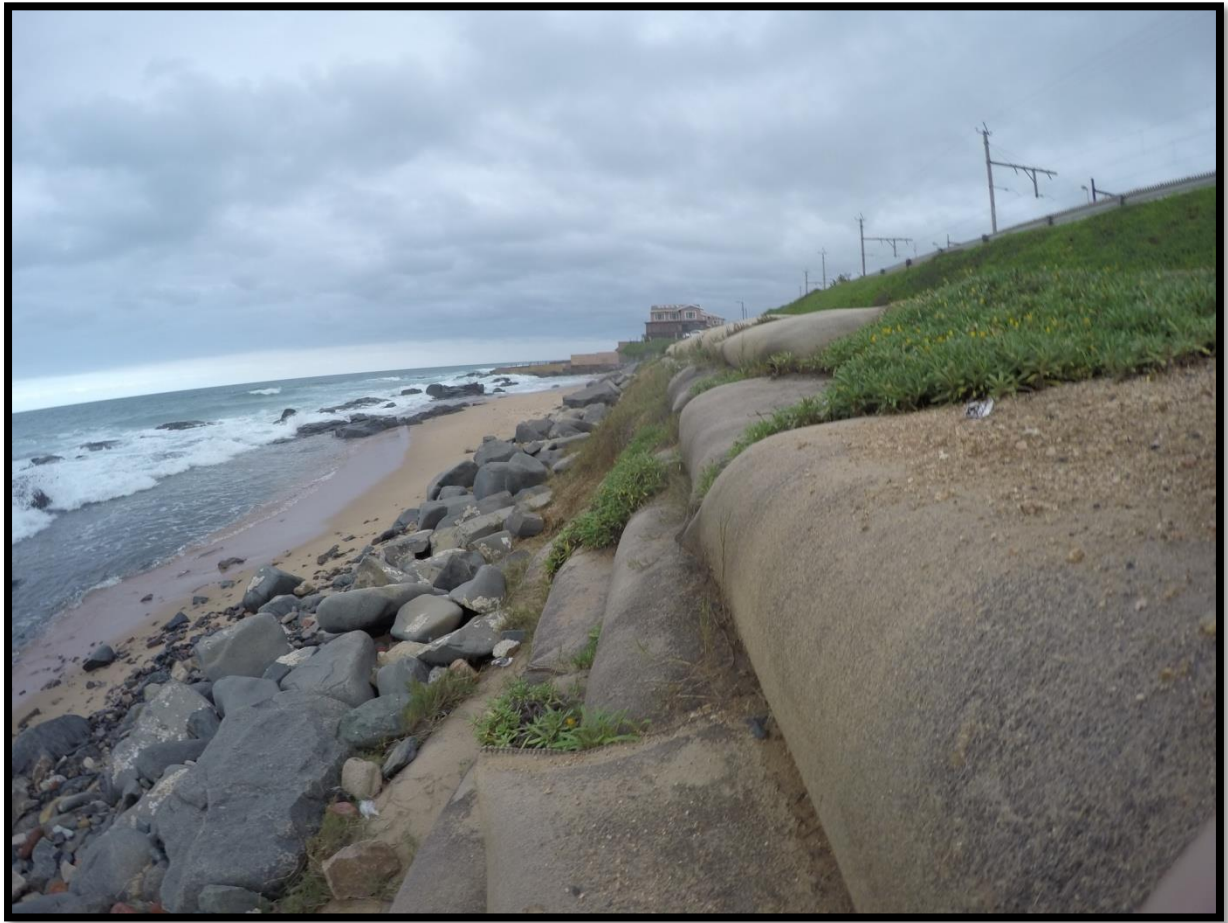
Figure 5.4: Sand bags below road structure to prevent the effects of coastal erosion at Umkomaas beach front.

Figure 5.4, there are single celled sand bags that have been put into place to help prevent the erosion of the coastline due to high swell periods. At the time of site visit, the ocean waves were running up and coming into contact with the rocks that were situated below the sand bags (Figure 5.2). There is a building that can be seen in Figure 5.4 that is in direct contact with the ocean when swells are high. This stretch of coast is also a mixed coastline, which as Smith *et al.*, (2007) stated, would be eroded faster than a coastline which is homogeneous.

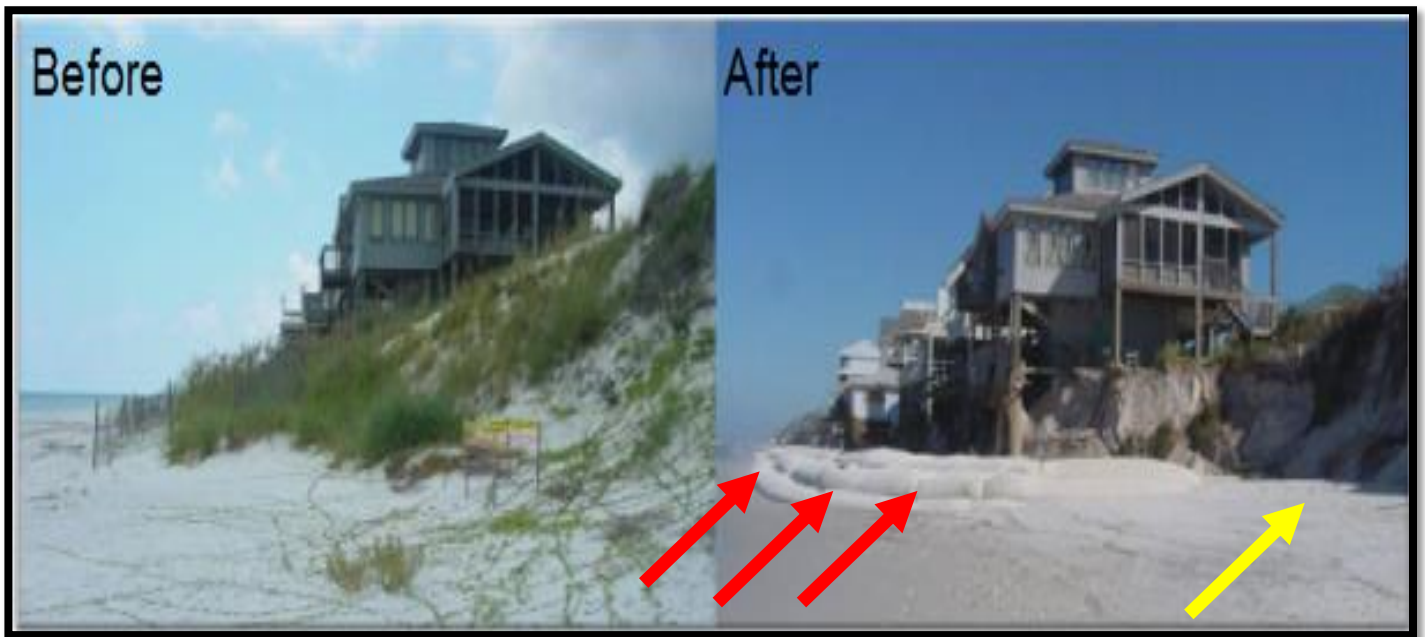
Figure 5.5: The results of coastal erosion after hurricane Ivan in 2004, proving that multicell bags have and could potentially work on our coastline
