# **ASPECTS OF THE ENGINEERING GEOLOGY OF MAPUTO CITY, MOZAMBIQUE**

Submitted in fulfilment of the academic requirements for the Doctoral degree (PhD) in  
the

School of Geological Sciences

University of KwaZulu-Natal

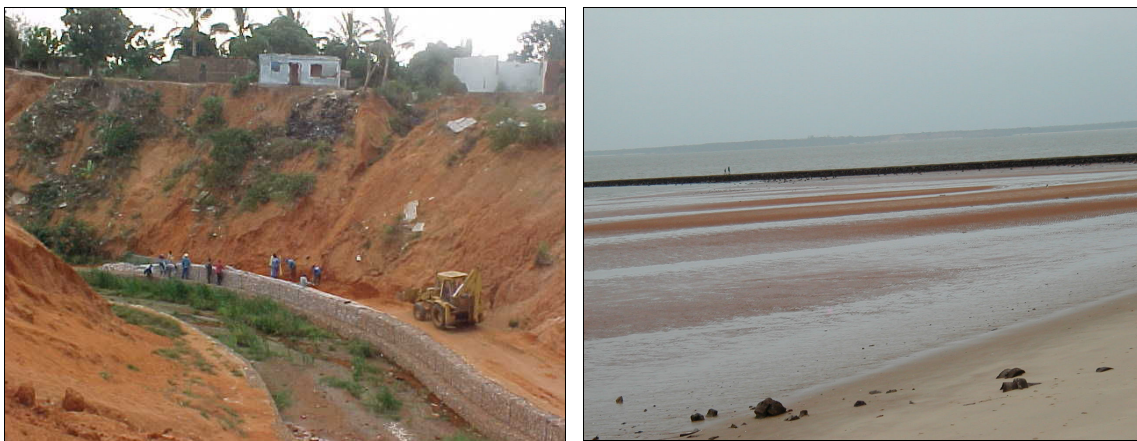
**Figure 4.7** – Gullying failure in a built up area of Polana-Caniço Quarter in 2000 which caused destruction of a number of houses as it eroded. Gabion baskets of rhyolite were used to protect the floor of the gully (left) and depositional area of the eroded red sediments (right)

Gully erosion in Maputo City occurs in the Ponta Vermelha Formation which divides the upper and down town. Changes in climatic conditions modified weather patterns and caused extreme rainfall which lead to gully formation in the upper town and sediment deposition in the beach (Figure 4.7). Thus, gullying problems started to be a cause of concern after the extreme rainfall events of 1999 and 2000, in this last case with a precipitation of 400 mm registered in four days. This precipitation is far beyond 132 mm, which is the mean monthly precipitation in the rainy season (November-March). The rain saturated the slopes and raised the water table resulting in flooding that caused movement. Combination with various other factors such as soil characteristics, poor urban planning and topography can have contributed to gullying failure and are discussed in full in Chapter 6.

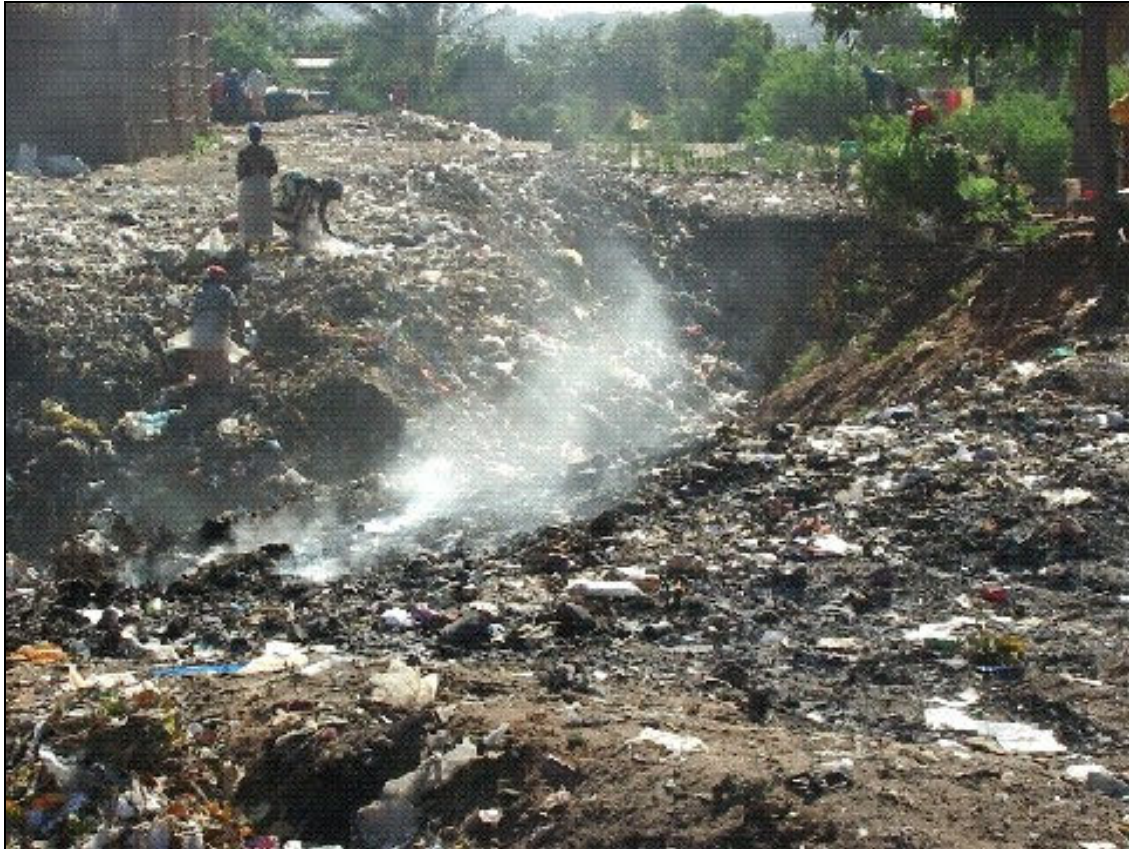
**Figure 4.9** – Gully filled with solid waste with people searching for useful things

site (e.g. leachate collection system, distance from residential area, impermeability of the place, etc). This can have implications in the future as waste can block the water flow and leachate contaminates the groundwater. People from the surrounding areas run into the site trying to get something of value (Figure 4.9).

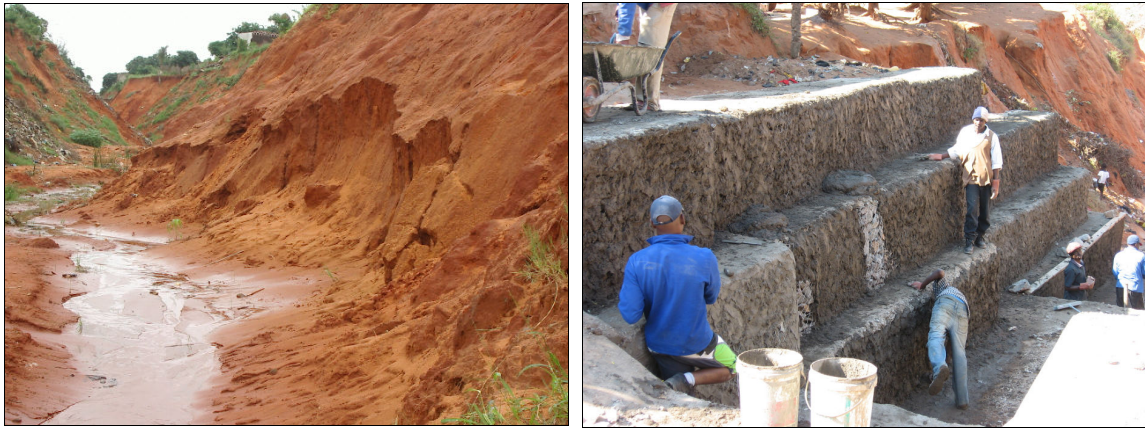
**Figure 4.10**– Extremely large gully in Ferroviário Quarter (left) and remedial work at the beginning of the gully in Ferroviário Quarter (right)

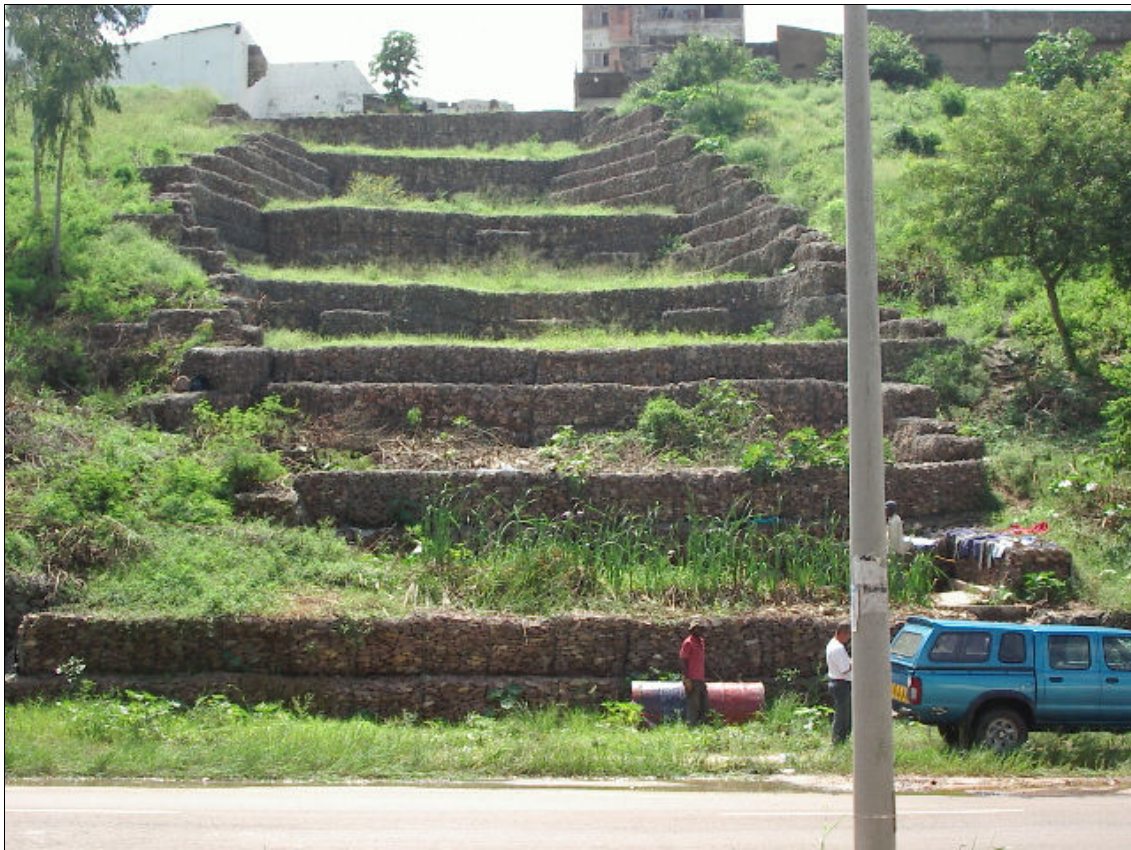
**Figure 4.11** – Gabion baskets filled with rhyolite used to support the slope at ONU Avenue

**c) Nações Unidas (NU) Avenue.** The gully is in the slope in the north side of the Nações Unidas Avenue (Figure 4.11) and is generally straight and uniform facing south and the Maputo Estuary. Slope angle appeared to be about 20-25° which implies a gullying failure rather than a slump. Also the depth was greater than would be expected for a slump and the width of the failure is too narrow for the depth. The municipality has done extensive remedial work by supporting the slope with gabion baskets filled with rhyolite.

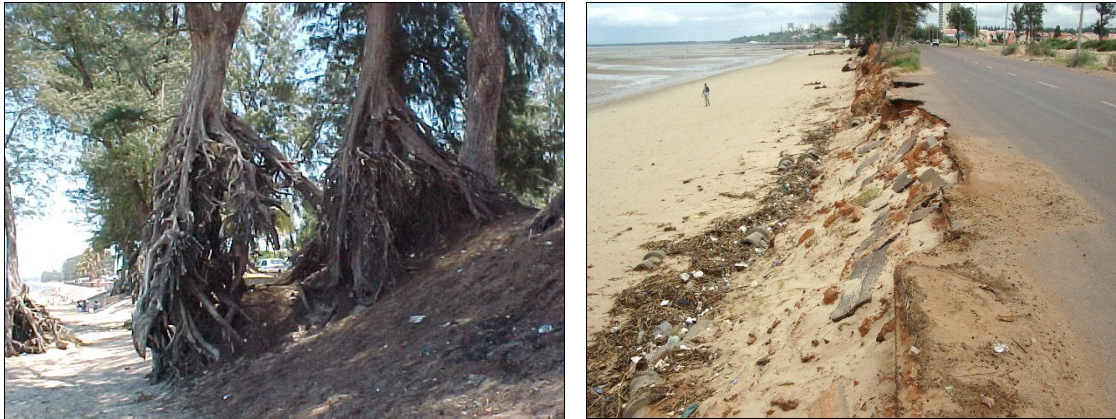
**Figure 4.12** – Signs of coastal erosion in Maputo City: (left) uncovered roots of trees along Marginal Avenue; (right) Destruction of the Marginal Ave.

Marginal Avenue, namely uncovered roots of trees, broken retaining walls and destruction of the Marginal Avenue (Figure 4.12).

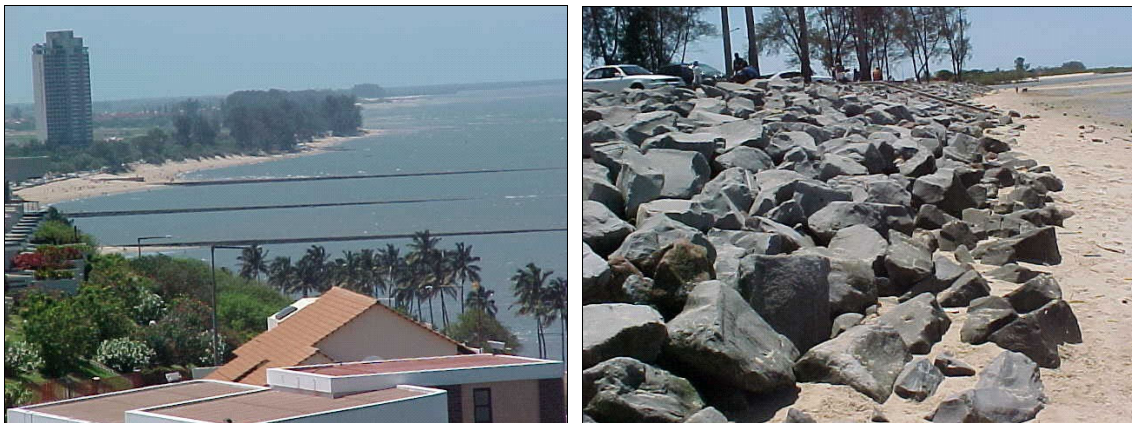
**Figure 4.13** – Measures undertaken to control coastal erosion in Maputo City: (left) Groins at Miramar Beach; (right) Riprap in front of Costa do Sol Restaurant.

Some measures have been undertaken to control coastal erosion such as groins and retaining walls at Miramar Beach and rip-raps in front of Costa do Sol Restaurant (Figure 4.13).

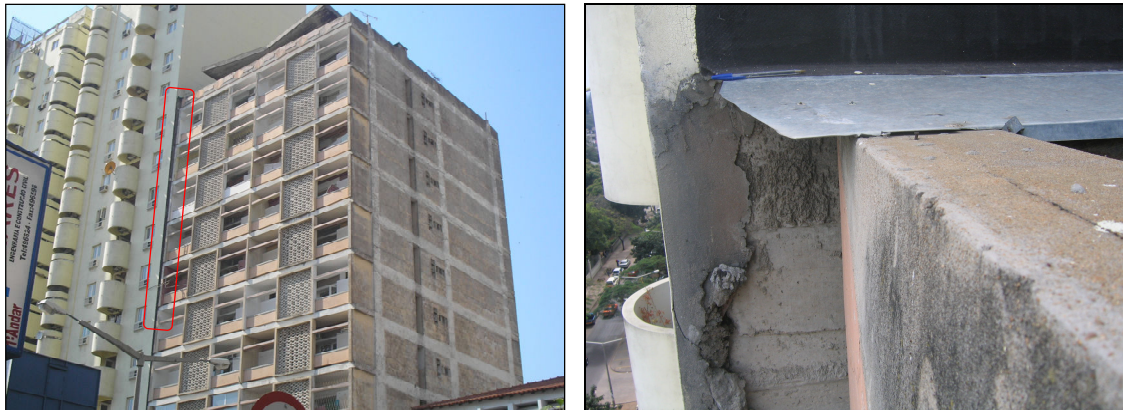
**Figure 4.15**– Frontal view of a problematic building at Site 1 (left). Backward (eastern) displacement observed from the top of the building (right).

a) Site 1 – This building is located at 702, Julius Nyerere Avenue, by the side of the Embassy of Portugal and is the most severely tilted and causing most concern. It comprises 10 floors, is approximately 30 m high and 15 m wide, and has raft foundations. It was built in 1970 but tilting started at the end of 1990s (Ms Ana Nóvoa, personal communication, 29<sup>th</sup> November, 2003). The backward tilt, to the East, is 400 mm measured at the top of the building (Figure 4.15) and the side tilt is 200 mm to the South. At the back of the building there is a single story construction attached to the main building. The backward and sideways rotation of the building caused it to crush the attached engineering structures (Figure 4.16). The damage is in the form of cracks also reported at the boundary wall. The raft foundation of the building is

considered to be related to the absence of cracks in the building itself.

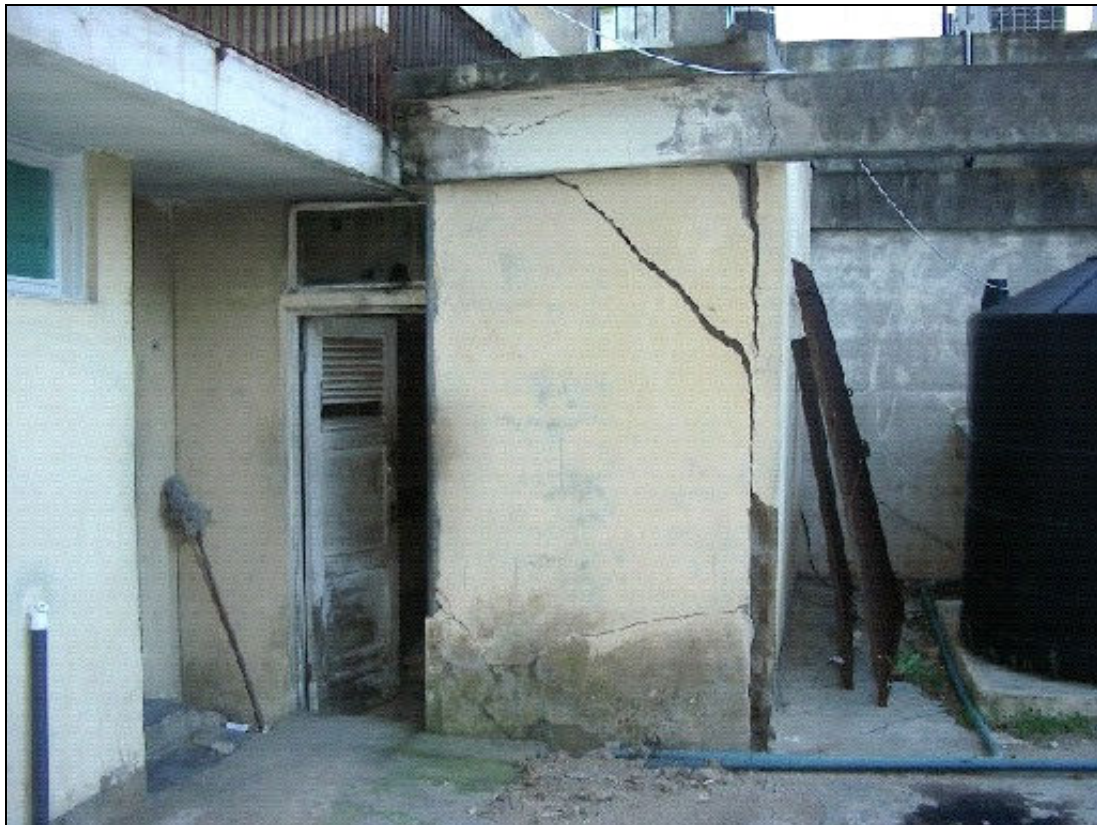
**Figure 4.16**– Cracks on a single story construction on the North hand side of a building on Site 1 as a result of backward and sideways rotation of the building.

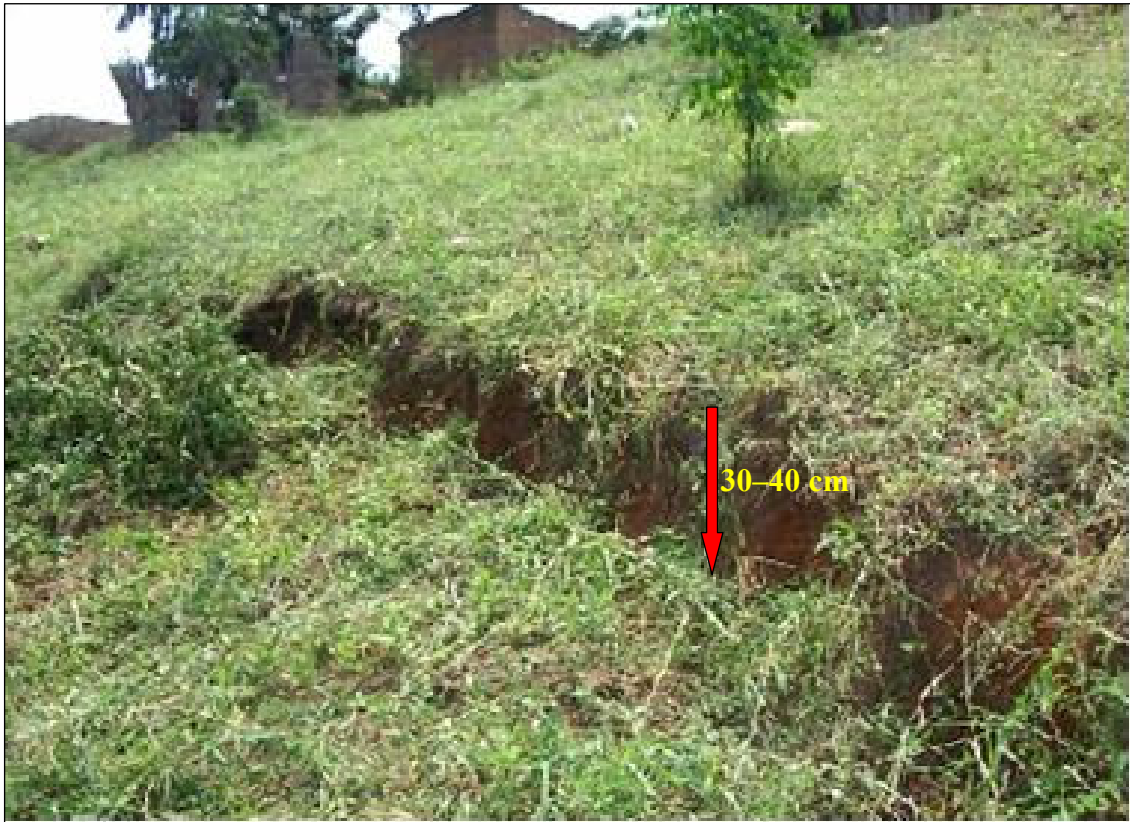
**Figure 4.17**– Shallow landslide along ONU Avenue with a vertical displacement of 30-40 cm

The slope appears unstable with evidence of active movement along the crack, because of it, remedial measures were undertaken by the municipality through the construction of gabions along the base of the slope. Evidence of water seepage is observed on the base of the slope. This water can be the trigger event of the landslide.

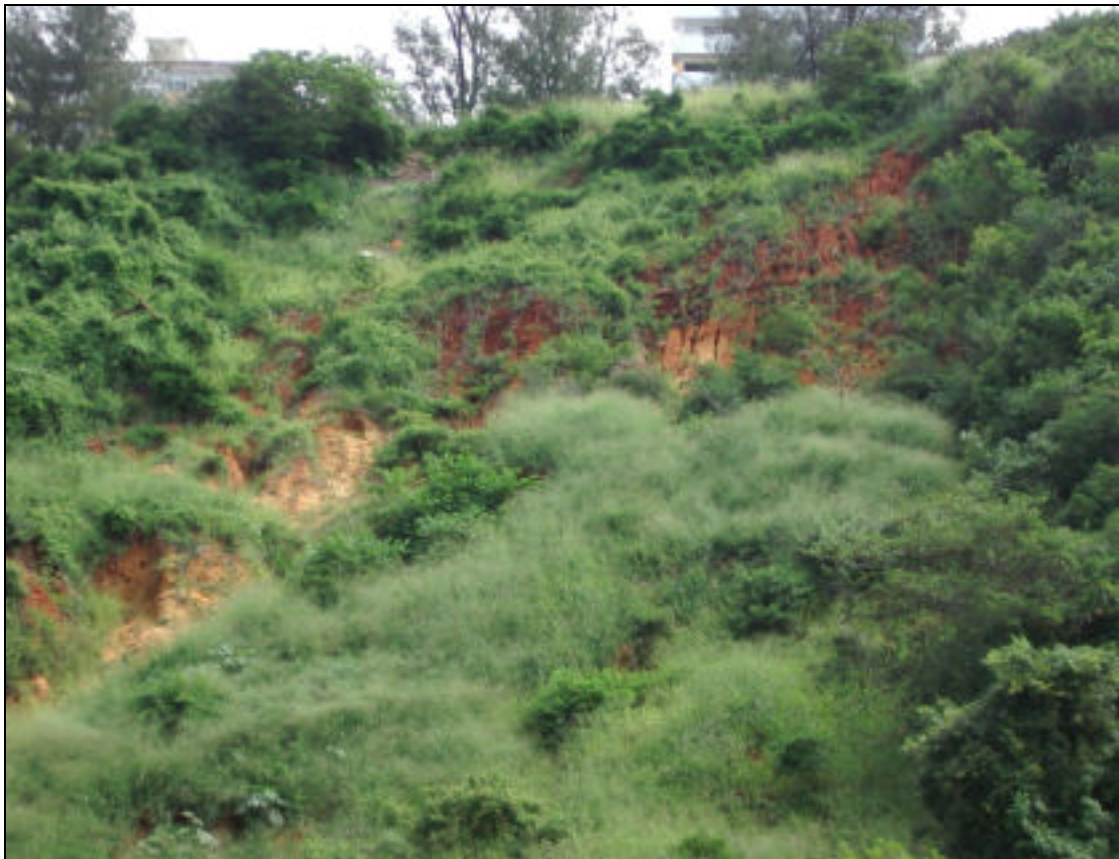
**Figure 4.18**– Slump in coastal slope deposits marked by Gap of thick vegetation (30 m wide) in the slope along Friedrich Engels Avenue (photo taken from the Marginal Avenue)

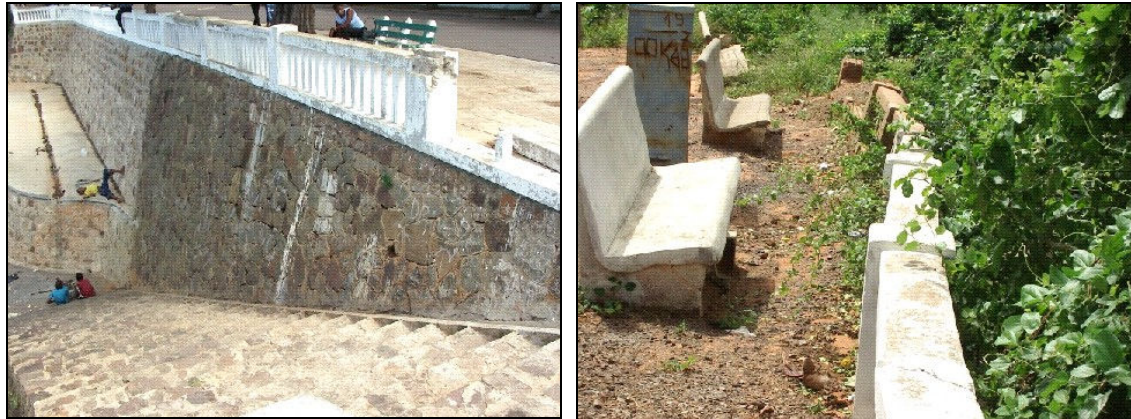
**Figure 4.19**– Evidence of movement at the top of the slope along Friedrich Engels Ave. (Left) retaining wall repaired after it had started to bulge. The dark part of the wall is the new; (Right) Protection wall in the North side of the promenade destroyed by the slope movement

**Friedrich Engels Avenue.** This area of active landslides is on the coastal slope about 40 metres high, angle of about 60° but locally steeper and face southeast and the Maputo Bay. It is thickly vegetated with shrubs and big trees and includes two active or recently active landslides. The most recent failure comprises a high angle slump that has moved from the top of the slope to rest above a slump earth flow at the bottom. This can be viewed by a gap of thick vegetation in an area of about 30 m wide (Figure 4.18). Additional evidences of movement are at the top of the slope. It has been cut back, with a masonry wall been constructed to form both a retaining wall (5 m height) and a short promenade. The retaining wall had been repaired after it had started to bulge (Figure 4.19). Other evidence includes distortions of the drainage system below the retaining wall and destruction of the protection wall in the north side of the promenade

(Figure 4.19). This evidence strongly suggests that this section of the slope is in an unstable state, and will continue to suffer minor failure unless stabilised.

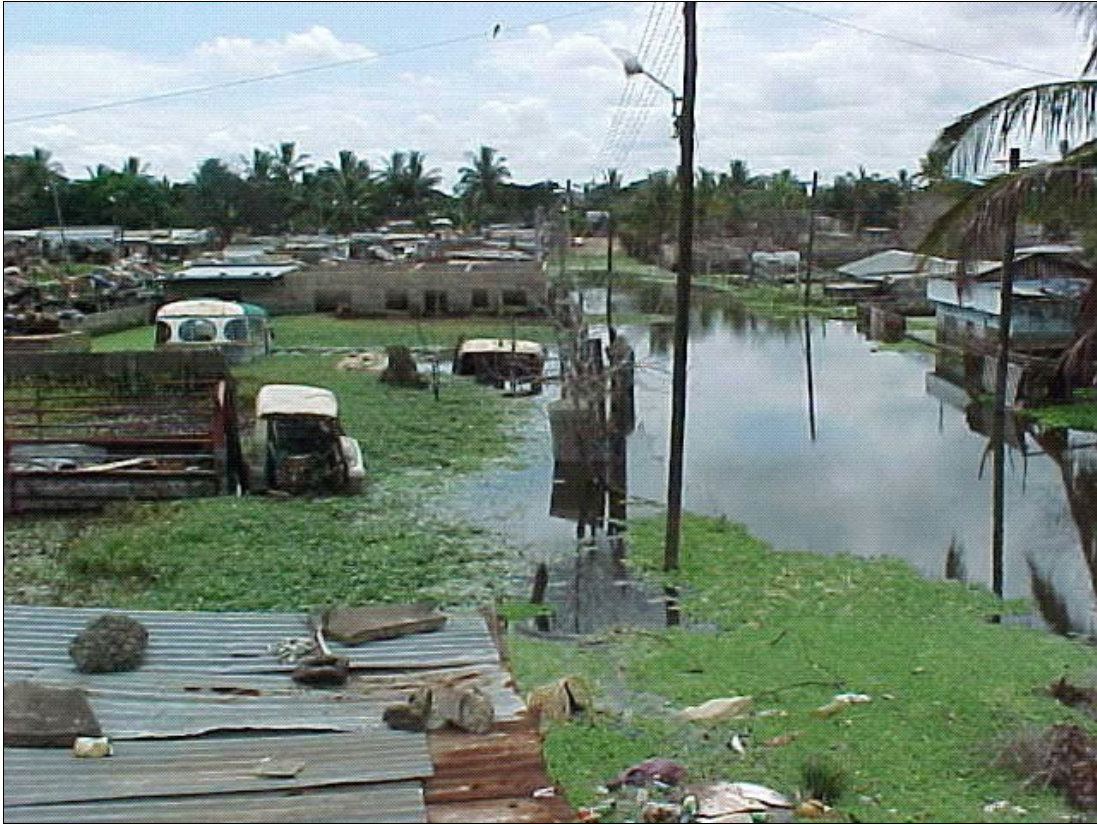
**Figure 4.20**– Flooded area in Inhagóia Quarter after the 2000 floods

**Inhagóia Residential Area.** Extreme rainfall events in Maputo City result in inundation in the Inhagóia Quarter. The 2000 flood event was the main event but this problem has been registered several times. About 60.000 m<sup>2</sup> in a densely populated area were covered by water (Figure 4.20) leaving tens of houses submerged as well as roads, market and several public services. The affected area is a basin in shape and water from the neighbourhood flows to it. The area remains flooded for several months before the water evaporates.

Apart from the topographic shape of the affected area, many factors can be considered as the reasons for the problem. The surface sandy layers in Inhagóia Quarter are underlain by clayey layers which have low permeability. These clayey layers from the Machava Formation (QMc) underneath the sandy layers from the Congolote Formation make water infiltration nearly impossible.

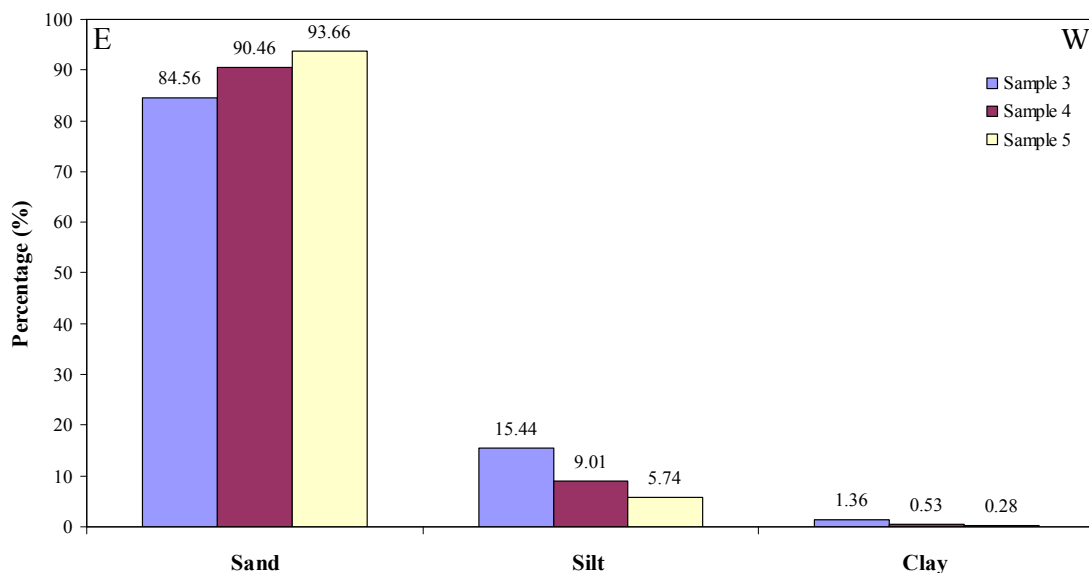
**Figure 5.3** – Geographical trend on the distribution of grain size particles in the Ponta Vermelha Formation (TPv). E – East; W – West.

from gravel to clay. This is particularly true for samples 5, 6 and 7 located in the area where ferricrete is found in the surface. The gravel content reaches values as high as 11.99 and 12.87% for samples 6 and 7 respectively. From east to west of the geological formation a gradual sand content reduction is observed as can be seen sequentially from samples 5, 4 to 3 with 93.7, 90.5 and 84.6 % respectively (Figure 5.3). There is no clear evidence of the cause of this apparent finer westward trend of the Ponta Vermelha Formation however, the presence of red ferruginous crust (ferricrete) at a depth of 3 and 5 m (Macedo, 1971) caused by the local presence of conglomerates with iron oxides justifies the trend. This is not true for silt and clay content where enrichment occurs. In the south- to north direction there is a general trend for enrichment with sand while the silt and clay contents remain with very low variations.

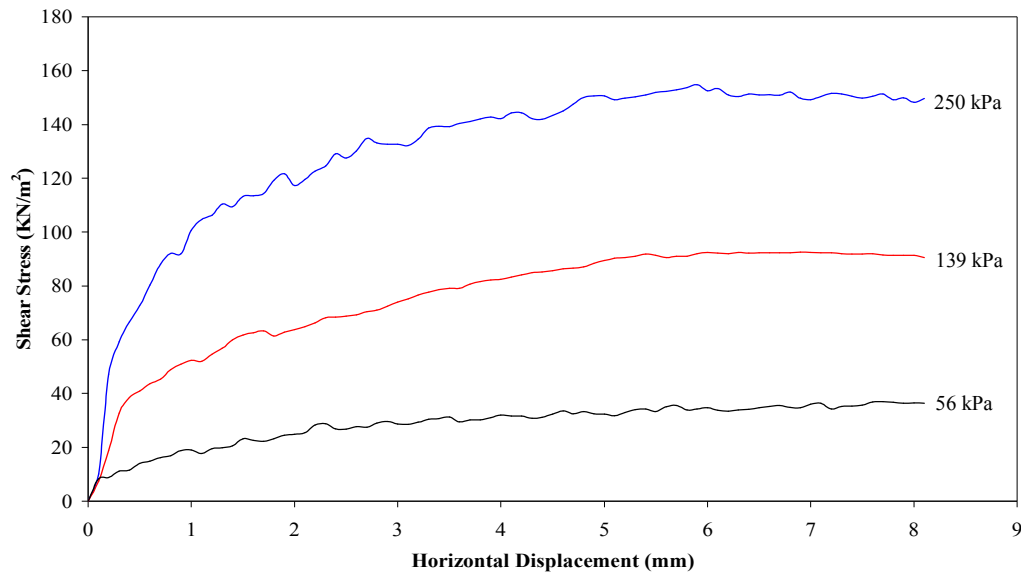
**Figure 5.4** – Shear stress-horizontal displacement curve of direct shear tests of Sample 8. This curve is typical for the loose and normally consolidated soil specimens of Maputo City

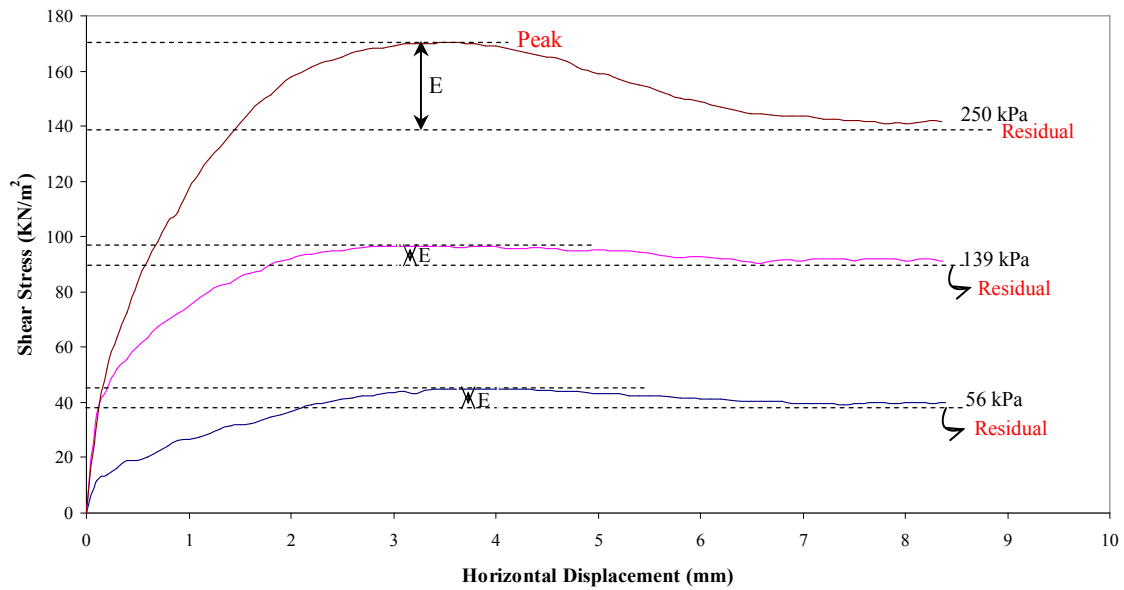
**Figure 5.5** – Stress–strain diagram of direct shear tests of the dense sand or bonded soils of Maputo City

The remaining 33% of tested soils present shear stress-shear strain plots illustrated as in Figure 5.5. It is clear from Figure 5.5 that shear stress curve at 250 kN/m<sup>2</sup> rises quite sharply to a peak and then falls off to a somewhat lower value. The excess of peak over the residual value, denoted by *E*, represents the extra work which has to be put in to produce the vertical movement due to dilatancy (Head, 1988). The behaviour observed in Figure 5.5 denotes dense sand or bonded soils and to some extent the cohesion of the soil. This *E* value shows also the effect of bonding on soil strength (Maccarini, 1993). The difference in values between the peak of the shear stress and the residual strength (*E* value) observed amongst samples corresponds to the differences in soil consistency as described in section 5.2.

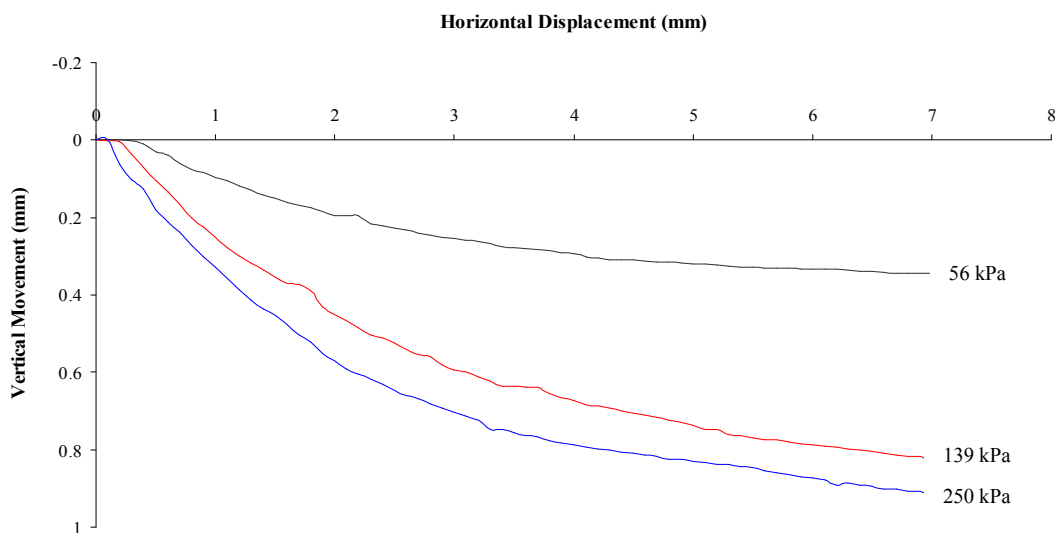
**Figure 5.6** – Vertical versus horizontal displacement curves for the tested soil of Maputo City

The corresponding vertical vs. horizontal displacement curves from the shear box test are presented in Figure 5.6. Volume decrease (contraction) is observed in the tested soils with the three selected normal pressures. The general characteristics of shear deformation and volume change reflect structure sensitive nature of the soils as correlations can be made with the general parameters of soil characterization.

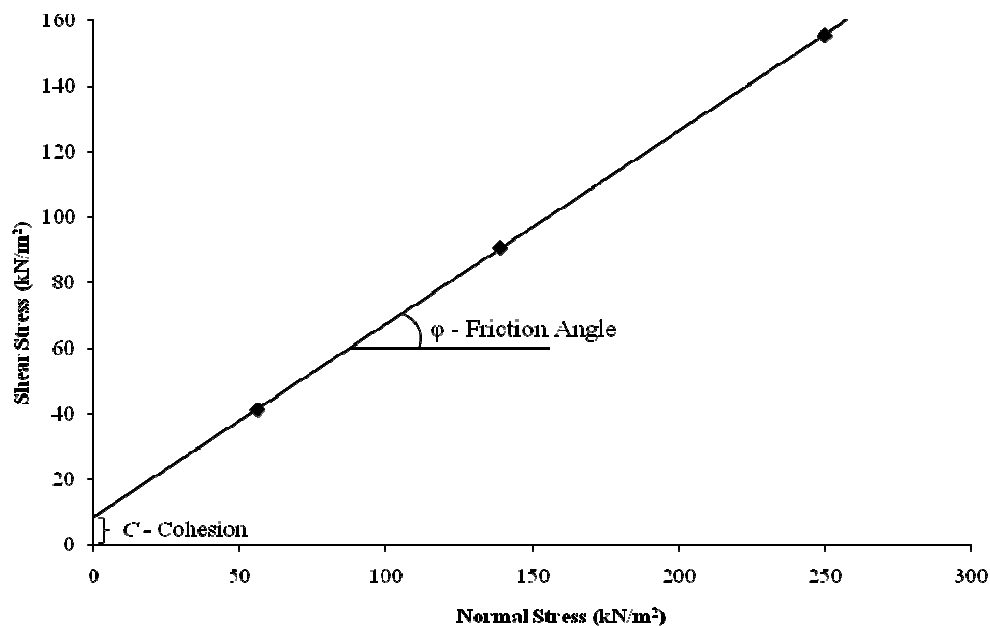
**Figure 5.7** – Shear stress vs. Normal stress for Sample 16 with the indication of the procedure to obtain the friction angle and cohesion

The maximum shear stress obtained in the shear stress-displacement curve of each of the three tests carried out on specimens of soil under different normal loads were plotted against the corresponding value of normal stress to obtain the shear strength parameters (Figure 5.7). Cohesion and angle of internal friction (angle of shear resistance), are the ones determined based on direct shear box test. The angle of internal friction of the soils of Maputo City varies from 28 to 33.5°. Only five samples had friction angles less than 30° (samples 3, 16, 17, 18 and 21). The highest friction angles are observed in the Ponta Vermelha Formation, 31–33.5°, and the lowest are in the Congolote and Malhazine Formations, 28–30°. Cohesion ranges from 0.83 to 11.14 kN/m<sup>2</sup>, with the highest values in the Ponta Vermelha Formation.

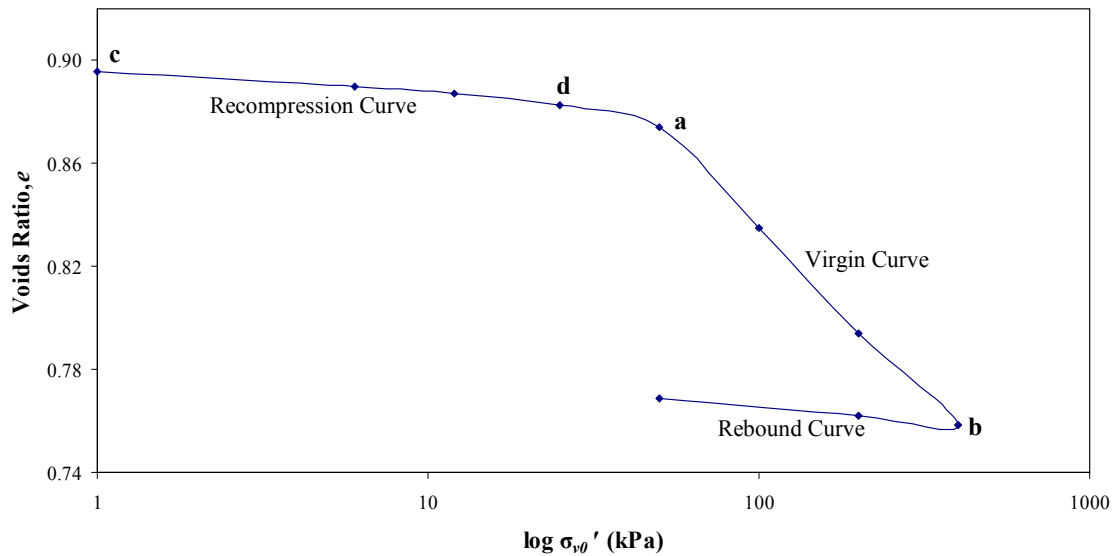
**Figure 5.8** – Typical consolidation voids ratio vs. vertical stress curve of the tested soils in Maputo City (Sample 18 tested fully saturated). Schematic representation of the curves is from Coduto (1999).

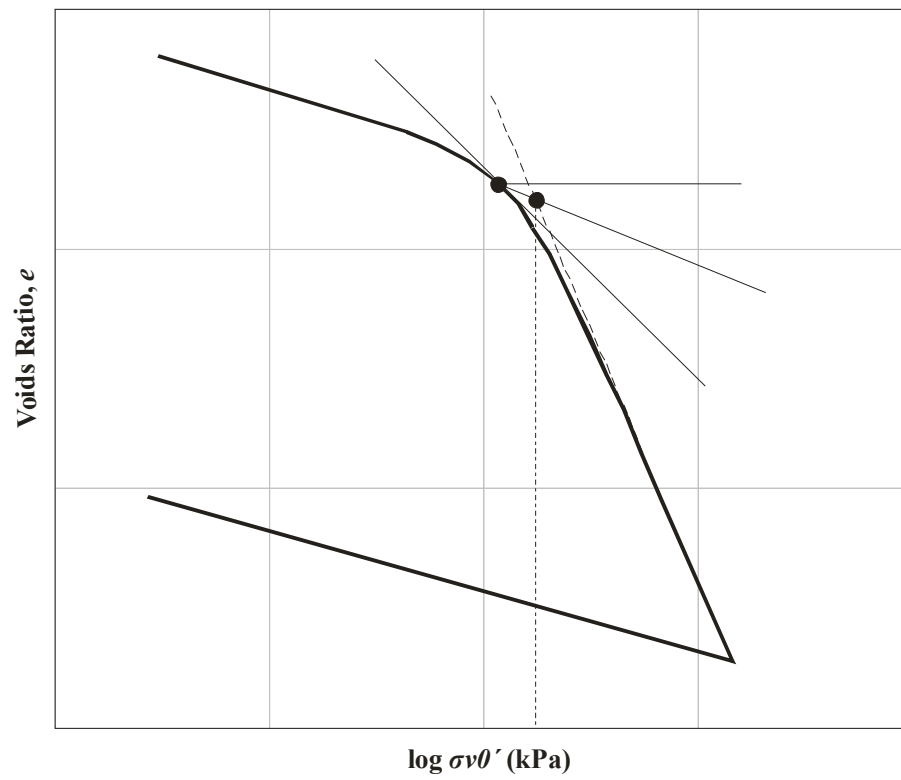
**Figure 5.9** – Casagrande's method of finding the preconsolidation stress (From Coduto, 1999)

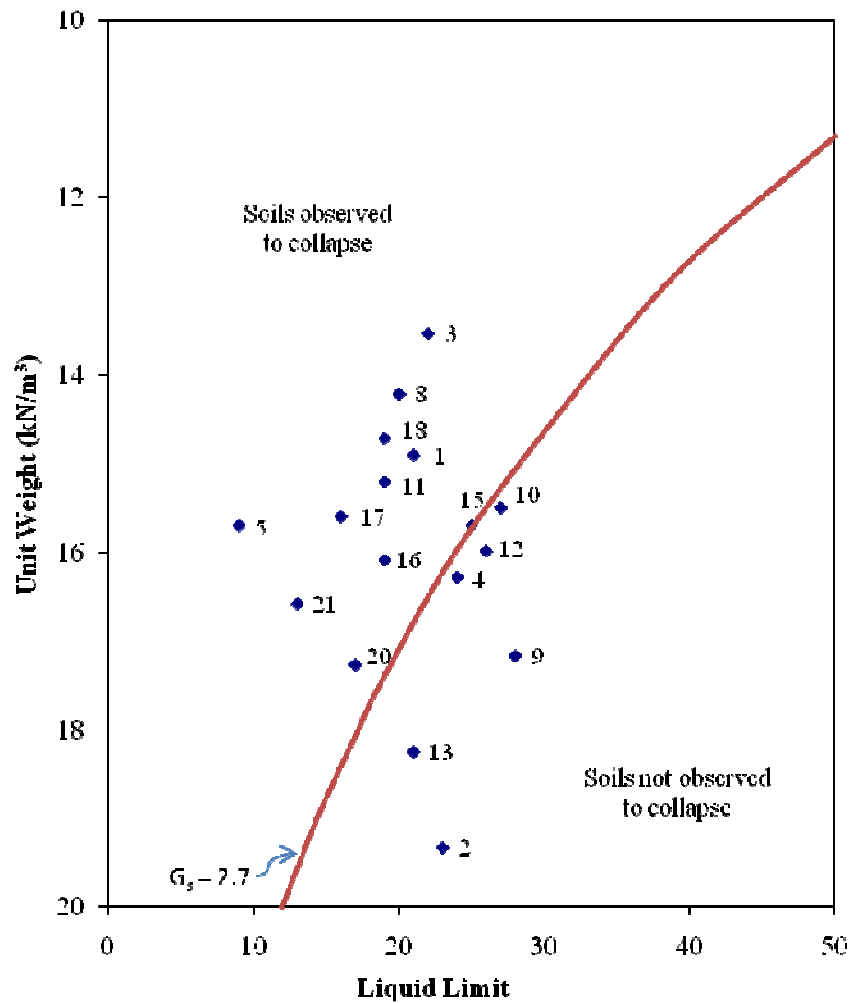
**Figure 5.10** – Collapsible and non collapsible soil using the Gibb (1962) criterion based on dry density and liquid limit. Most of the tested soils plot in the area of soils likely to collapse.

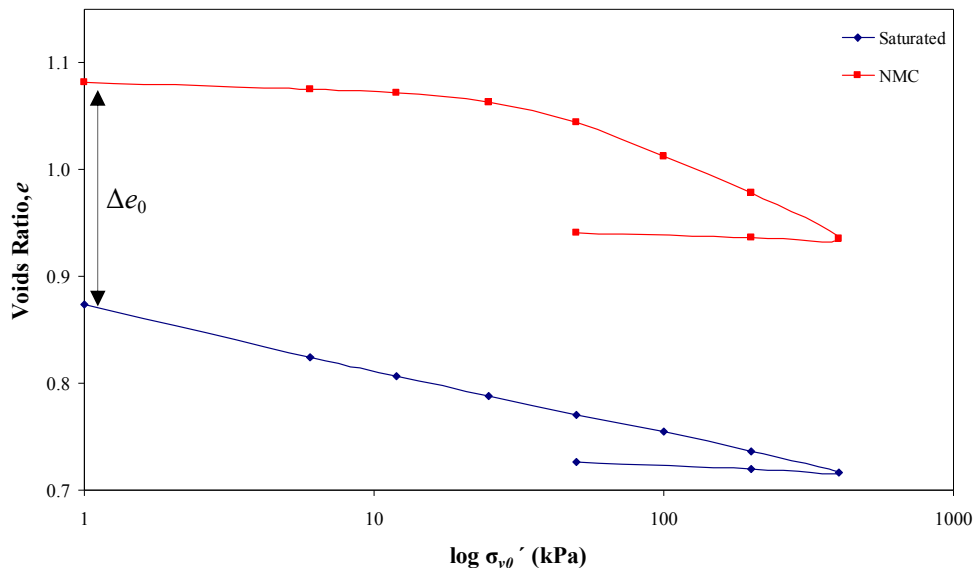
**Figure 5.11** – Double consolidation test of Sample 1 showing full collapse of the soil structure of the saturated soil. This graph is also characteristic for samples 2, 3, 10, 12 and 16.  $\Delta e_0$  denotes reduction of voids ratio with addition of water under 1kPa at the beginning of the test

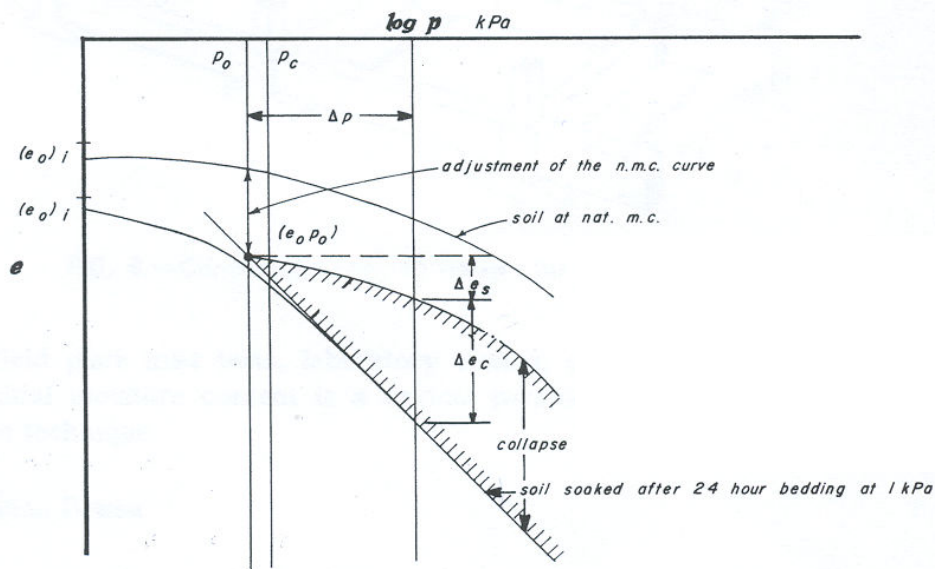
**Figure 5.12** – Double consolidation test and adjustments of curves for normally consolidated soils (Jennings & Knight, 1957; Clemence & Finbarr, 1981)

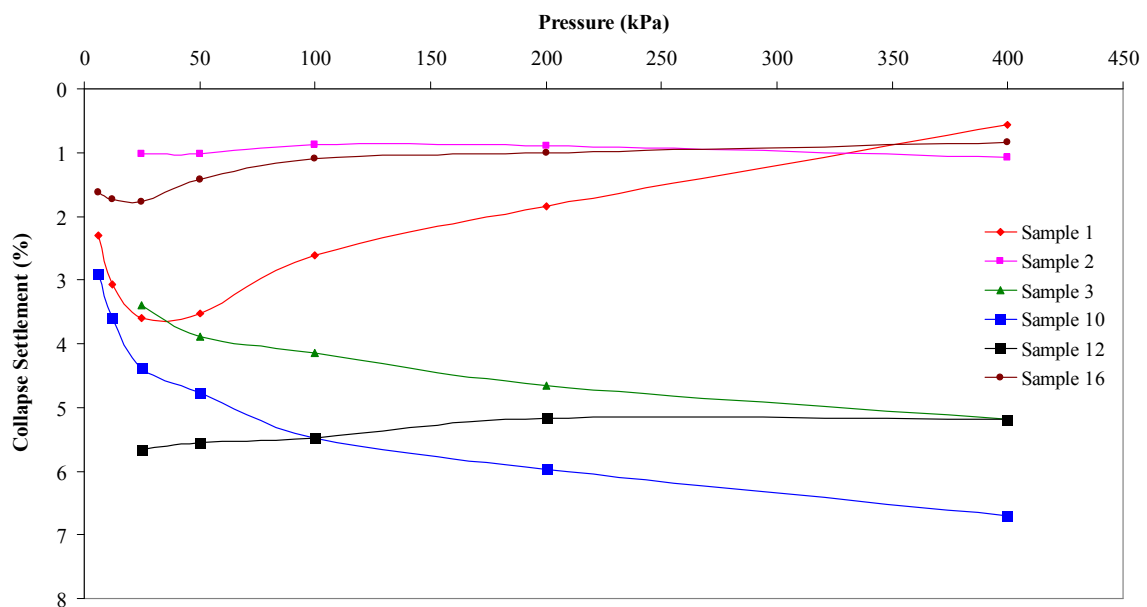
Figure 5.13 – Collapse ranges for the collapsible soils of Maputo City.

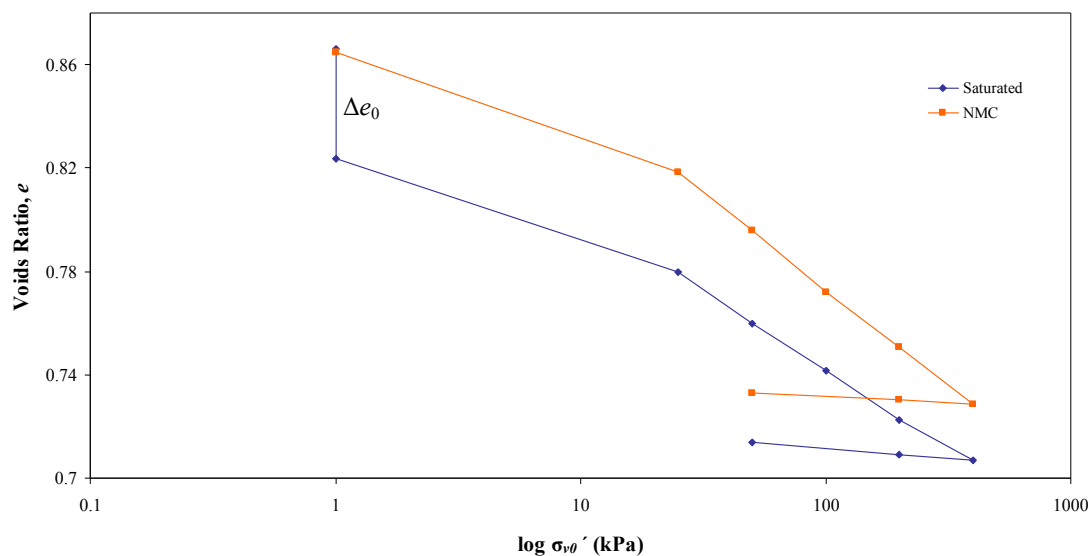
**Figure 5.14** – Typical  $e/\log \sigma_{v0}'$  curves from the double consolidation test performed on the soils of Maputo City showing the presence of the bonding material in the soil structure.

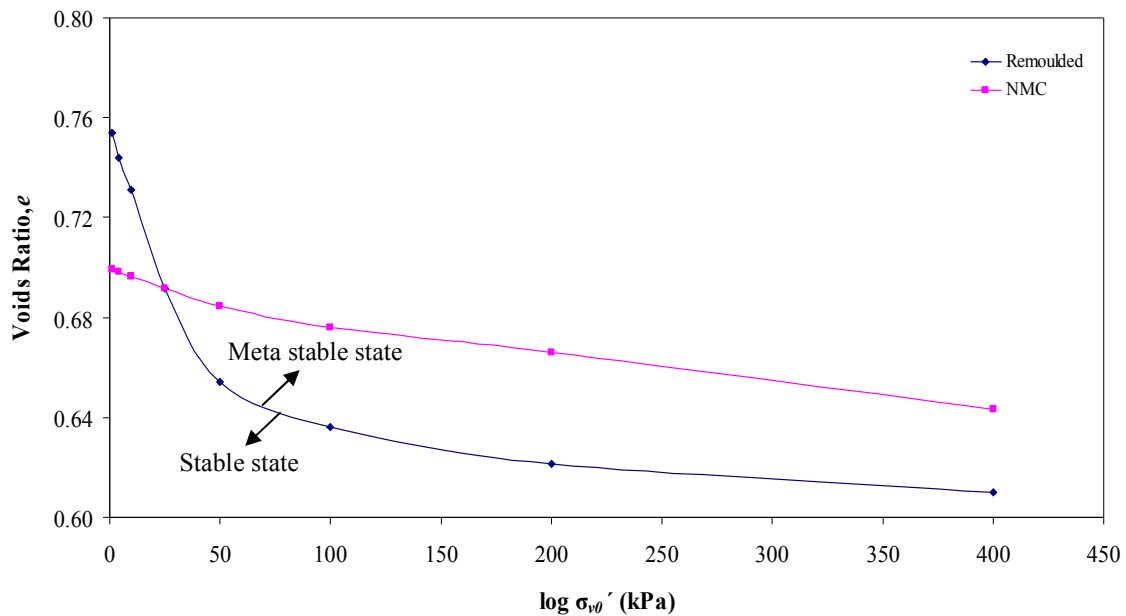
**Figure 5.15** – Typical compression curve in a normal scale of an oedometer test of the remoulded soil compared with the curve of a bonded soil occurring in Maputo City (Sample 20)

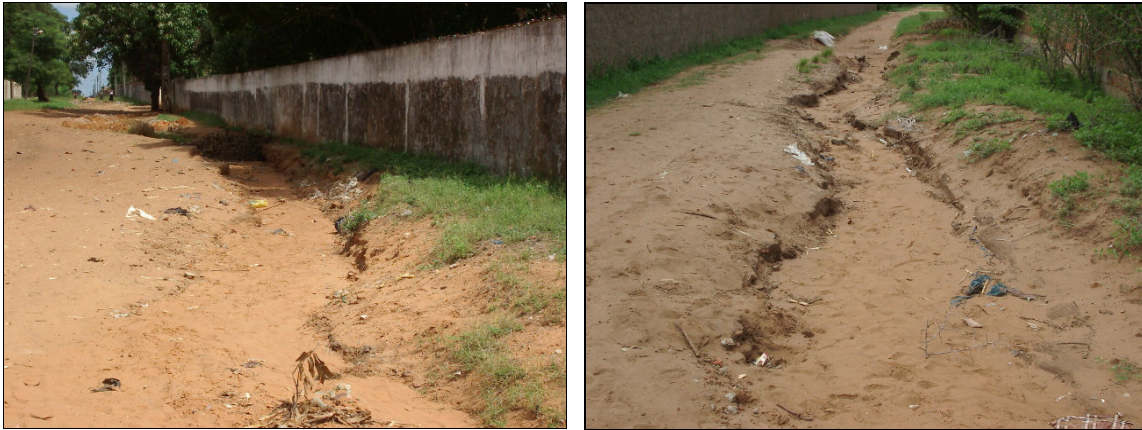
**Figure 6.1** – Rill erosion in Ferroviário Quarter, Maputo City. The rills preferentially follow the roads and footpaths

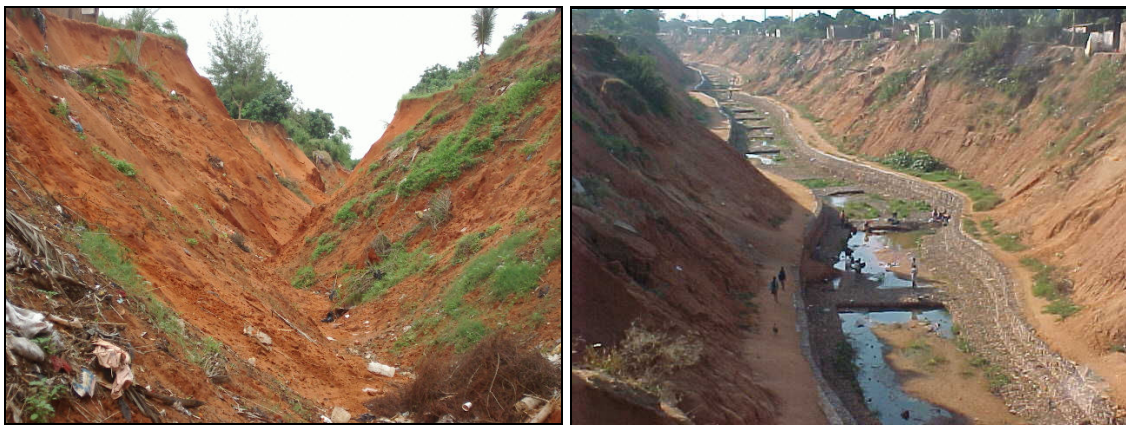
**Figure 6.2** – V-shaped gullies occurring in Ferroviário Quarter (left); U-shaped gully crossing the Polana-Caniço Quarter in Maputo City (right)

The shape of the gully cross-sections depends on the properties and strength of the soil matrix (Øygarden, 2003). Although the two most affected areas are in the same geological formation composed by silty sand, the gullies show different cross-sectional shapes. Gullies in Ferroviário Quarter are mainly V-shaped while the ones in the Polana-Caniço are U-shaped (Figure 6.2).

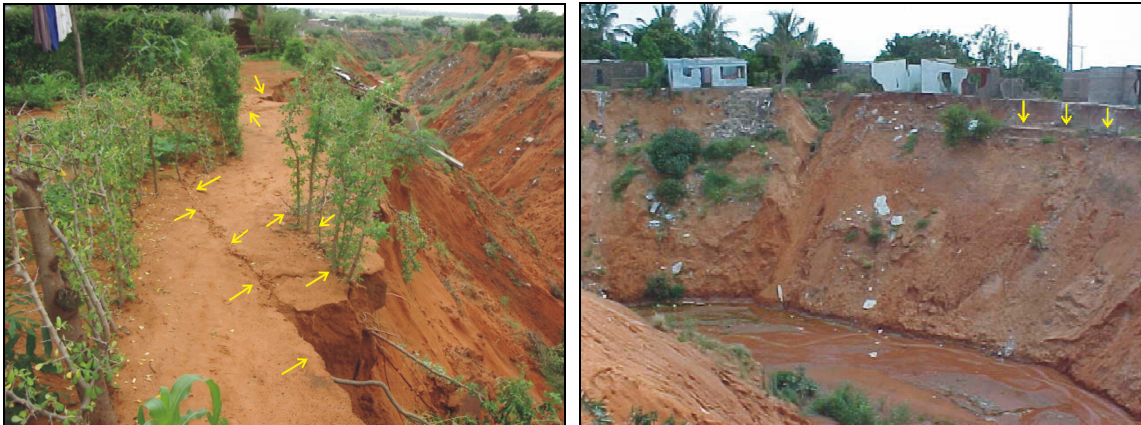
**Figure 6.3** – Tension crack development at a gully sidewall in Ferroviário Quarter, Maputo City. The load of people using the footpath on top of the crack will trigger the mass sliding downward (Left). Soil fall of 1.80 m occurred on a gully sidewall in Polana-Caniço Quarter (right).

The sidewalls of most of the gullies are still uncovered due to their steepness. They are unstable and suffer continuous erosion in every heavy rainfall event. Poesen *et al.* (2002b) and Vandekerckhove *et al.* (2003) estimate that sidewall erosion can be responsible for more than 50% of the total sediment produced in gullies. Study from Martínez-Casasnovas *et al.* (2004) indicates that the sidewall processes are multifaceted and result from a combination of factors. Their intensity is probably related to the duration and intensity of rainfall and to the potential energy variations linked to changes in soil moisture content (Poesen *et al.*, 2002b; Collison, 2001). These authors reveal also that gully sidewall failure is controlled by the gully-wall slope angle and height and that, *tension crack development is the main process promoting wall collapse in gully walls with high slope angles*. The sidewalls in every affected area in Maputo City are very steep with slope angles generally up to 60 degrees but locally steeper. This slope angle favours the development of tension cracks in gully sidewalls (Figure 6.3) which are the starting point of future gully widening (Collison, 2001; Martínez-Casasnovas *et al.*, 2004; Oostwoud Wijdenes *et al.*, 2000). This comes from the assumption that the tension cracks is likely to lower the stability of the gully sidewall by reducing cohesion and increasing pore water pressure as they easily allow water flow inside the soil and are filled with runoff water in a rainy event which will lower the shearing resistance of the soil (Martínez-Casasnovas *et al.*, 2004; Collison, 2001; Poesen *et al.*, 2002b).

The FS calculated for Sites 9, 10 and 12 using the slope angles given by the adjacent gullies sidewall is very low (0.569 to 0.652) indicating instability. This proves that the sidewalls of most of the gullies are unstable and suffer continuous erosion in every heavy rainfall event (Figure 6.3). Gully-wall slope angle and height are the main factors controlling gully sidewall failure through tension crack development and wall collapse (Poesen *et al.*, 2002b; Collison, 2001). Figure 7.6 and 7.7 show respectively the geometry and Factor of Safety calculations of the slopes for Site 10 in relation to the general natural slope angle of the area and to the slope angle created by the adjacent gullies. Appendix C presents the geometry and FS calculations of the remaining slopes.
