# **ASPECTS OF THE ENGINEERING GEOLOGY OF MAPUTO CITY, MOZAMBIQUE**

Submitted in fulfilment of the academic requirements for the Doctoral degree (PhD) in  
the

School of Geological Sciences

University of KwaZulu-Natal

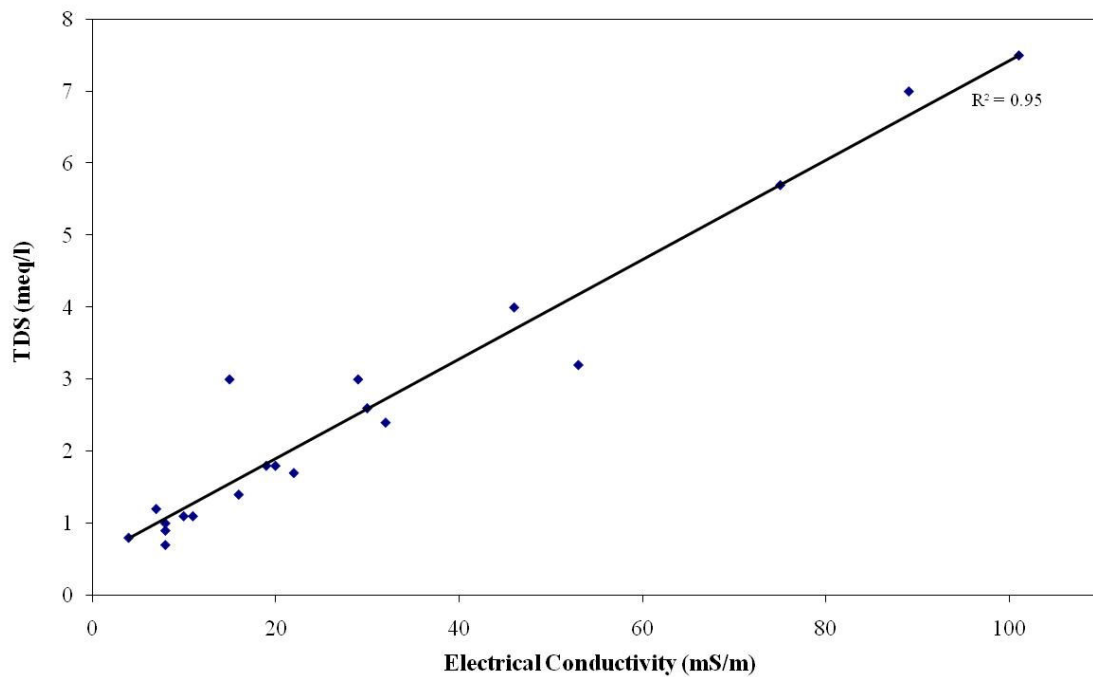
**Figure 6.11** – Strait line relationship between the total dissolved solids and the electrical conductivity of the tested soils of Maputo City.

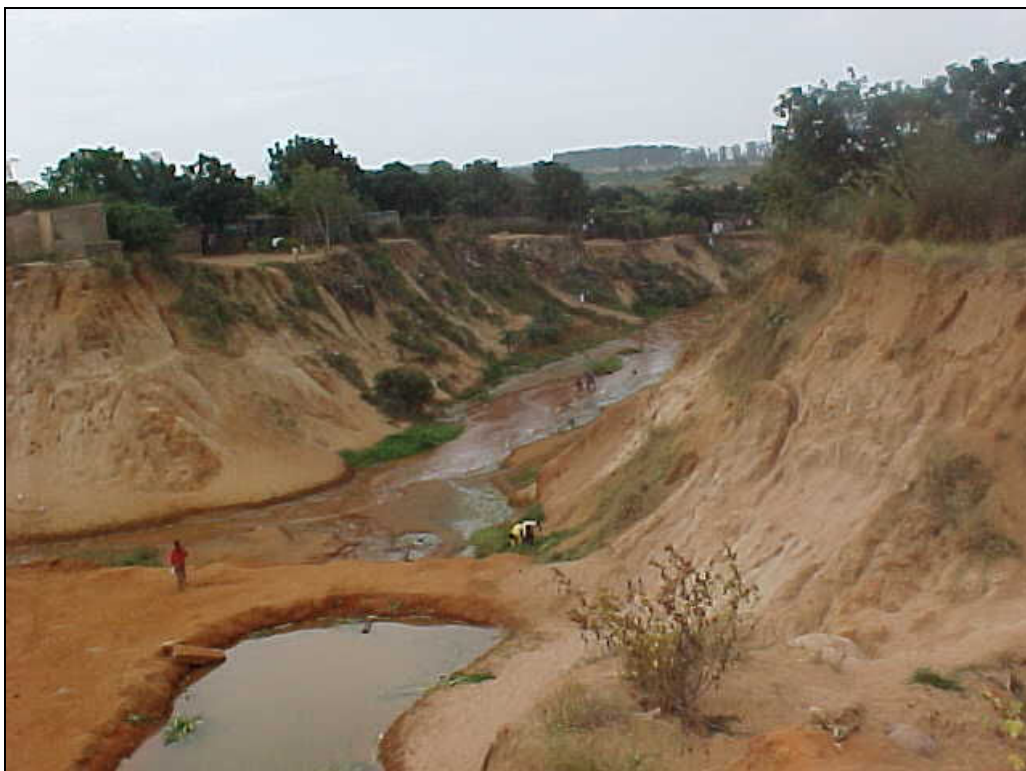
**Figure 6.14** – Groundwater seepage in the Polana-Caniço Quarter gully (photograph taken in the dry season)

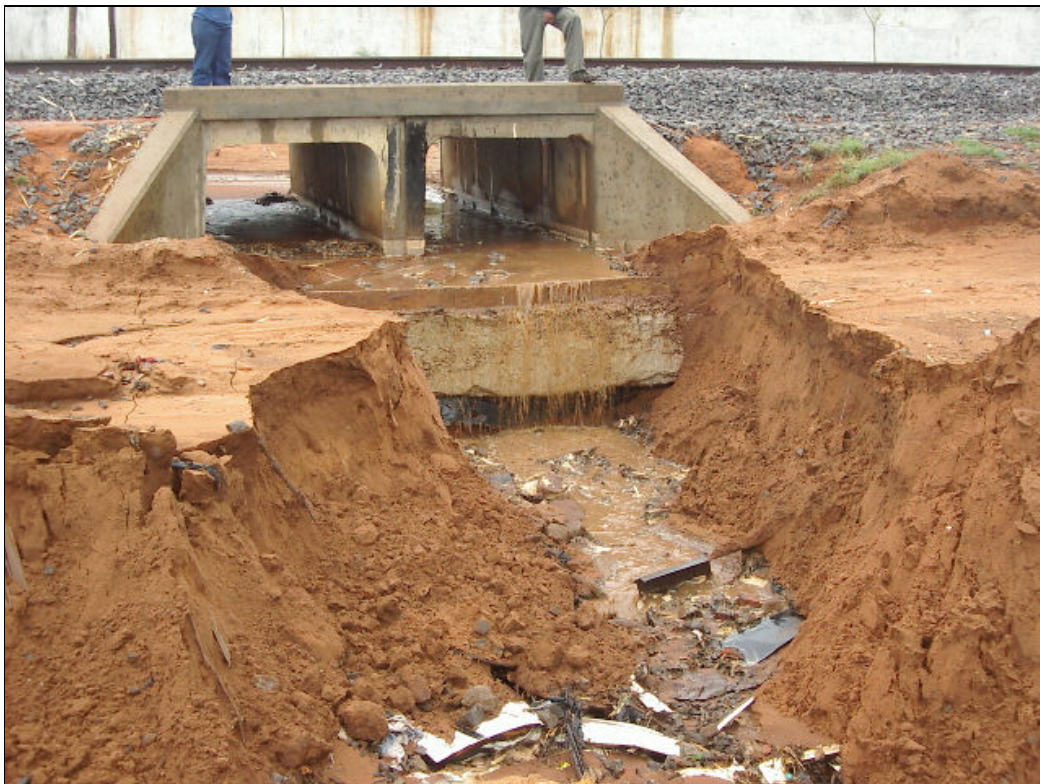
**Figure 6.15** – Gully initiating in the discharging point of concentrated water flow from the railway drainage system in Ferroviário Quarter, Maputo City.

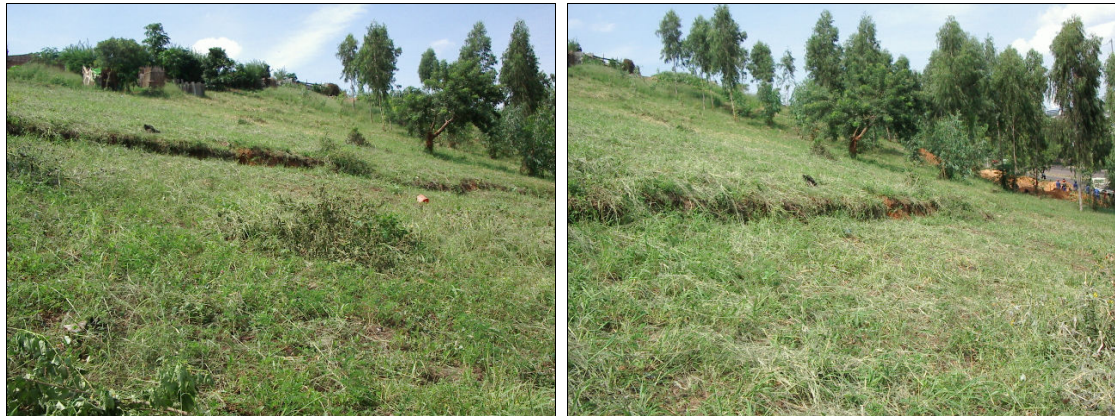
**Figure 7.1** – Shallow landslide along Nações Unidas Av with a vertical displacement of 30-40 cm. The crack is located only some meters above the ground surface

Both shallow and deep-seated landslides can be found in Maputo City. A shallow landslide is observed in the slope in the Nações Unidas Avenue. A mid-slope contour concave crack, with a vertical displacement of 30-40 cm, is observed (Figure 7.1). The slope appears unstable with evidence of active movement along the crack. Shallow landslides, as the name implies, are characterized by a sliding surface at depths up to 2-3 metres (Abramson *et al.*, 2002). The shallow surface failure with translational character in this slope occurs in soils with high permeability and is probably controlled by its sandy composition. The shallow failures likely occur in slopes comprising sandy and gravelly soils, in contrast to those composed of clays and silts (Lee *et al.*, 1983). The soil grain size has been used to evaluate surficial stability which has

normally a bias in relation to cohesion. With rainfall and water infiltration, the groundwater table rises and a decrease in the matric suction of the slope soils is observed. The topsoil becomes saturated creating conditions for high pore water pressure and reduction of the soil shear strength (Abramson *et al.*, 2002). The high soil weight and the low shear strength trigger failure and rainfall-induced landslide (Li *et al.*, 2005).

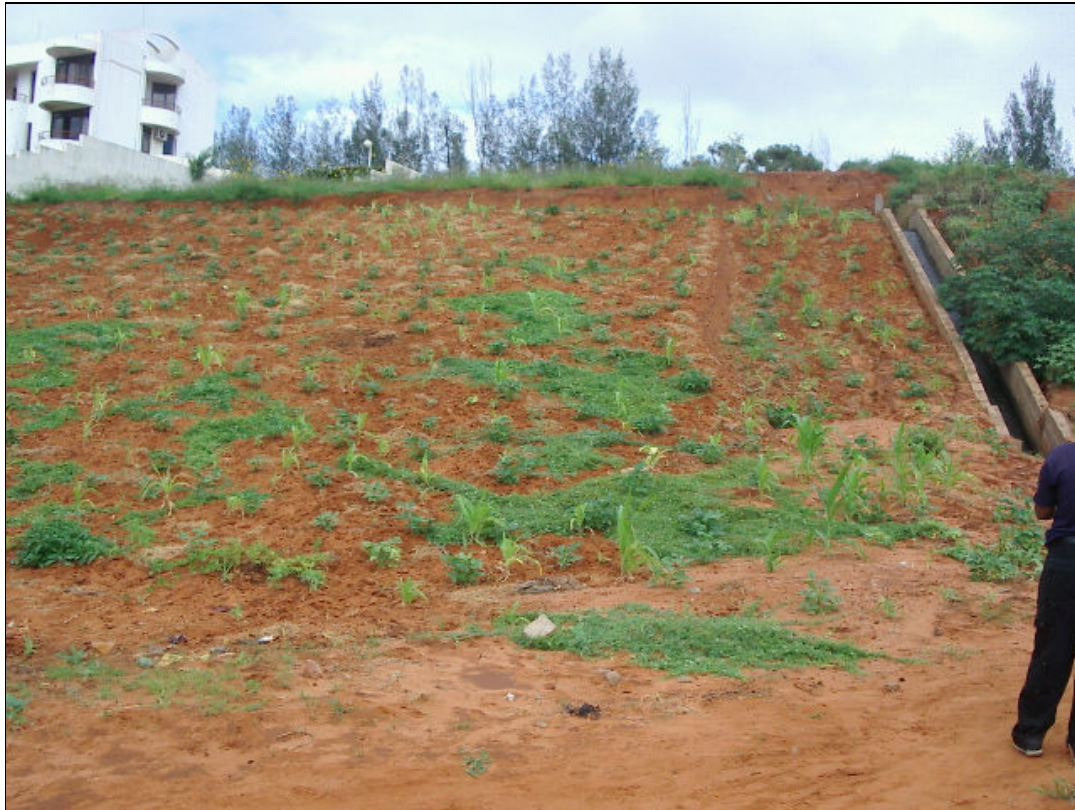
**Figure 7.4** – Slope face exposure as a result of cultivation

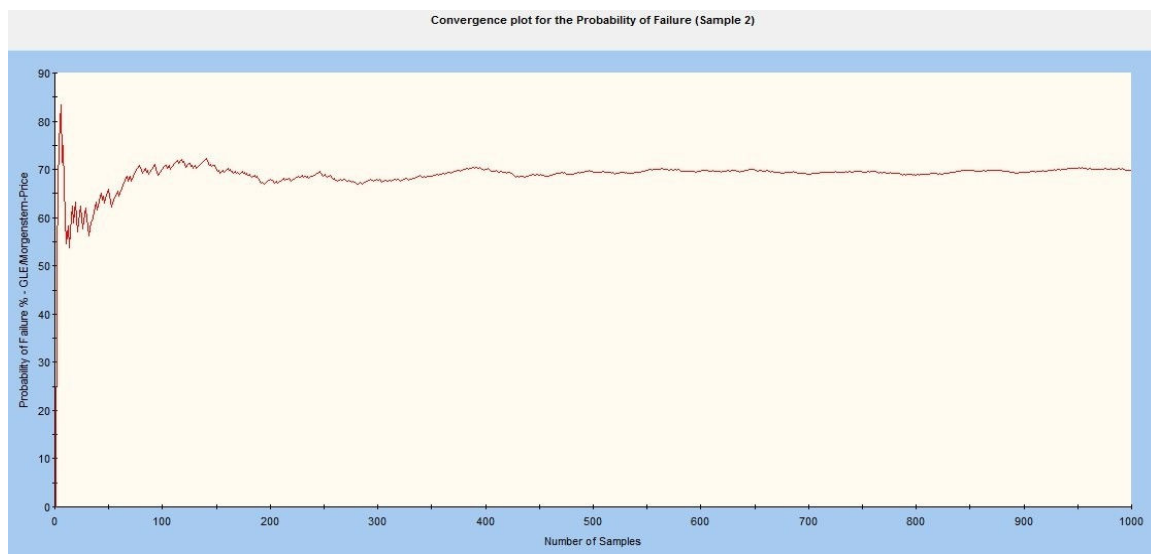
**Figure 7.8** - Convergence plot of the probability of failure analysis for Site 2

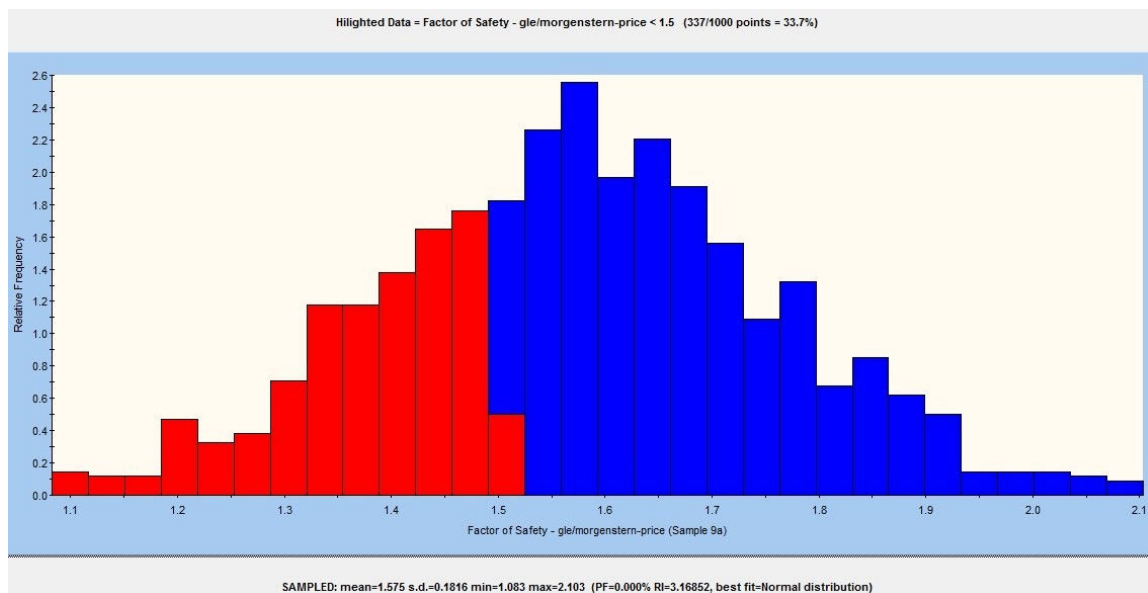
**Figure 7.9** – Histogram illustration the probability of failure for the slope on Site 9a

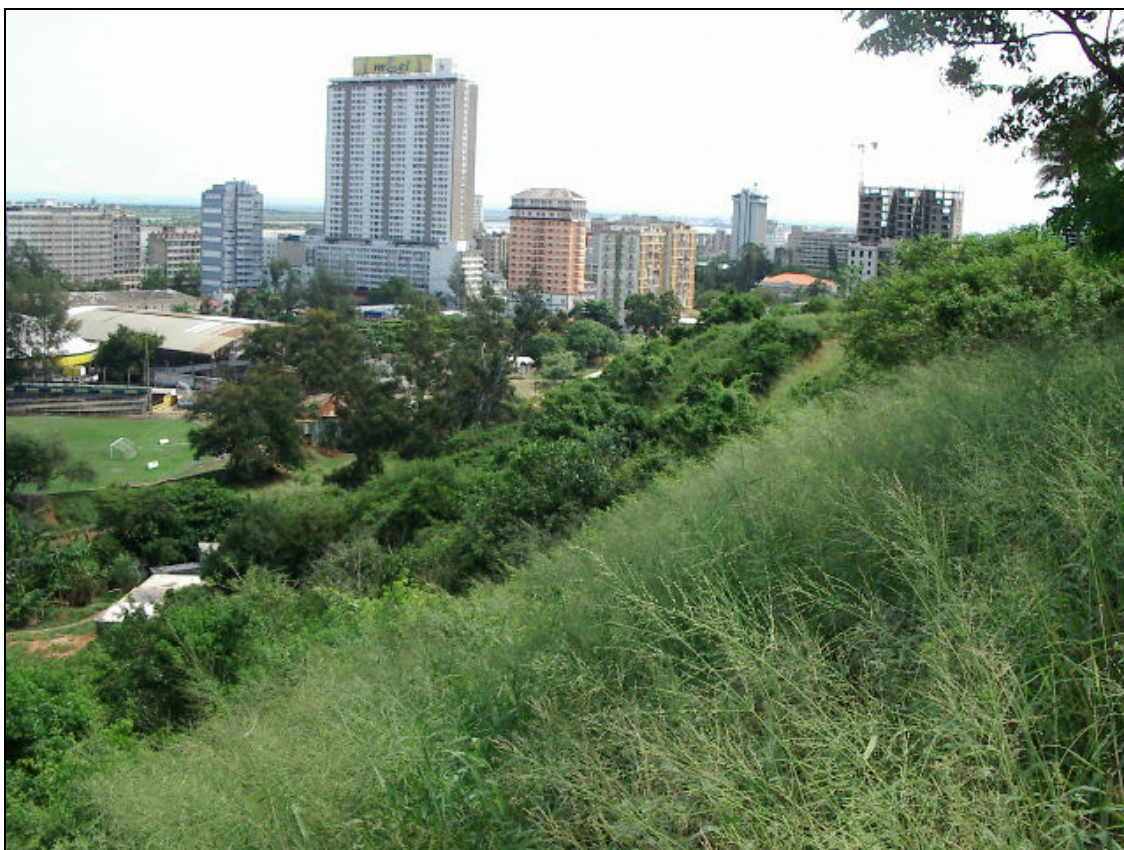
**Figure 7.11** – Lateral view of the Maxaquene Barrier heavily vegetated giving stability to the slope

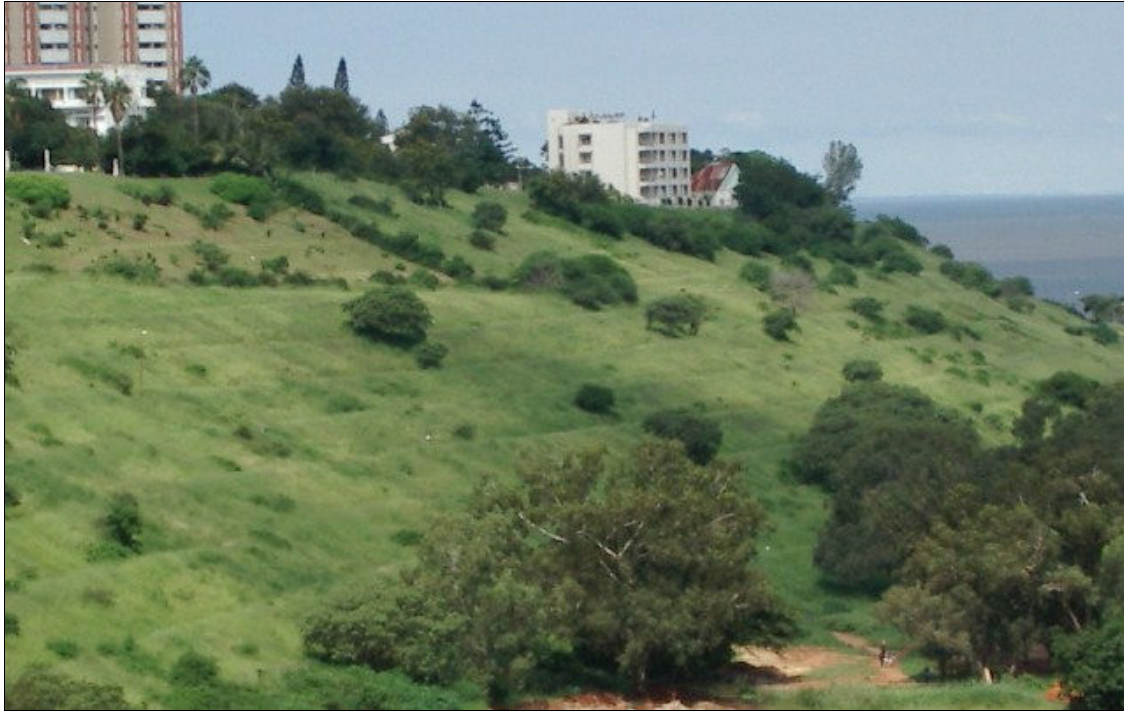
**Figure 7.13**– Surface slope drainage in front of Cardoso Hotel used with relative success as lack of maintenance limits its usefulness

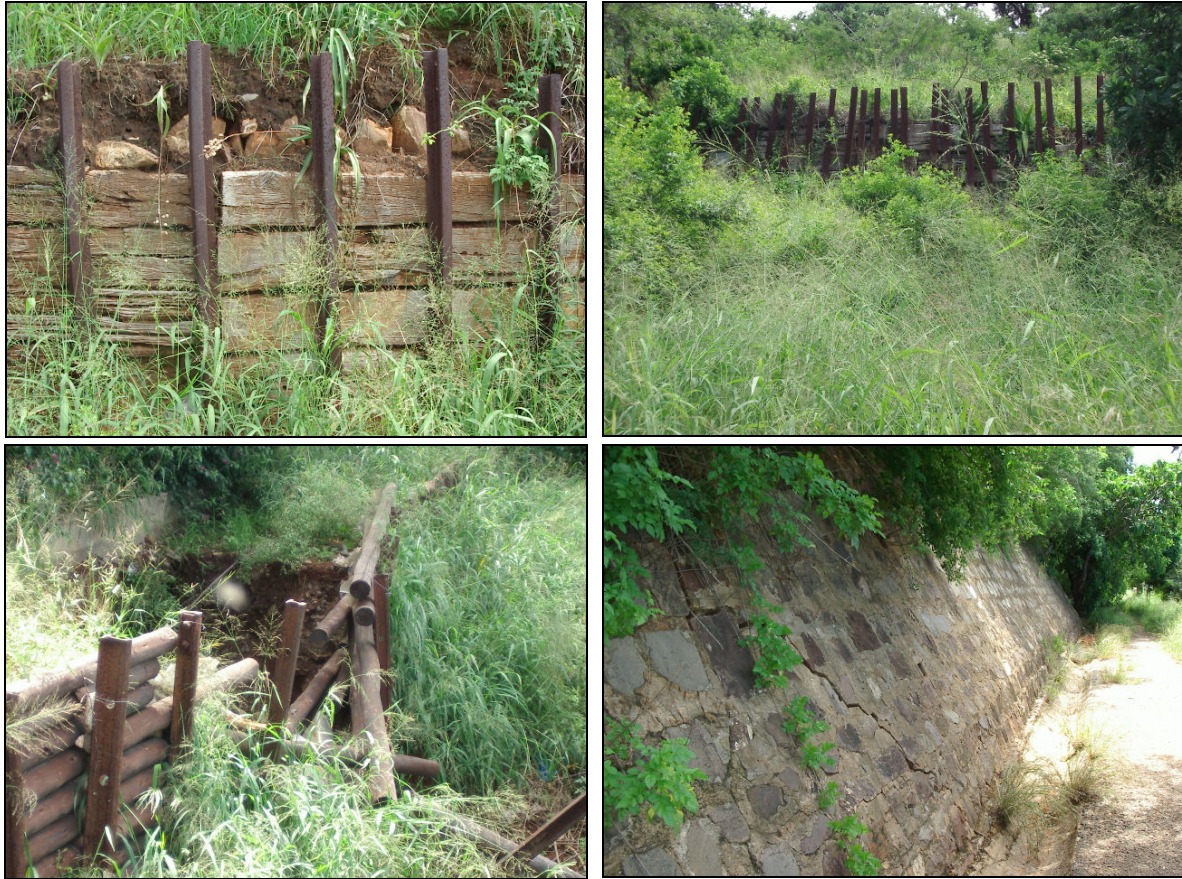
**Figure 7.14**– Some remedial measures undertaken on the slope of Friedrich Engels (Site 8) showing deficiencies of maintenance
