A STUDY OF POLE TOP FIRES ON 22KV WOOD POLE POWER LINES IN KWAZULU - NATAL

**A postgraduate dissertation submitted to the Discipline of Electrical Engineering at
the University of KwaZulu - Natal in partial fulfillment for the requirements of
Master of Science in Electrical Engineering.**

Date: October 2007

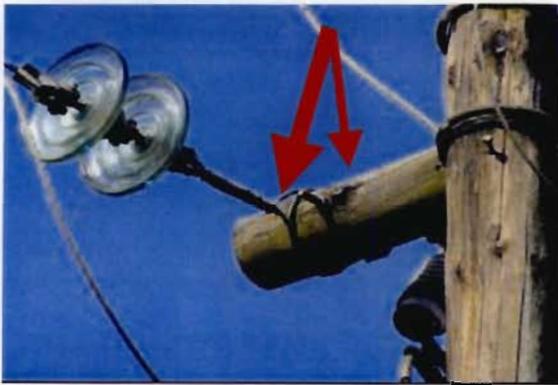
Figure 2 – 4: Application of binding wire to strain off conductor.

Prior to 1995, a common Eskom Distribution design included the double wrap binding wire method to strain off conductors via glass disc type insulators or long rod porcelain type insulators. This is illustrated in Fig 2 – 4 below. Notice the tracking at the mounting bolt of the cut out link on the opposite side.

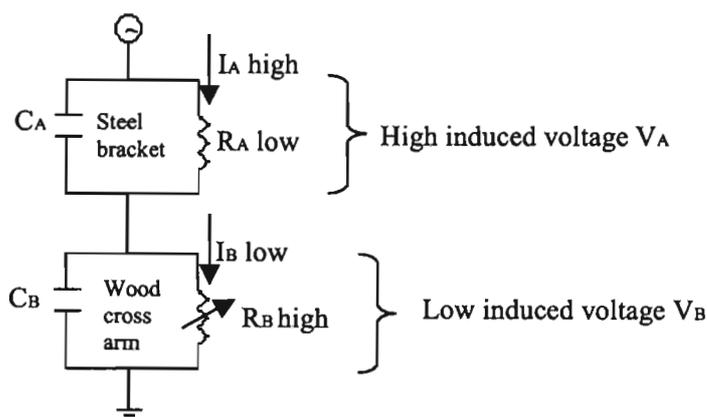
Initially, it was difficult to understand how the leakage current got to the U – bolt bracket and then tracked onto the wood surface. It was speculated that a higher voltage gradient existed on the U – bolt bracket than on the cross arm. The U – bolt bracket has rough edges along its surface. These rough edges create local non – uniform electric fields which causes self sustained electric discharges to take place between the metal surface and wood cross arm surface. Figure 2 – 13 can be electrically modeled as shown in Figure 2 – 12. As can be seen in Figure 2 – 13, the letter A represents the steel U – bolt bracket and the letter B represents the wood cross arm. Steel has a characteristic of very low resistance. That is R_A is very low. Wood has a characteristic of very high resistance. That is R_B is very high. For self sustained electric discharges, a higher induced voltage (V_A) is required on the U – bolt bracket than on the wood surface. From Ohm's Law ($V = IR$), a higher current (I_A) will flow in the bracket compared to a lower current (I_B) flowing in the wood.

Figure 2 – 12: Electrical model of the steel bracket and wood cross arm (Persadh, 2007).

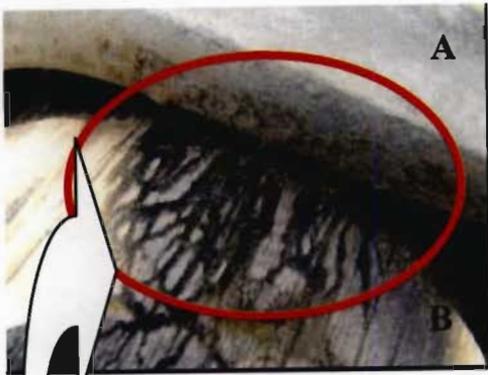
One interesting sample was a section of a bonded cross arm that was secured to a pole via a steel U – bolt bracket. Pictures of the sample can be seen below. It is shown that the bracket was tightly pressed against the surface of the wood. It was very interesting to find severe tracking at the interface between the U – bolt bracket and a section of the wood pole surface. There were no insulators connected in the immediate vicinity of the pole.

Figure 2 – 13: Severe tracking between bracket (A) and wood pole surface (B).

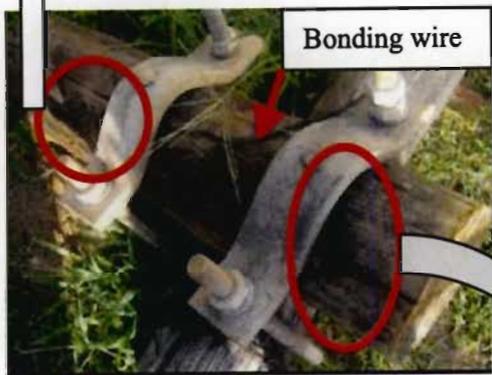
Figure 2 – 14: Cross arm secured via a U – bolt.

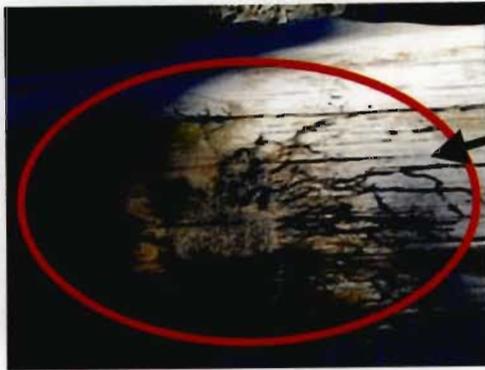
Severe tracking from an insulator base that was pressed against the surface of the cross arm.

Figure 3 – 4: Tracking gets more severe and starts to ignite the wood surface.

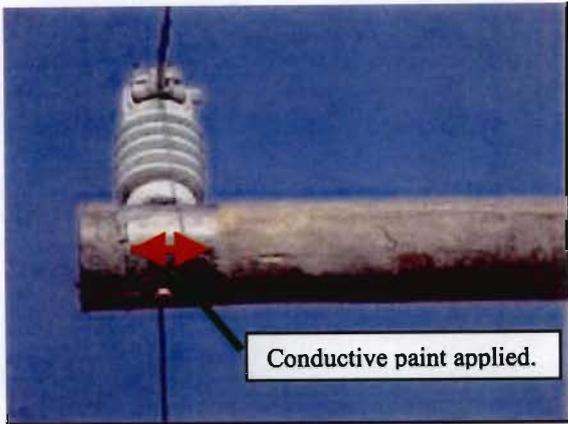
Figure 3 – 17: Illustration of conductive paint applied to the cross arm 100mm on either side of the insulator pin (Loxton, 1998).

On energizing the sample, the wetted insulator started emitting flashover sparks between the sheds and onto the surface of the conductive paint. The current immediately rose to 32 – 40mA RMS. The unit remained energized for 20 minutes. After the insulator sheds had become dry from the heating activity on the surface, little or no activity was observed. At all times during the test, no traces of surface burning or smoke were seen at all. There was no burning to the cross arm surface at all (Loxton, 1998).

The conductive paint was applied with a paintbrush on the brushed wooden surface. After nine months of being in service, the paint started to flake and crack at various points on the cross arm. This was due to the unstable surface of the wood and the harsh weather conditions causing wetting, heating and cooling of the wood. Although this method showed extremely positive results in overcoming burning, the results were disappointing as the lifespan of the conductive paint had reduced by three quarters. The formula for the conductive paint needs to be further investigated and worked on to cater for the longer durations in the field. It should have a lifespan of at least twenty years. Hence applying conductive paint is an excellent method to overcome pole top fires, however, it is not yet practical as the paint is not yet durable for the long periods required.

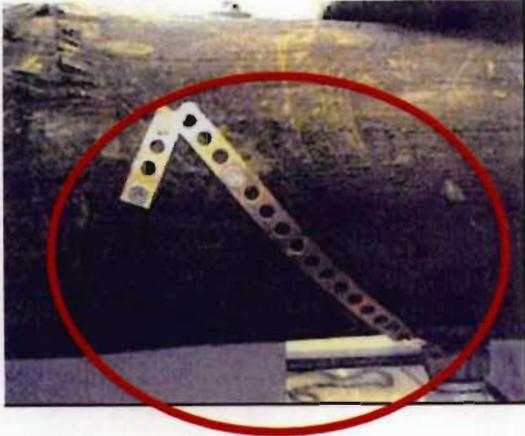
Figures 3 – 19: Illustration of copper strip attached to the bottom of the insulator pin and fixed approximately 200mm from the insulator pin (Loxton, 1998).

The copper strip was bolted to the bottom of the insulator pin and taken towards the centre of the cross arm. This removed the leakage current concentration away from the insulator pin thus preventing any form of ignition or surface burning. The test sample was set up the same as in the maintained series impedance test described in 3.3.6.1 above and the same environmental conditions were adhered to. The result was similar to that of the banding experiment above. On energizing the test, the current immediately rose to 21mA and slowly subsided after 7 minutes to 1.3mA as the pollutant dried on the surface of the insulator. No ignition or burning was observed (Loxton, 1998).

Due to ease of application and efficiency in preventing burn offs on un – bonded cross arms, this method was suggested for implementation in the field. The important feature with this method is that it maintains the series wood path impedance required under high lightning conditions.

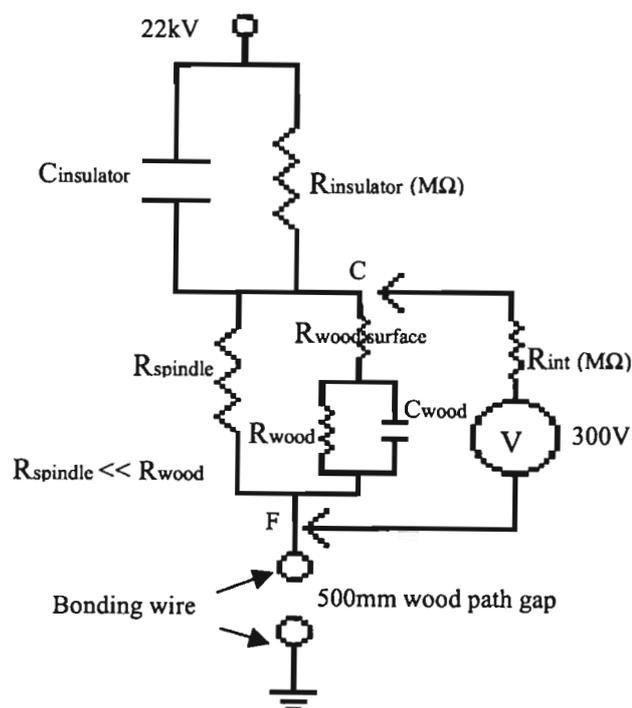
Figure 4 – 5: Electrical model of diagram of measurement with Ceramic insulators.

The 300V measured between points C and F appears to be suspiciously low. Note that point C is at the bottom end of the insulator. Considering that the voltmeter / phasing stick has a very high internal resistance which is in the range of mega ohms, the following explanation refers. The resistance of the insulator is in the range of mega ohms. Similarly, the resistance of the wood cross arm is very high (possibly in the range of mega ohms as well). The resistance of the spindle / threaded rod is far less than that of the wood. That is, $R_s \ll R_{wood}$. Hence, greater leakage current will flow from the insulator surface and into the spindle. This would yield a lower voltage drop. Therefore the low measured voltage is the voltage drop across the spindle.

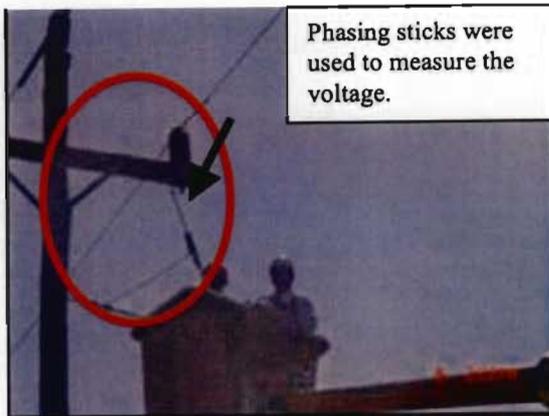
Figure 4 – 6: Live – Line inspection and voltage measurements on a D DT 1740B structure.

- The wood cross arm was bonded 100% to standard.
- The structure was fitted with post top ceramic insulators of specific creepage 31mm/kV.
- These outer phase insulators were loose. The researcher was able to physically and easily rotate them with his hands.
- Traces of burning was observed on the cross arm at the outer phase insulator bases.
- There was evidence of tracking or leakage current activity between the insulator base and cross arm surface. This was evident at both insulators. The insulators did not have a metal base.
- Upon closer examination, the tracking had emanated from the insulator spindle oval shaped washer and onto the wood surface.
- There was a very thin and almost transparent layer of pollution on the sides of the insulators where the tracking was evident. The pollution appeared to be washing away onto the wood surface.

The following are pictures of the correctly bonded structure and show early signs of burning of the wood cross arm surface.

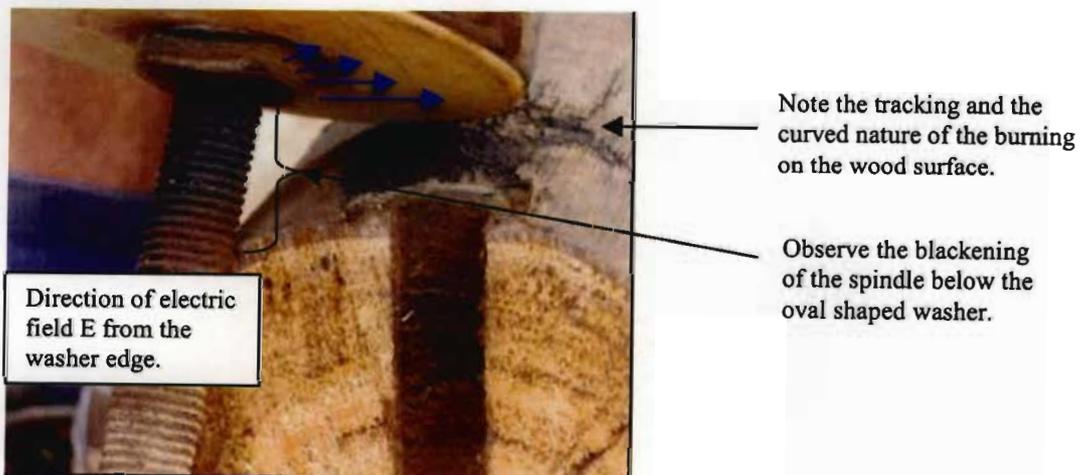
Figure 4 – 13: Sectionalized cross arm with spindle and insulator base showing direction of electric fields from spindle washer and tracking on the wood surface.

Due to dry band arcing and the dissimilar impedances of the three branches the potential of the bonding wire may be raised to such a voltage as to cause sparking.

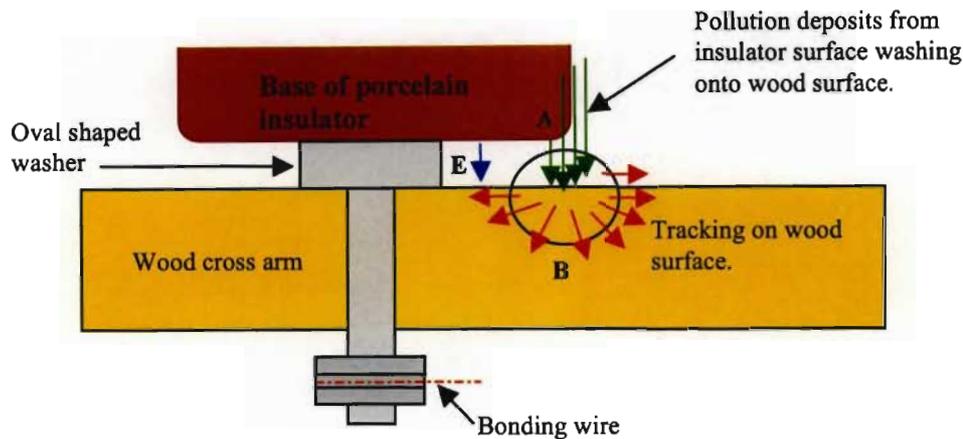
Figure 4 – 14: Diagram illustrating pollution deposits from insulator washed onto wood surface.

The above diagram further illustrates the burning mechanism as pointed out in Figure 4 – 13. Further to the explanation given in 4.6.2, pollution stains were observed at the base of the porcelain insulators. The pollution appeared to be washing away onto the wood surface and thus accumulating onto it. It is important to note that the edge (point A) of the base of these porcelain insulators is not as smooth as the insulator sheds. These rough edges lead to non – uniform electric fields. As pointed out in 4.6.3 above high electric fields exist between points A and B respectively. This resulted in sustained sparking between points A and B, thus causing the burning of the wood surface.

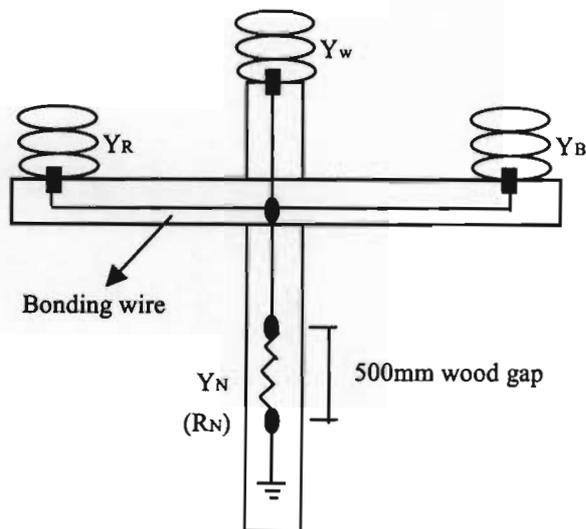
Figure B – 1: Diagram of a bonded cross arm

Consider a properly bonded wood cross arm. Figure B – 1 below refers.

- Resistances of the wood cross arm are not taken into consideration as bonding wire is present.
- However, varying amounts of pollution across each phase insulator contribute to the variable resistance across each insulator. Thus the impedances are non-linear and the leakage currents contain harmonics.
- Hence there exist resistances R_R , R_W and R_B or Admittances Y_R , Y_W and Y_B respectively. R_N is the high resistance (or Y_N - admittance) of the 500mm wood gap. These are indicated in the figure below.

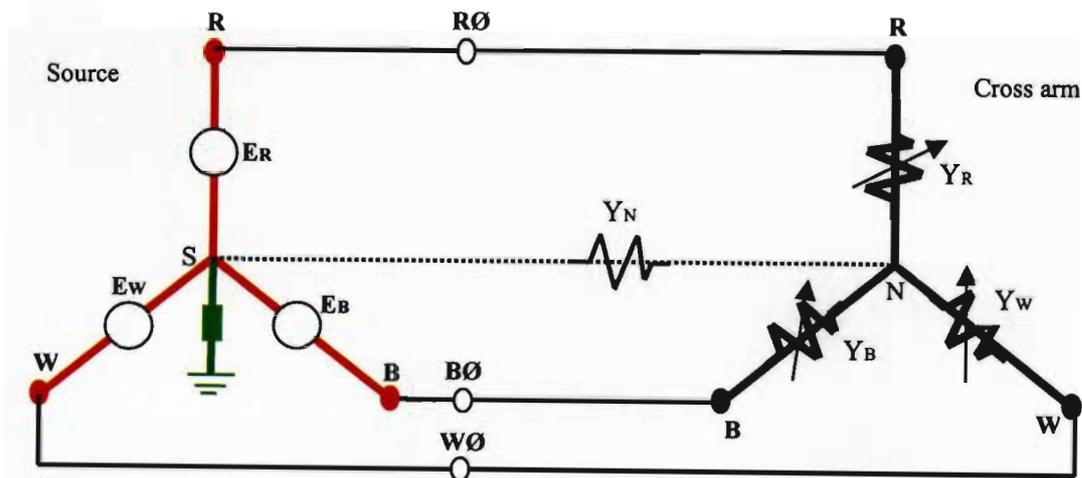
Figure B – 2: Electrical model of the bonded cross arm above.

- Assume that all the insulators are of the same type and with the same insulator specific creepage level. If the pollution layer on all these insulators is exactly the same, then: $Y_R = Y_W = Y_B$ and Y_N is negligible.

- This is the ideal situation to have. However, the pollution layer is not always the same on all three insulators and hence $Y_R \neq Y_W \neq Y_B$ and as such V_{SN} cannot equate to zero. In practice a small neutral voltage will usually exist. This applies only when the pollution is conductive, that is in wet conditions only.

- This unbalanced resistive load (pollution layer) causes the potential V_{SN} to rise with respect to the local pole earth. Note that the pole itself has a finite resistance to true earth and hence forms the earth of the supply system. In extreme pollution conditions, this may cause the bonding wire to reach a potential of several kV for short periods.

- This potential difference creates a high electric field to exist between the bonding wire and wood surface or between the inside of the insulator spindle and inside of the wood cross arm. It is this high electric field that causes sparking between these surfaces and consequently burning to start from inside of the cross arm.

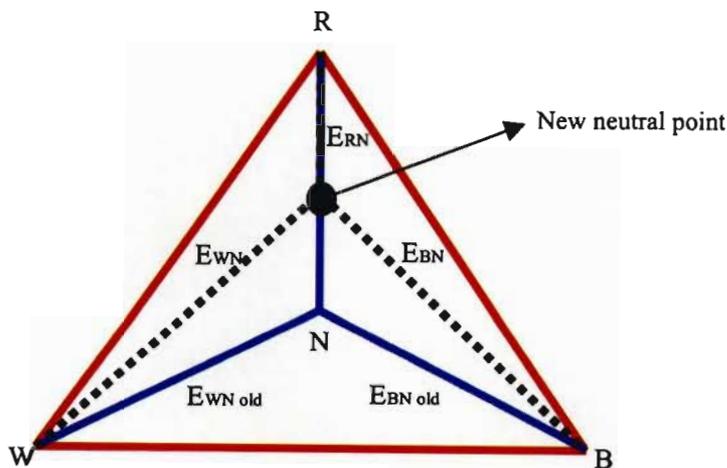
Figure B – 3: Phasor diagram illustrating the Neutral Shift.

- Since $V_{SN} \neq 0$, this implies that the phase voltages will not be equal, that is:
 $E_{RN} \neq E_{WN} \neq E_{BN}$
- Hence the neutral has shifted (Neutral Shift). This is demonstrated in the Figure B – 3 below.

- This phenomenon cannot be avoided in highly polluted areas.

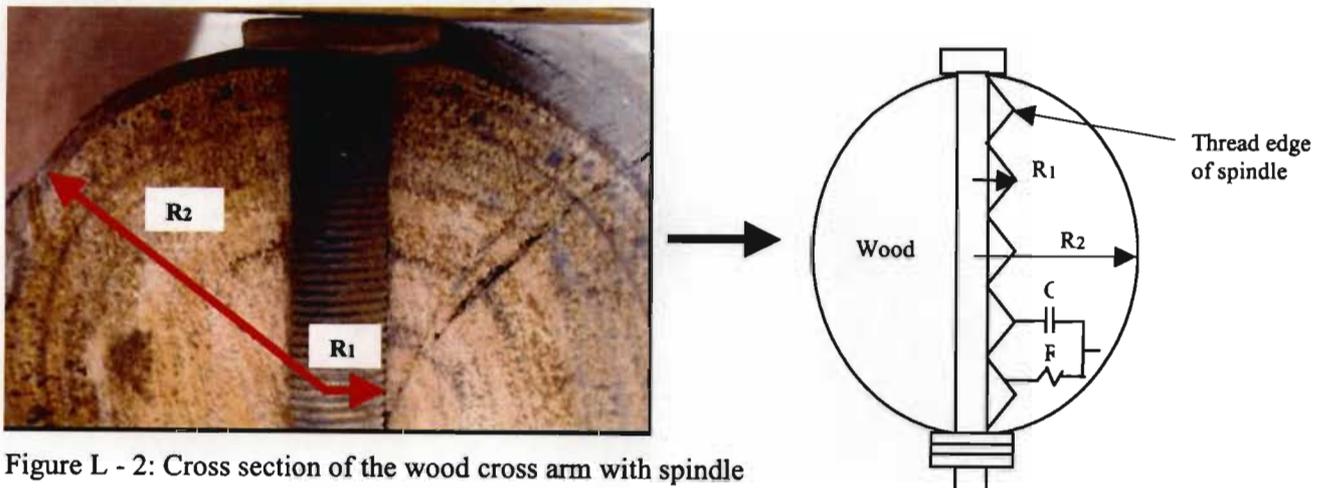
Figure L - 2: Cross section of the wood cross arm with spindle

$$= 14.43 \text{Vmm}^{-1}$$

This is an astonishingly high figure which could easily lead to sparking resulting in the cavities found between the spindle / threaded rod and the wood.
