Investigation of the Directional Effect on Low Cost Houses Due to the 2014 Orkney Earthquake

Thando Nqasha

A dissertation submitted in fulfilment of the academic requirements for the
degree of Master of Science in Land Surveying

15 May 2020

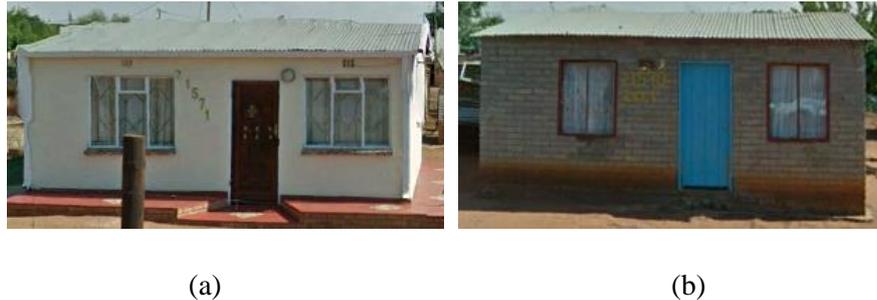
The building finish variable referred to whether plaster was present on the external wall of a low-cost house (Figure 3-8 a and b). Google Earth was used to view the external walls where possible.

Figure 3-8: External building finishes, (a)Plastered house. (b) Un-plastered house (Khoyratty, 2016).

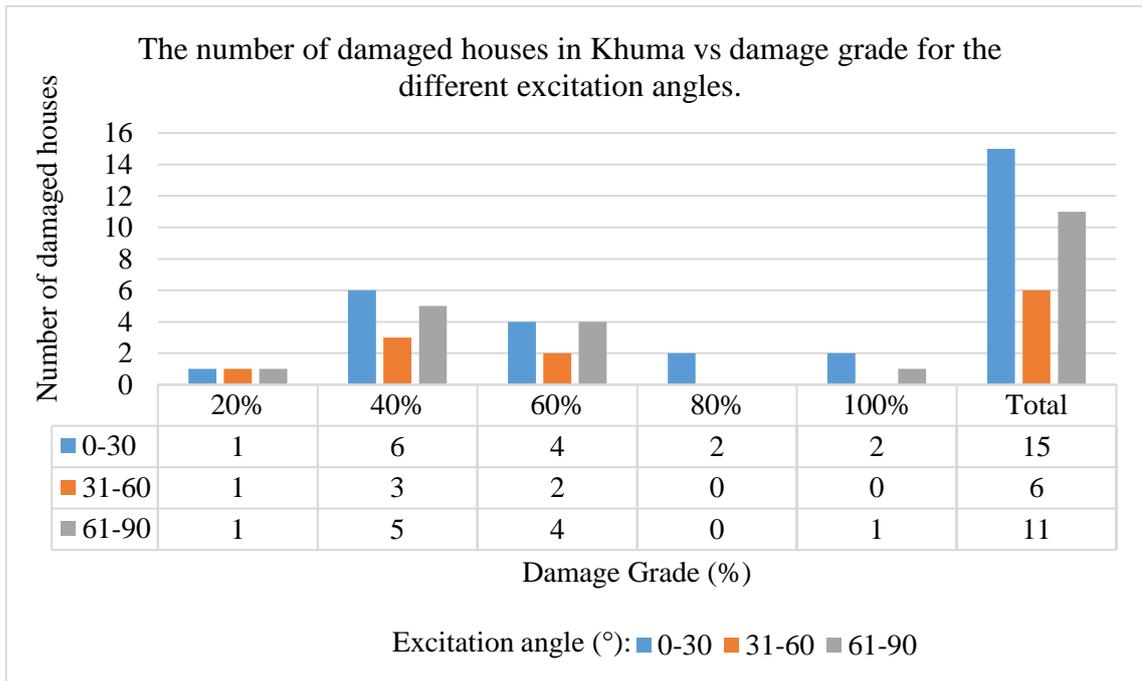
Figure 4-1: Number of damaged houses classified according to excitation angle and damage grade in Khuma

Figure 4-1 provides the same information as the map however the variable relations can be seen quantitatively. For example, the total number of damaged houses with excitation angle 0° - 30° was 15, while excitation angle 31° - 60° had 6 damaged houses and excitation angle 61° - 90° had 11 damaged houses.

In terms of damage grade 100%, 2 damaged houses had excitation angle 0° - 30° and 1 damaged house had excitation angle 61° - 90°. Damage grade 80% had only 2 damaged houses, with excitation angle 0° - 30°. For damage grade 60%, excitation angle 0° - 30° and 61° - 90° had the same number (4) of damaged houses while excitation angle 31° - 60° had 2 damaged houses. For damage grade 40%, there were 6, 3 and 5 damaged houses for excitation angles 0° - 30°, 31° - 60°, and 61° - 90° respectively. For damage grade 20% all excitation angles had 1 damaged house.

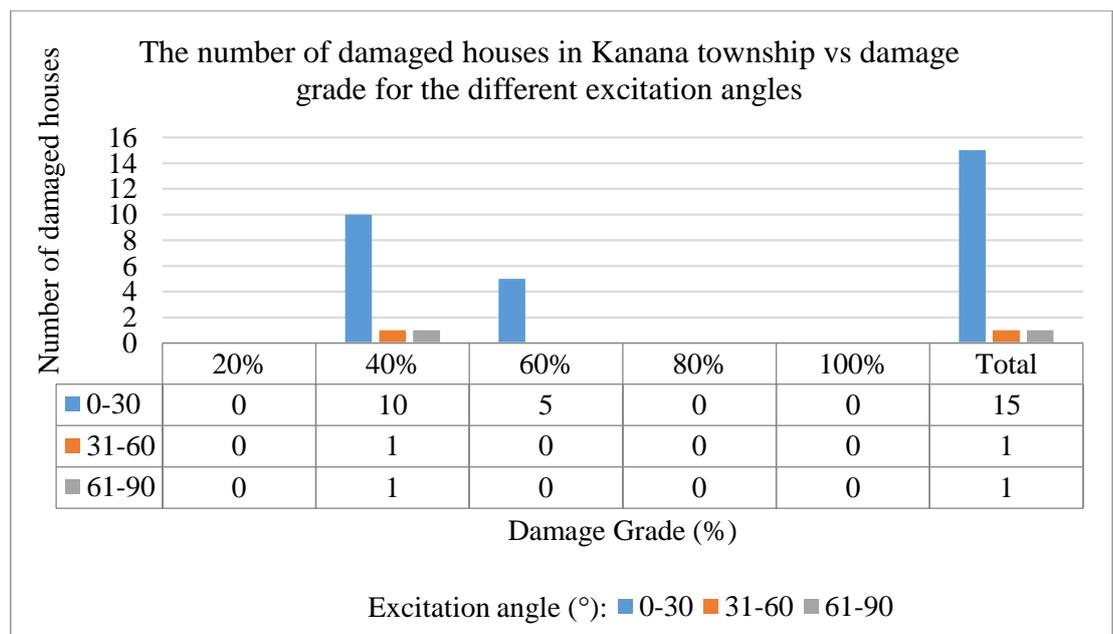
Figure 4-2: Number of damaged houses classified according to excitation angle and damage grade in Kanana.

Figure 4-2 provides the same information as the map in Figure 7-3, but with the variable relations being given quantitatively. For example, the total number of damaged houses with excitation angle $0^\circ - 30^\circ$ was 15 and both excitation angles $31^\circ - 60^\circ$ and $61^\circ - 90^\circ$ had 1 damaged house. For damage grade 60%, there were only 5 damaged houses, all with excitation angle $0^\circ - 30^\circ$. For damage grade 40% there were 10 damaged houses for excitation angle $0^\circ - 30^\circ$ and both excitation angle $31^\circ - 60^\circ$ and $61^\circ - 90^\circ$ had 1 damaged house.

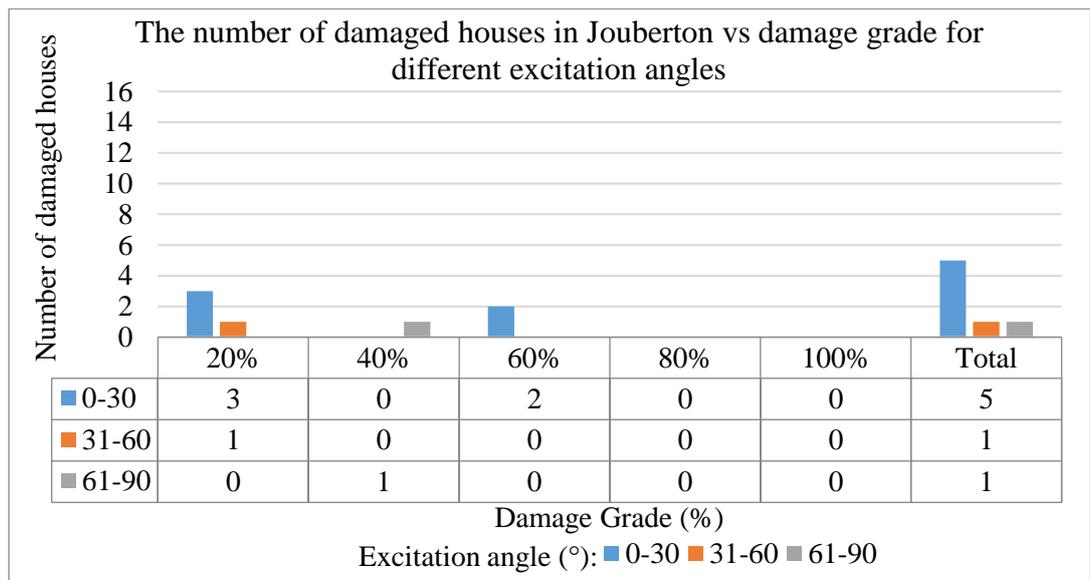
Figure 4-3: Number of damaged houses classified according to excitation angle and damage grade in Jouberton.

Figure 4-3 provides the same information as the map in (Figure 7-4 in Appendix C), but given quantitatively. For excitation angle $0^\circ - 30^\circ$ there were 5 damaged houses. Excitation angle $61^\circ - 90^\circ$ and $31^\circ - 60^\circ$ there was 1 damaged house for each (Figure 4-3). For damage grade 60% there were only 2 damaged houses both with excitation angle $0^\circ - 30^\circ$. For damage grade 40% there was only 1 damaged house and it had excitation angle $61^\circ - 90^\circ$. For damage grade 20% there were 3 damaged houses with excitation angle $0^\circ - 30^\circ$ and 1 damaged house for excitation angle $31^\circ - 60^\circ$.

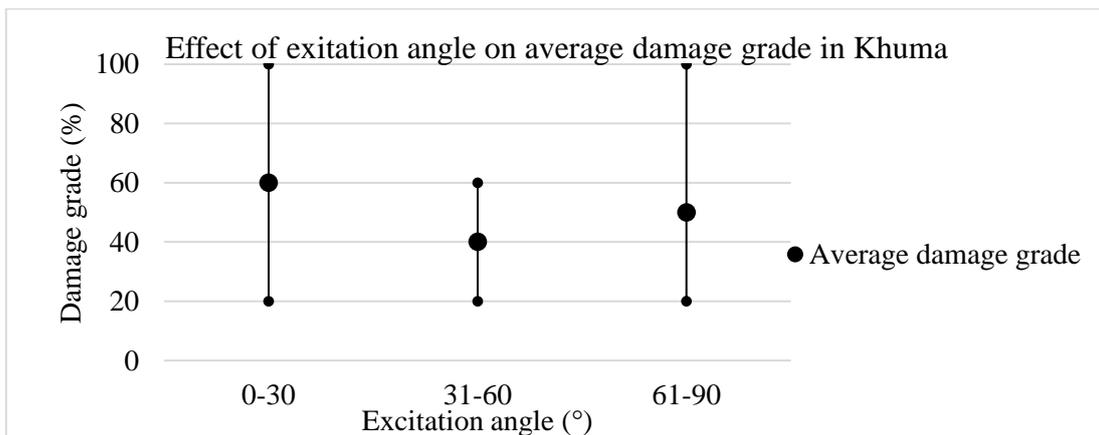
Figure 4-4: The minimum, maximum and average damage grade percentage for the respective excitation angle in Khuma.

Table 4-1 and Figure 4-4 provide the relationships between the excitation angle and weighted average damage grade, minimum and maximum damage grade in Khuma.

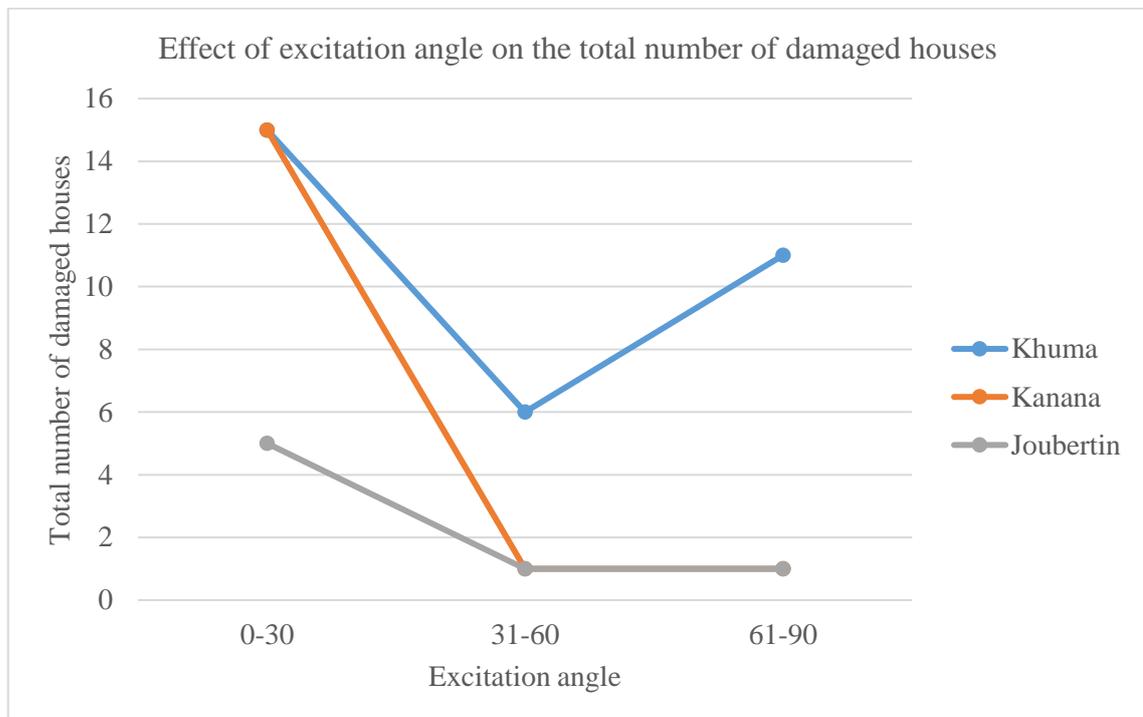
Figure 4-5: Total number of damaged houses classified according to excitation angle in all affected townships.

In all three townships excitation angle 0° - 30° had the greatest number of damaged houses (Figure 4-5). In Khuma excitation angle of 31° - 60° produced the least number of damaged houses; In Kanana, excitation angles of 31° - 60° and 61° - 90° experienced the fewest damaged houses and in Jouberton, excitation angle of 31° - 60° had the fewest damaged houses. To summarise, in all three townships excitation angle of 31° - 60° had the fewest damaged houses (Figure 4-5).

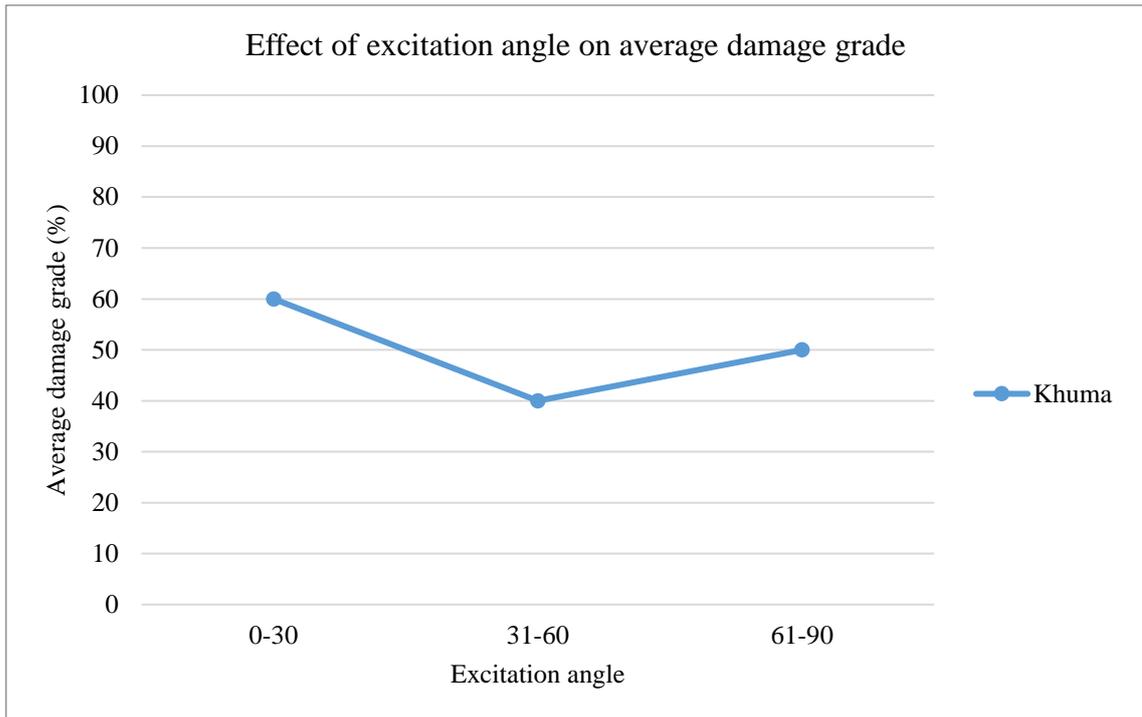
Figure 4-6: Effect of excitation angle on the average damage grade in Khuma.

In Khuma township excitation angle 0° - 30° had the highest weighted average damage grade (Figure 4-6). The lowest weighted average damage grade, In Khuma corresponded to excitation angle of 31° - 60° In Kanana and Jouberton the data was too sparse and not enough to do any statistics for excitation angle.

From the results obtained in this section, the most vulnerable excitation angle on low-cost houses was 0° - 30° . since this angle recorded the highest number of damaged houses in all townships and the highest weighted average damage grade in Khuma. The most favourable angle on low-cost houses was excitation angle 31° - 60° ; this angle recorded the lowest number of damaged houses in all townships and the lowest weighted average damage grade in Khuma.

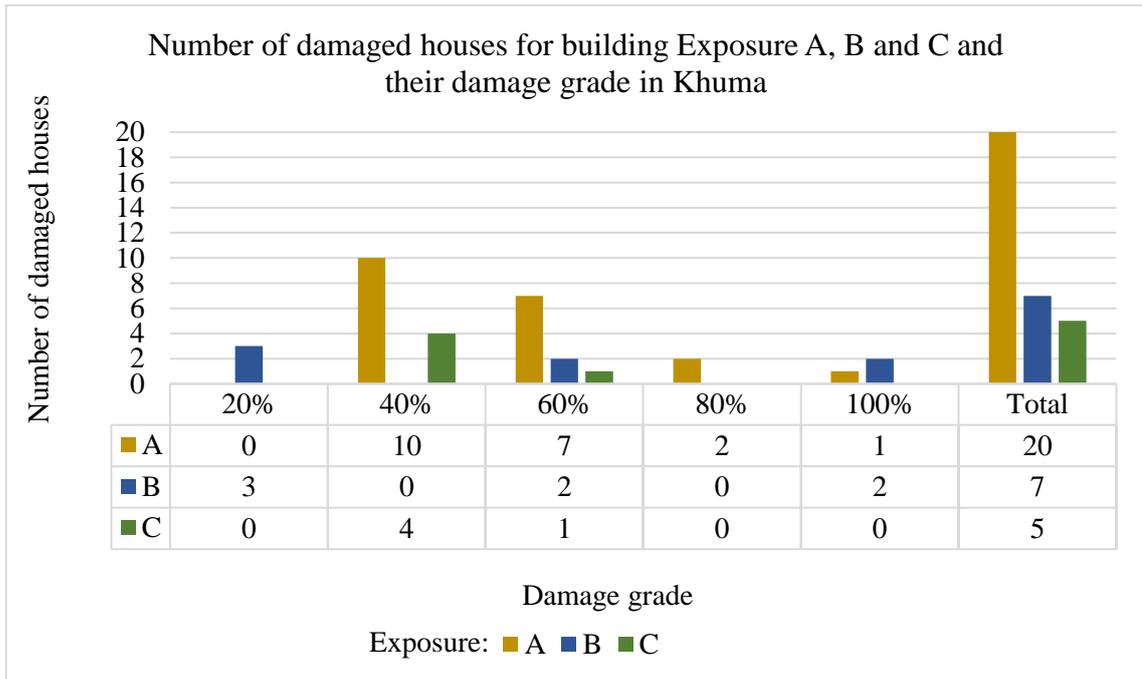
Figure 4-7: Number of damaged houses classified according to Exposure and damage grade in Khuma.

Figure 4-7 provides the same information as the map but with variable relations given quantitatively. For example, the total number of damaged houses with the exposure A was 20, while exposure B had 7 damaged houses and exposure C had 5 damaged houses. For damage grade 100%, there was 1 damaged house with exposure A and 2 damaged houses with exposure B. Damage grade 80% had only 2 damaged houses, both with exposure A. For damage grade 60%, exposure A had 7 damaged houses, exposure B had 2 damaged houses and exposure C, one damaged house. For damage grade 40%, there were 10, 0 and 4 damaged houses for exposures A, B, and C, respectively. For damage grade 20%, there were only 3 damaged houses, all with exposure B.

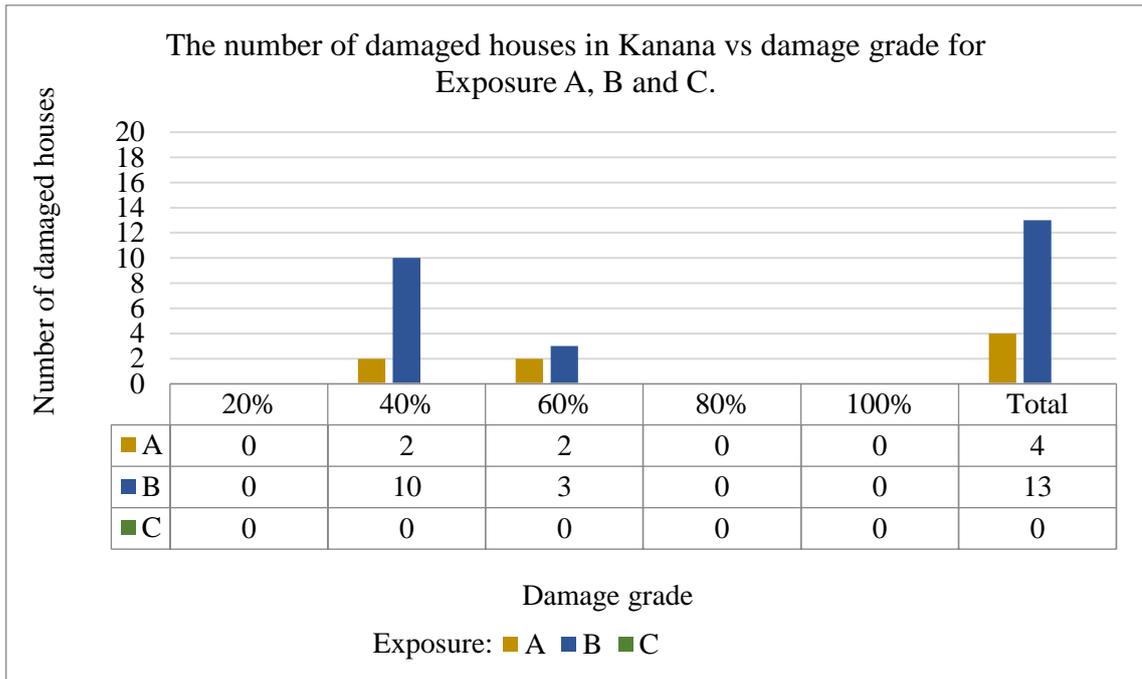
Figure 4-8: Number of damaged houses classified according to exposure and damage grade in Kanana.

Figure 4-8 provides the same information as the map in Figure 7-6, however the variable relations can be seen quantitatively. The total number of damaged houses with exposure A was 4, exposure B had a total of 13 damaged houses and exposure C had no damaged house. For damage grade 60%, there were 2 damaged houses with exposure A and 3 houses with exposure B. For damage grade 40% there were 2 damaged houses with exposure A and 10 damaged houses with exposure B.

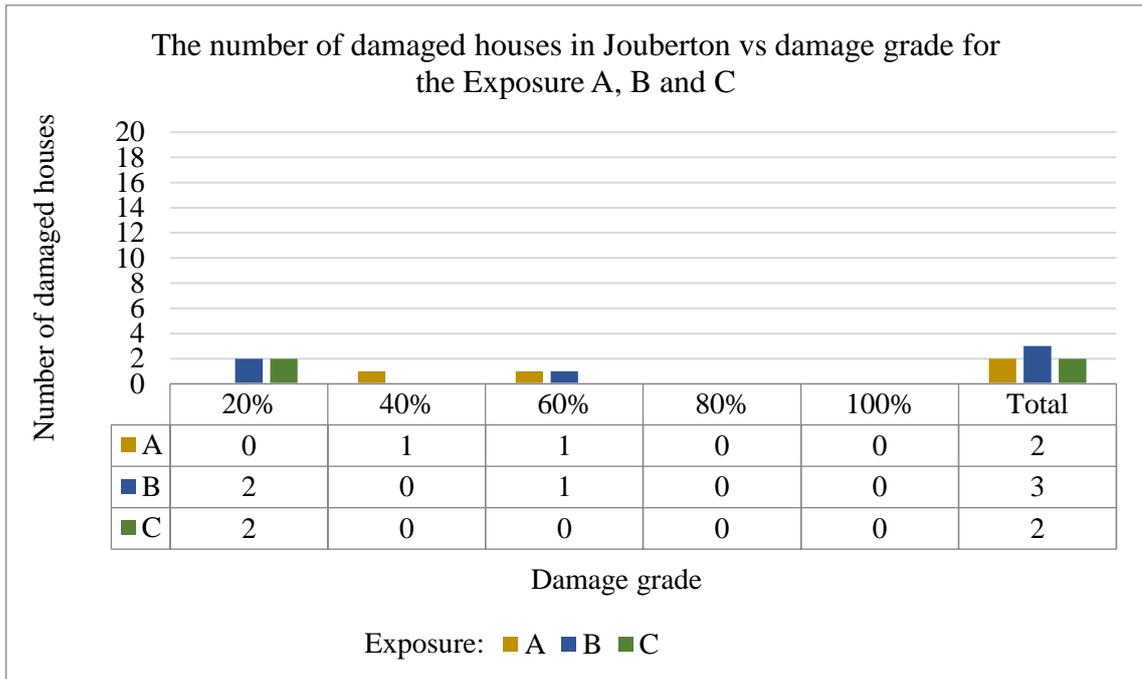
Figure 4-9: Number of damaged houses classified according to Exposure and damage grade in Jouberton.

Figure 4-9 provides the same information as the map in (Figure 7-7 in Appendix C), but quantitatively. The total number of damaged houses for exposure A was 2, 3 damaged houses had exposure B and 2 had exposure C. For damage grade 60%, exposure A and B had one damaged house. For damage grade 40% there was only 1 damaged house with exposure A. For damage grade 20%, exposure B and C each had 2 damaged houses.

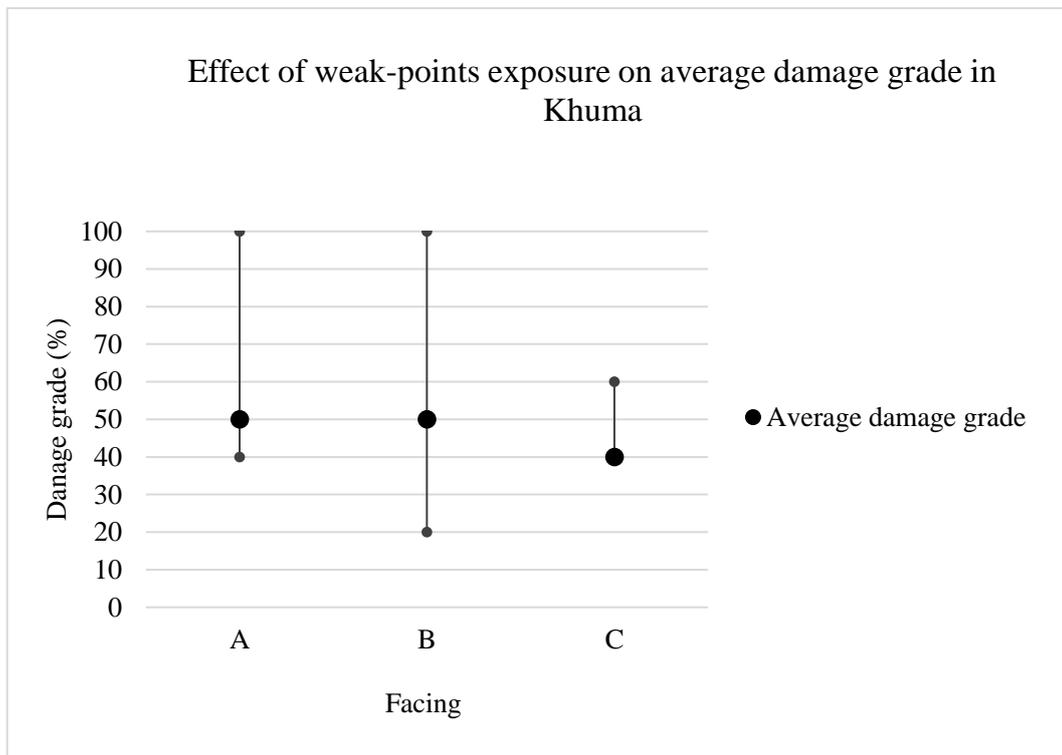
Figure 4-10: Average damage recorded for Exposure A, B and C in Khuma

Table 4-2 and Figure 4-10 in show the relationships between building weak-point exposure and the weighted average damage grade, minimum and maximum damage grade in Khuma.

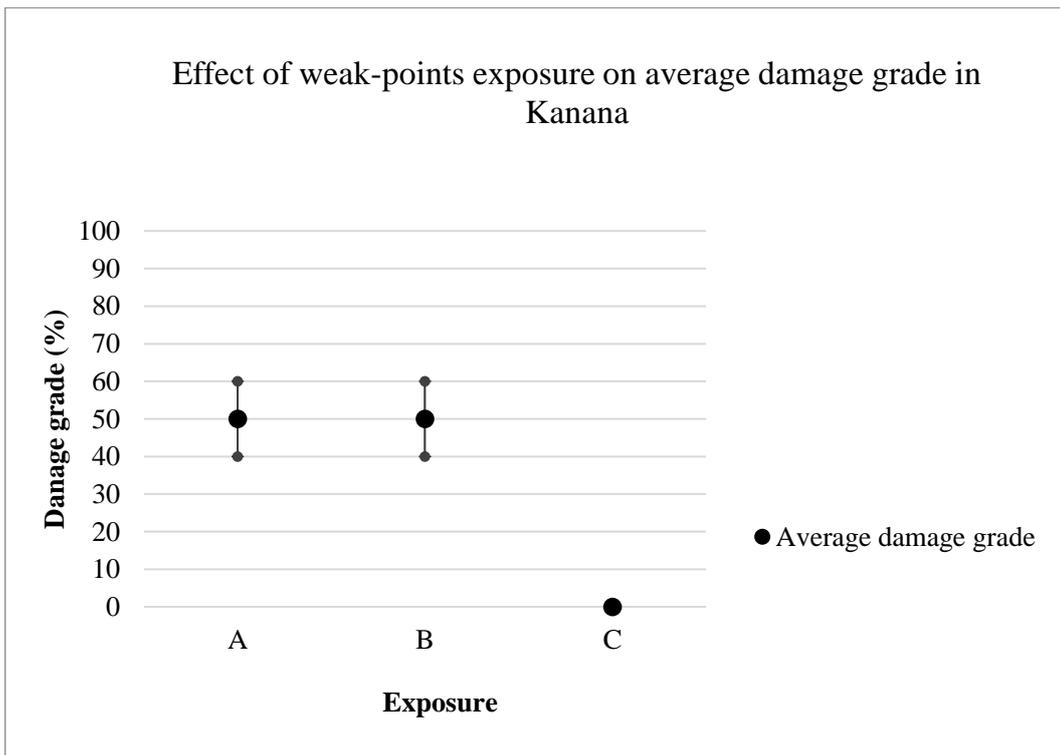
Figure 4-11: Average damage recorded between Exposure A, B and C in Kanana

Table 4-3 and Figure 4-11 provide the relationships between the building weak-points exposure and the weighted average damage grade, minimum and maximum damage grade in Kanana.

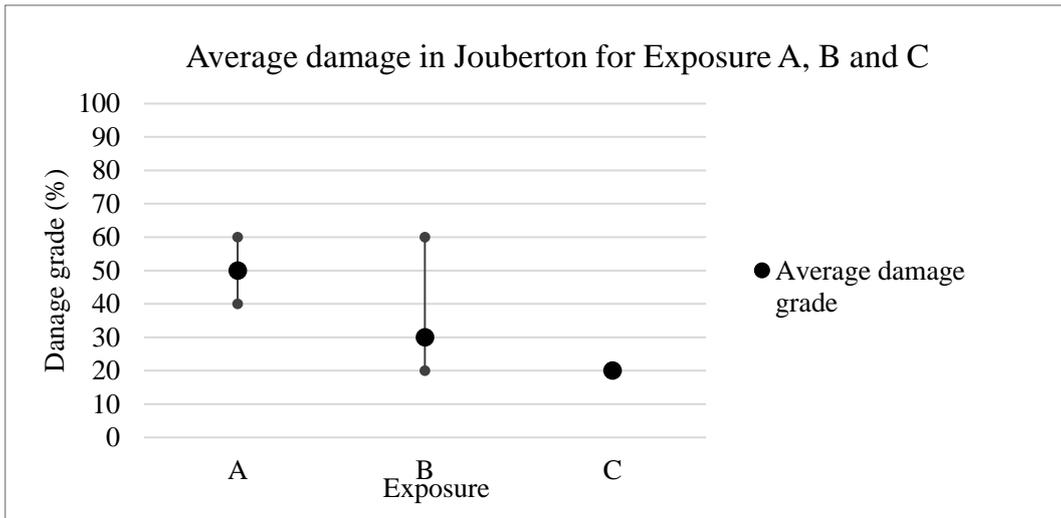
Figure 4-12: Average damage recorded between Exposure A, B and C in Jouberton

Table 4-4 and Figure 4-12 provide the relationships between the building weak-points exposure and the weighted average damage grade, minimum and maximum damage grade in Jouberton.

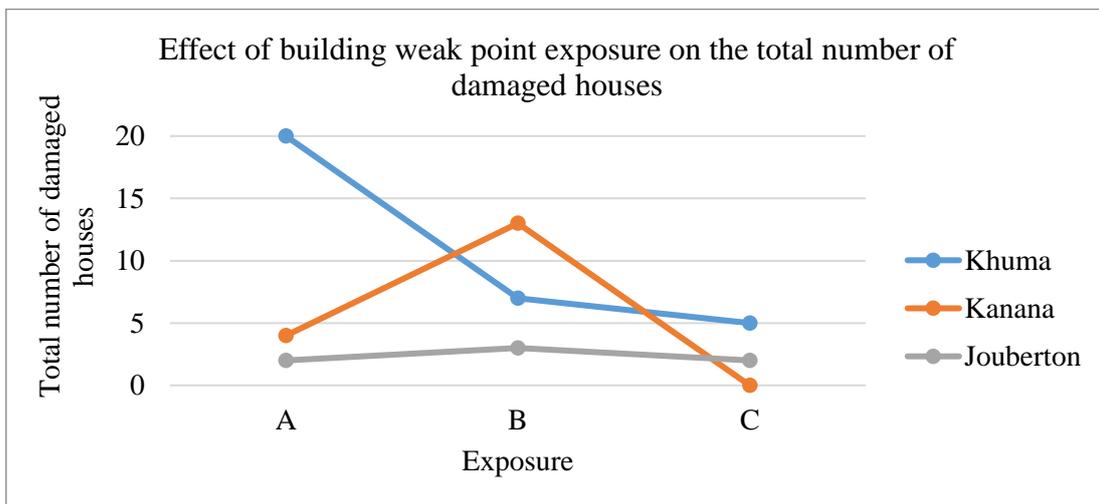
Figure 4-13: Total number of damaged houses classified according to building weak points Exposure in all affected townships.

In all three townships exposure C had the least number of damaged houses (Figure 4-13). In Khuma, Kanana and Jouberton, exposures A, B and B respectively, had the most damaged houses (Figure 4-13). So for two of the three settlements, exposure B had the highest number of damaged houses while exposure A had the highest number of damaged houses in only one township (Khuma).

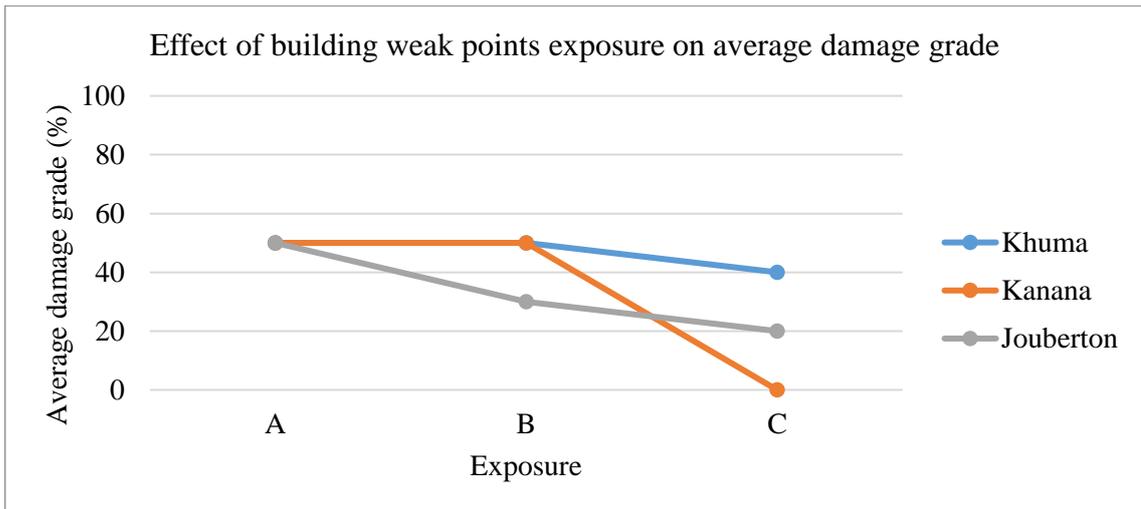
Figure 4-14: Effect of building weak points Exposure on the average damage grade in Khuma, Kanana and Jouberton

In all three townships exposure C had the lowest weighted average damage grade (Figure 4-14). In Khuma and Kanana exposure A and B had the highest and similar weighted average damage grade. In Jouberton, exposure A had the highest weighted average damage grade and exposure B the second highest (Figure 4-14). The results in Jouberton were not very reliable, since this settlement had few data points.

The most favourable building weak points exposure was exposure C, with the lowest number of damaged houses and lowest weighted average damage grade in all three townships. The most vulnerable building weak points exposure was between exposure A and exposure B. Exposure A had the highest number of damaged houses for Khuma township and highest weighted average damage grade in all three townships. Exposure B had the highest number of damaged houses in two townships (Kanana and Jouberton) and the highest weighted average damage grade for two townships (Khuma and Kanana).

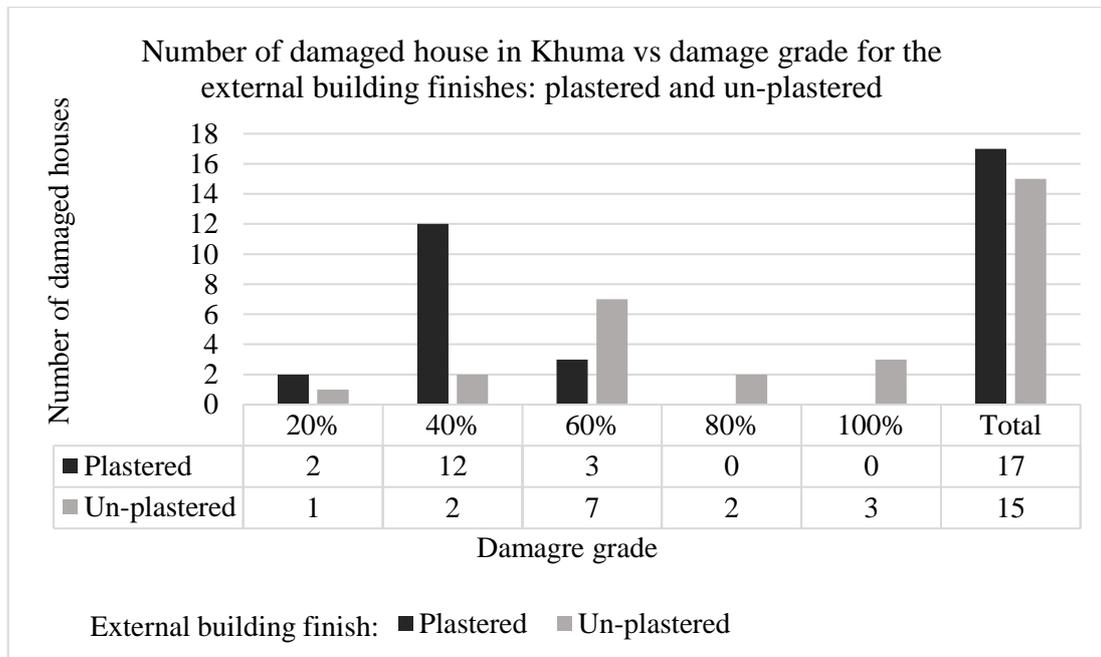
Figure 4-15: Number of damaged houses classified according to external building finish (plastered or un-plastered) and damage grade in Khuma.

Figure 4-15 provides the same information as the map in Figure 7-8 however the variable relations can be seen quantitatively. The total number of damaged plastered houses was 15 and the total damaged un-plastered houses was 17. For damage grades 80% and 100, all the damaged houses were un-plastered. For damage grade 60%, there were 3 damaged plastered houses and 7 damaged un-plastered houses. For damage grade 40%, there were 12 damaged plastered houses and 1 damaged un-plastered house. For damage grade 20%, there were 2 damaged plastered houses and 1 damaged un-plastered house.

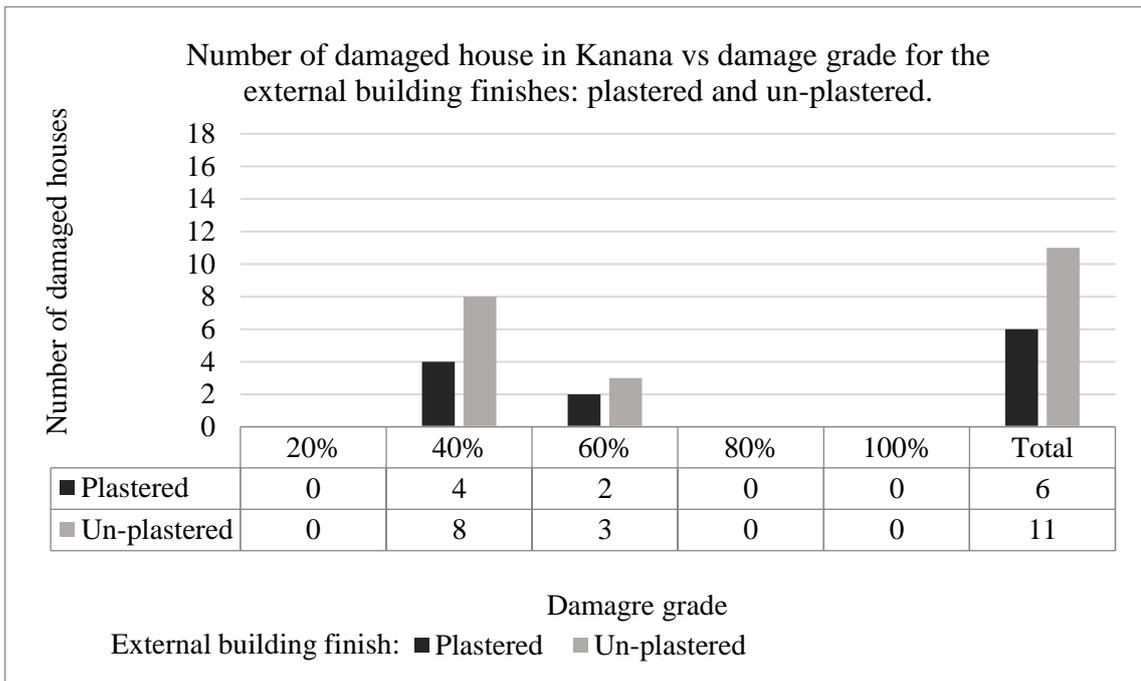
Figure 4-16: Number of damaged houses in Kanana vs damage grade for the building finishes: plastered and un-plastered.

Figure 4-16 provides the same information as the map in Figure 7-9, but quantitatively. The total number of damaged plastered houses was 6 and for un-plastered houses, 11. For damage grade 60%, there were 2 damaged plastered houses and 3 damaged un-plastered houses. all these houses having excitation angle 0° - 30° . For damage grade 40%, there were 4 plastered houses and 8 un-plastered houses.

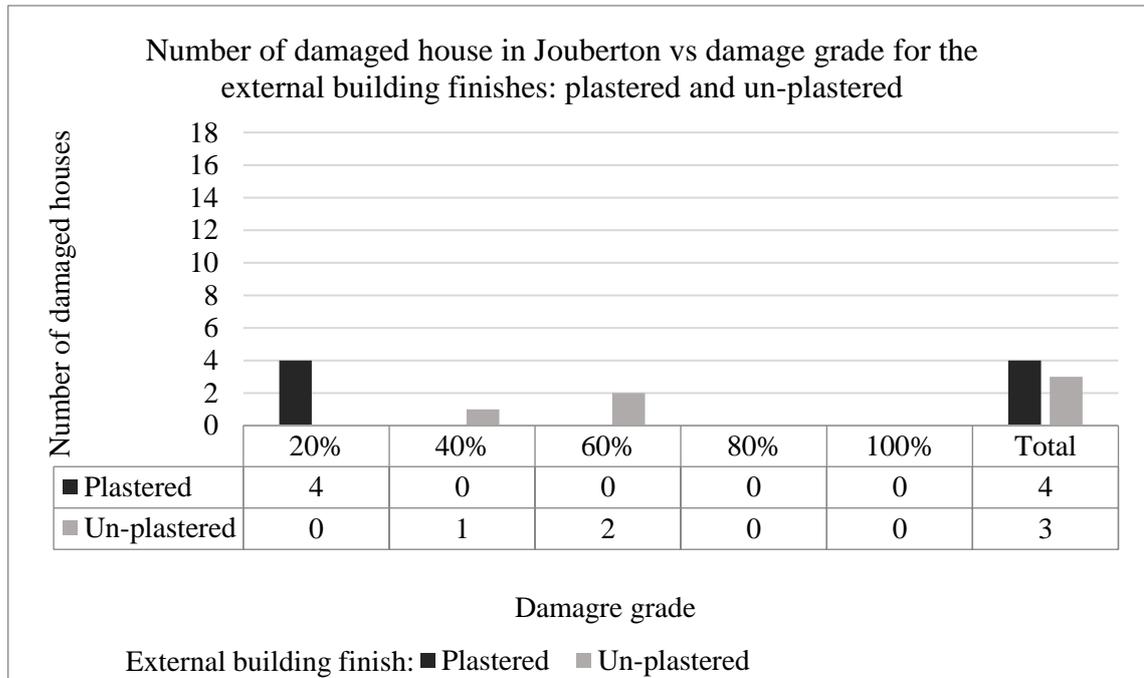
Figure 4-17: Number of damaged houses in Jouberton vs damage grade for the building finishes: plastered and un-plastered.

Figure 4-17 provides the same information as the map in Figure 7-10, but quantitatively. Four of the damaged houses were plastered and 3 were un-plastered. For damage grade 60% there were only 2 damaged un-plastered houses. For damage grade 40% there was only 1 damaged un-plastered house. For damage grade 20% there were 4 damaged plastered houses.

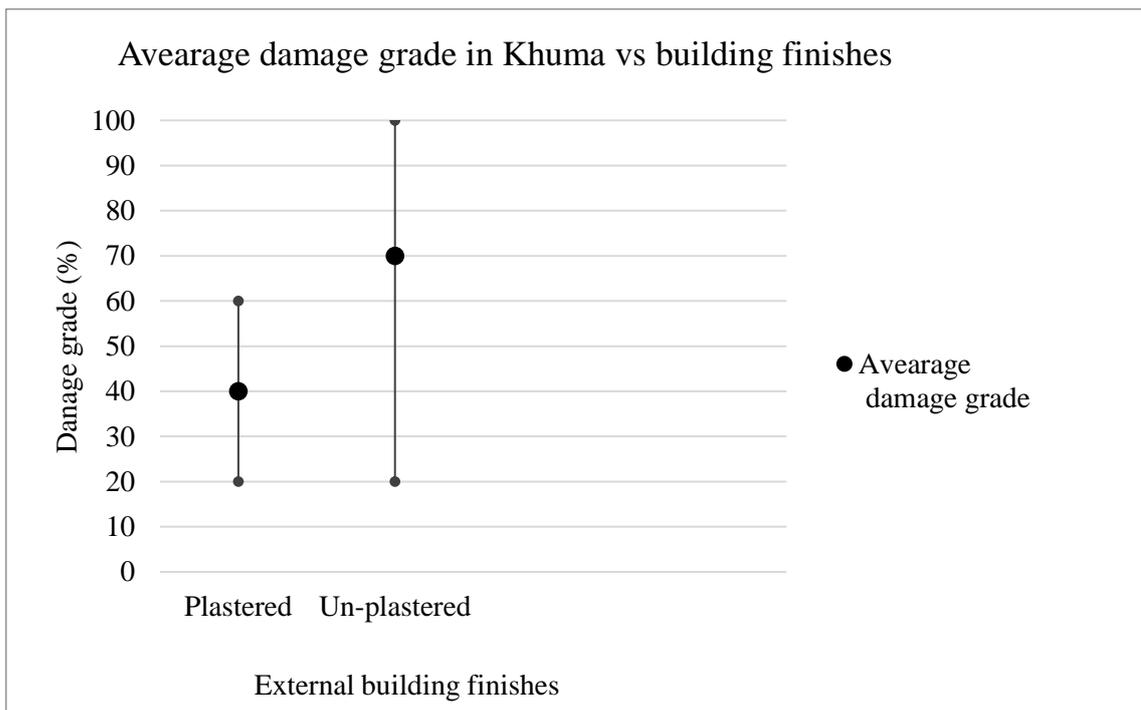
Table 4-5 and Figure 4-18 provides the relationship between the external building finish and the weighted average damage grade, minimum and maximum damage grades in Khuma.

Figure 4-18: Average damage recorded between plastered and un-plastered houses in Khuma.

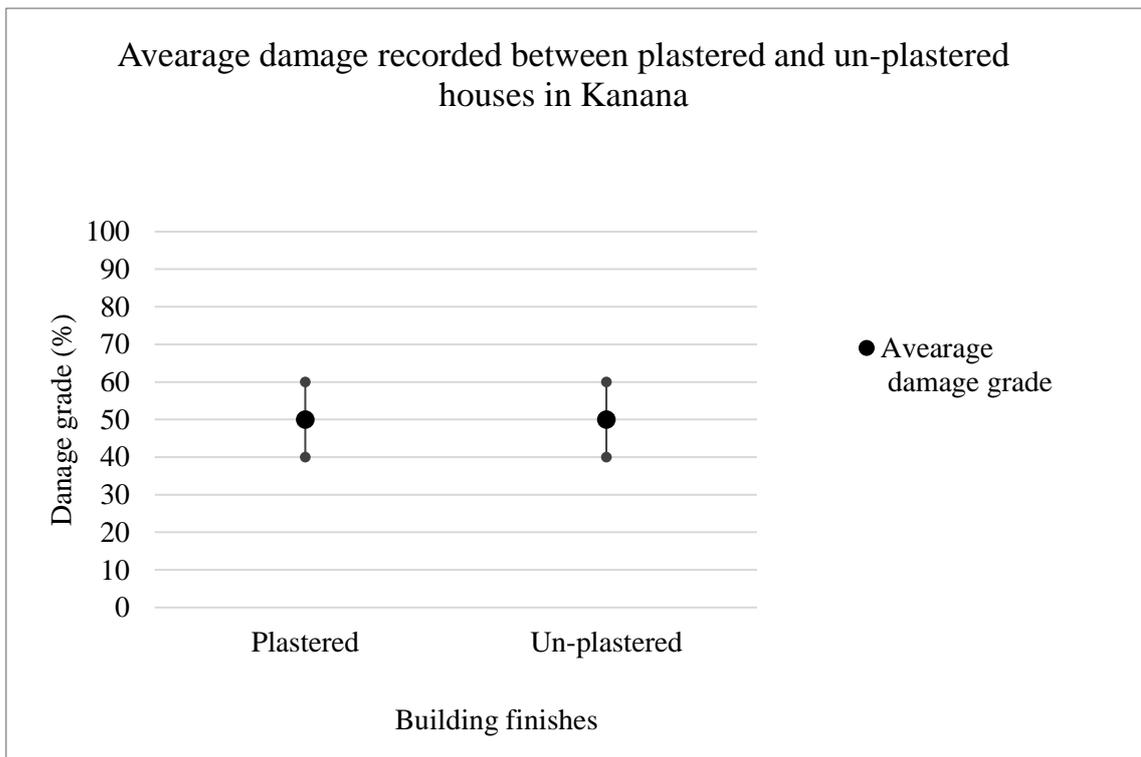
Both plastered and un-plastered houses had a damage grade ranging from 40% to 60% and a weighted average damage grade of 50%.

Figure 4-19: Average damage recorded between plastered and un-plastered houses in Kanana.

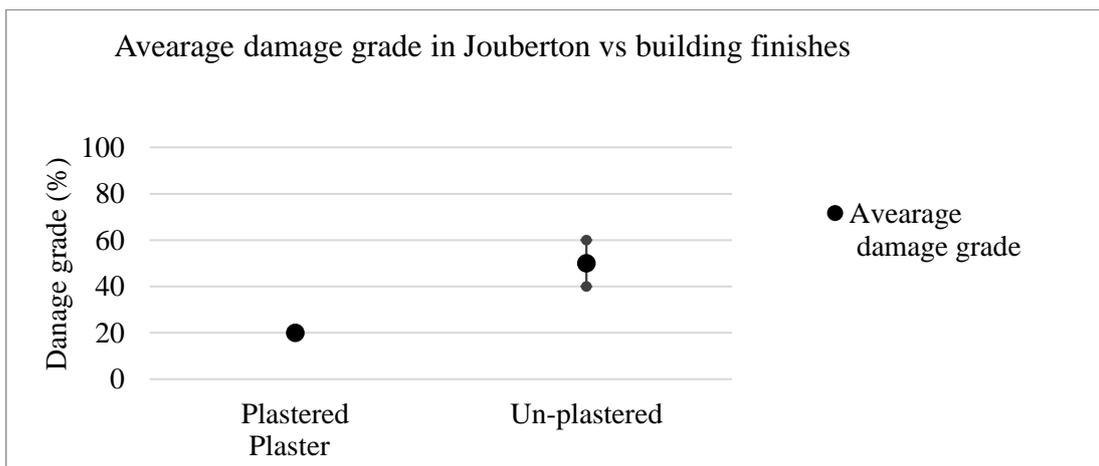
- All the damaged plastered houses had a damage grade of 20%; and correspondingly the minimum, maximum and average of 20%.
- Un-plastered houses had a damage grade ranging from 40% to 60% and the weighted average damage grade of 50%.
- Hence, un-plastered houses were more vulnerable to earthquake damage. However, in Jouberton, there were few data points, which decreased the reliability of the results obtained in this settlement.

Figure 4-20: Average damage recorded between plastered and un-plastered houses in Jouberton.

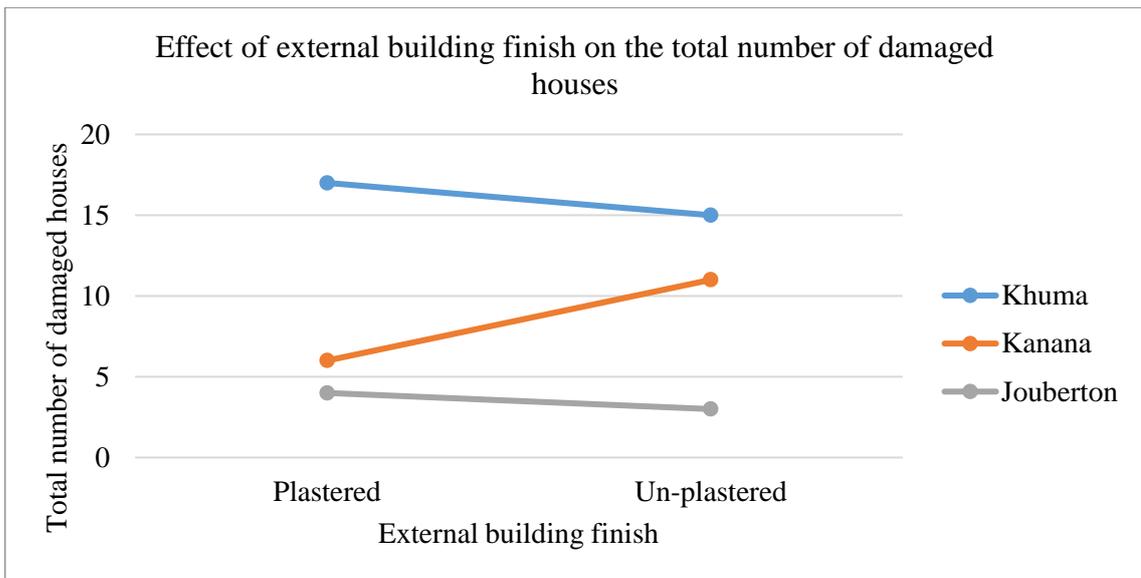
From Figure 4-21, in Khuma, more damaged houses were plastered than un-plastered. In Kanana more damaged houses were un-plastered houses and the fewest damaged houses were plastered. In Jouberton more damaged houses were plastered houses less un-plastered. In two of the three settlements then (Khuma and Jouberton) more damaged houses were plastered.

Figure 4-21:: Total number of damaged houses classified according to external building finish in all affected townships.

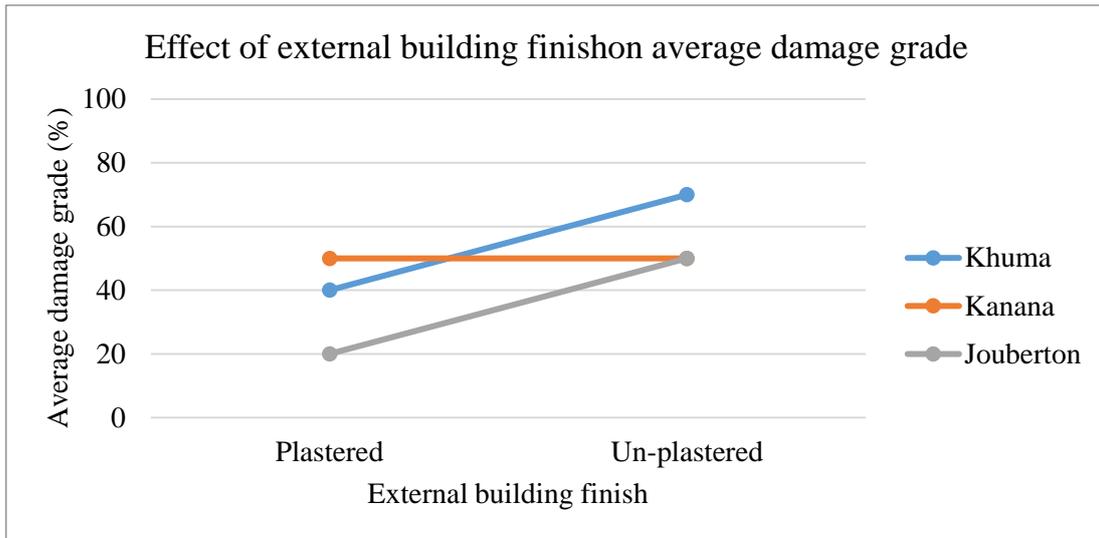
From Figure 4-22, in Khuma, the average damage grade for plastered houses was lower than average damage grade for un-plastered houses. In Kanana, both plastered and un-plastered houses had the same average damage grade. In Jouberton, the weighted average damage grade was higher in un-plastered houses. Un-plastered houses then had the higher damage grade in two townships, with the exception of Kanana where damaged plastered and un-plastered houses suffered the same levels of damage. Again, the results in Jouberton were not very reliable, since this settlement had few data points.

Figure 4-22: Effect of external building finish on the average damage grade in Khuma, Kanana and Jouberton

Overall, un-plastered houses were more vulnerable, having the higher weighted damage grade for two townships and the higher number of damaged houses for Kanana. The average difference in damage grade between the more and the less favourable external building finish was 20%.

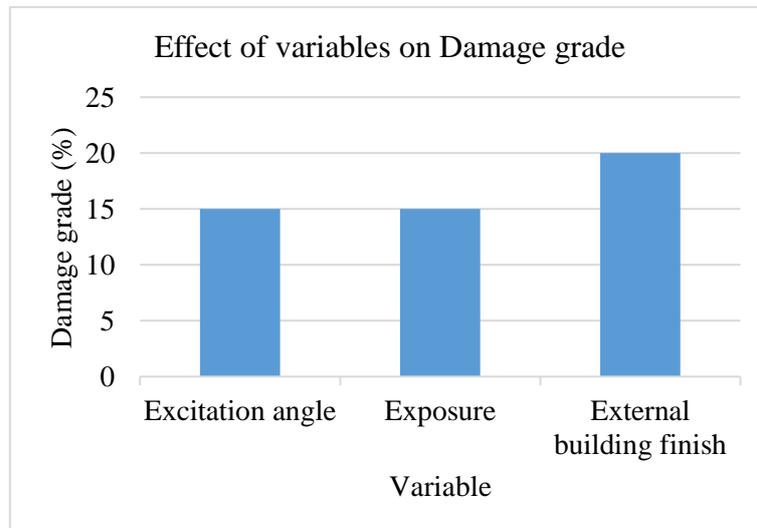
The presence or absence of plaster in the houses was then the highest contributing factor for damage grade in this study. This information is also represented in Figure 4-23

Figure 4-23: The effect of excitation angle, exposure and external building finish on damage grade.

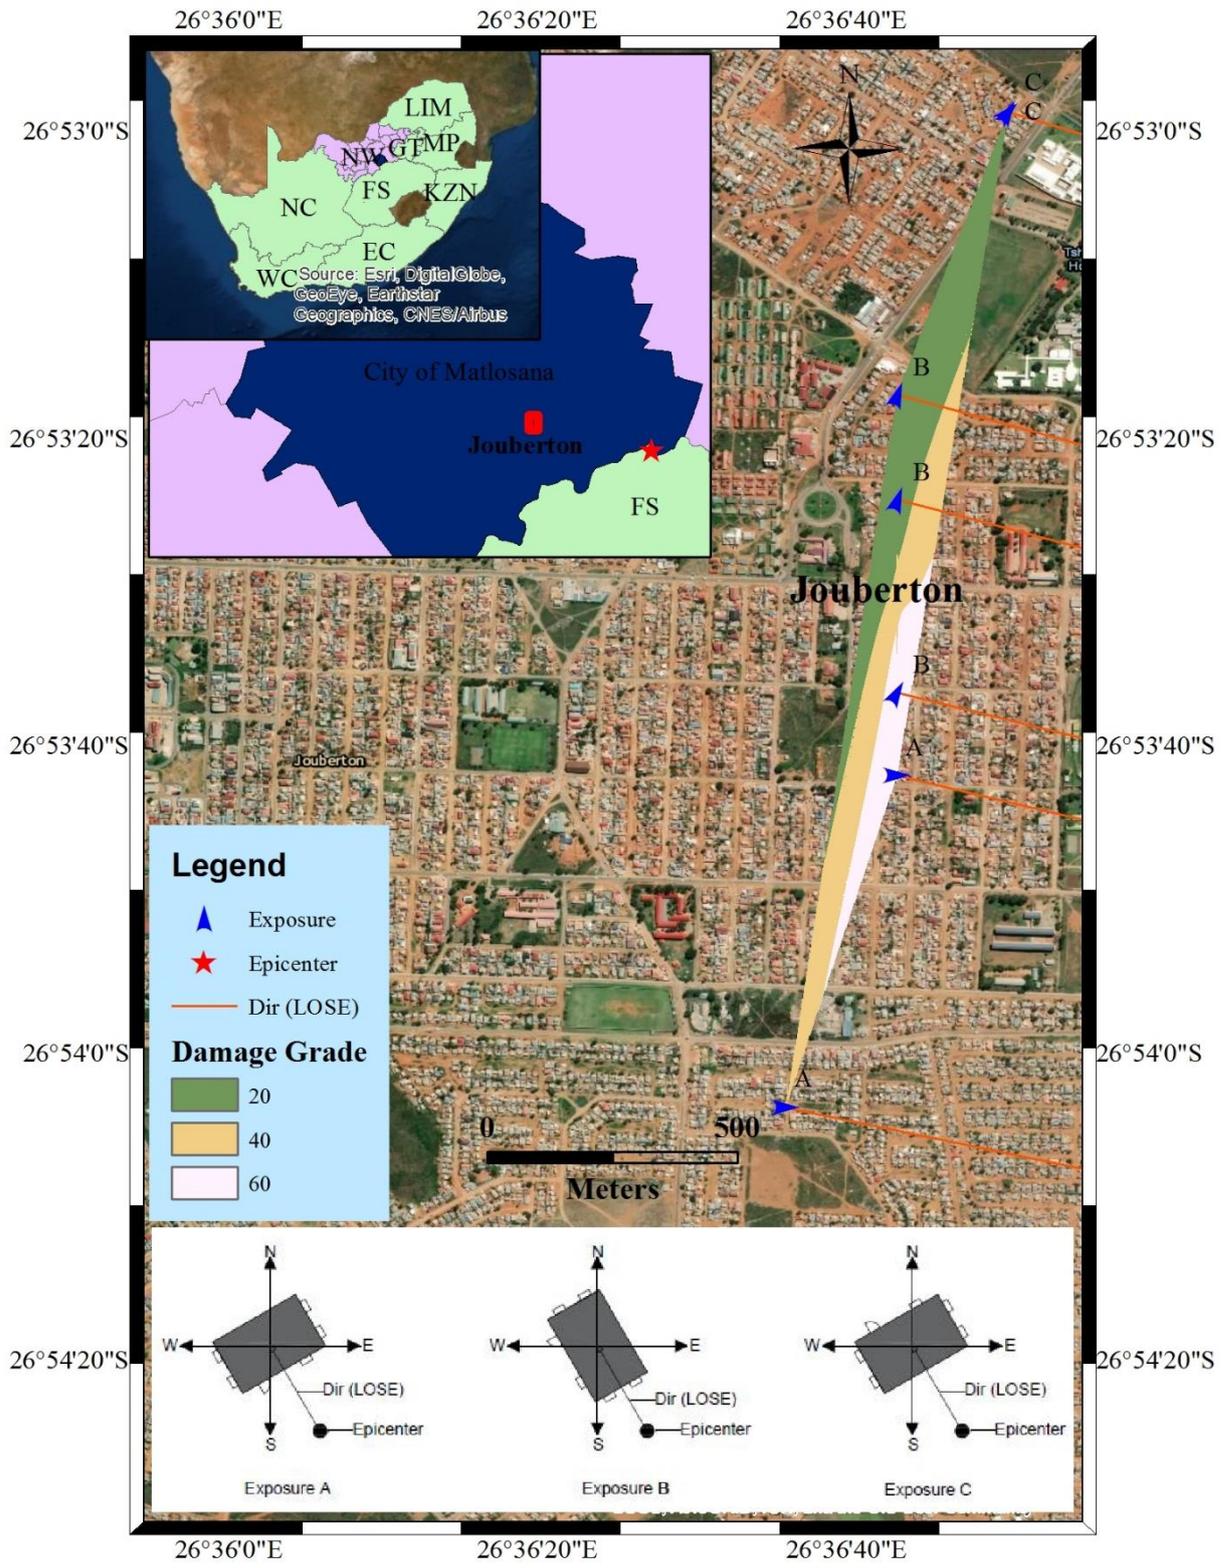
Jouberton experienced the least damage from the 2014 Orkney earthquake, being the furthest from the epicentre, with an average epicentral distance of 23 km (Figure 7-7 in Appendix D) and the fewest (7) damaged houses. The graphs and maps produced indicate the number of damaged houses and the damage grade.

The map for Jouberton (Figure 7-7 in Appendix D) shows that the highest number of damaged houses had exposure B. Exposure A and C had the same number of damaged houses. Exposure A and B both had 1 house at damage grade 60%. From this map, a zone of high levels of 60% damage grade can be observed, in this zone, houses had exposures A or B.

Figure 7-7: Spatial representation of building weak points exposure and damage grade in Kanana
