Investigation of the Directional Effect on Low Cost Houses Due to the 2014 Orkney Earthquake

Thando Nqasha

A dissertation submitted in fulfilment of the academic requirements for the
degree of Master of Science in Land Surveying

15 May 2020

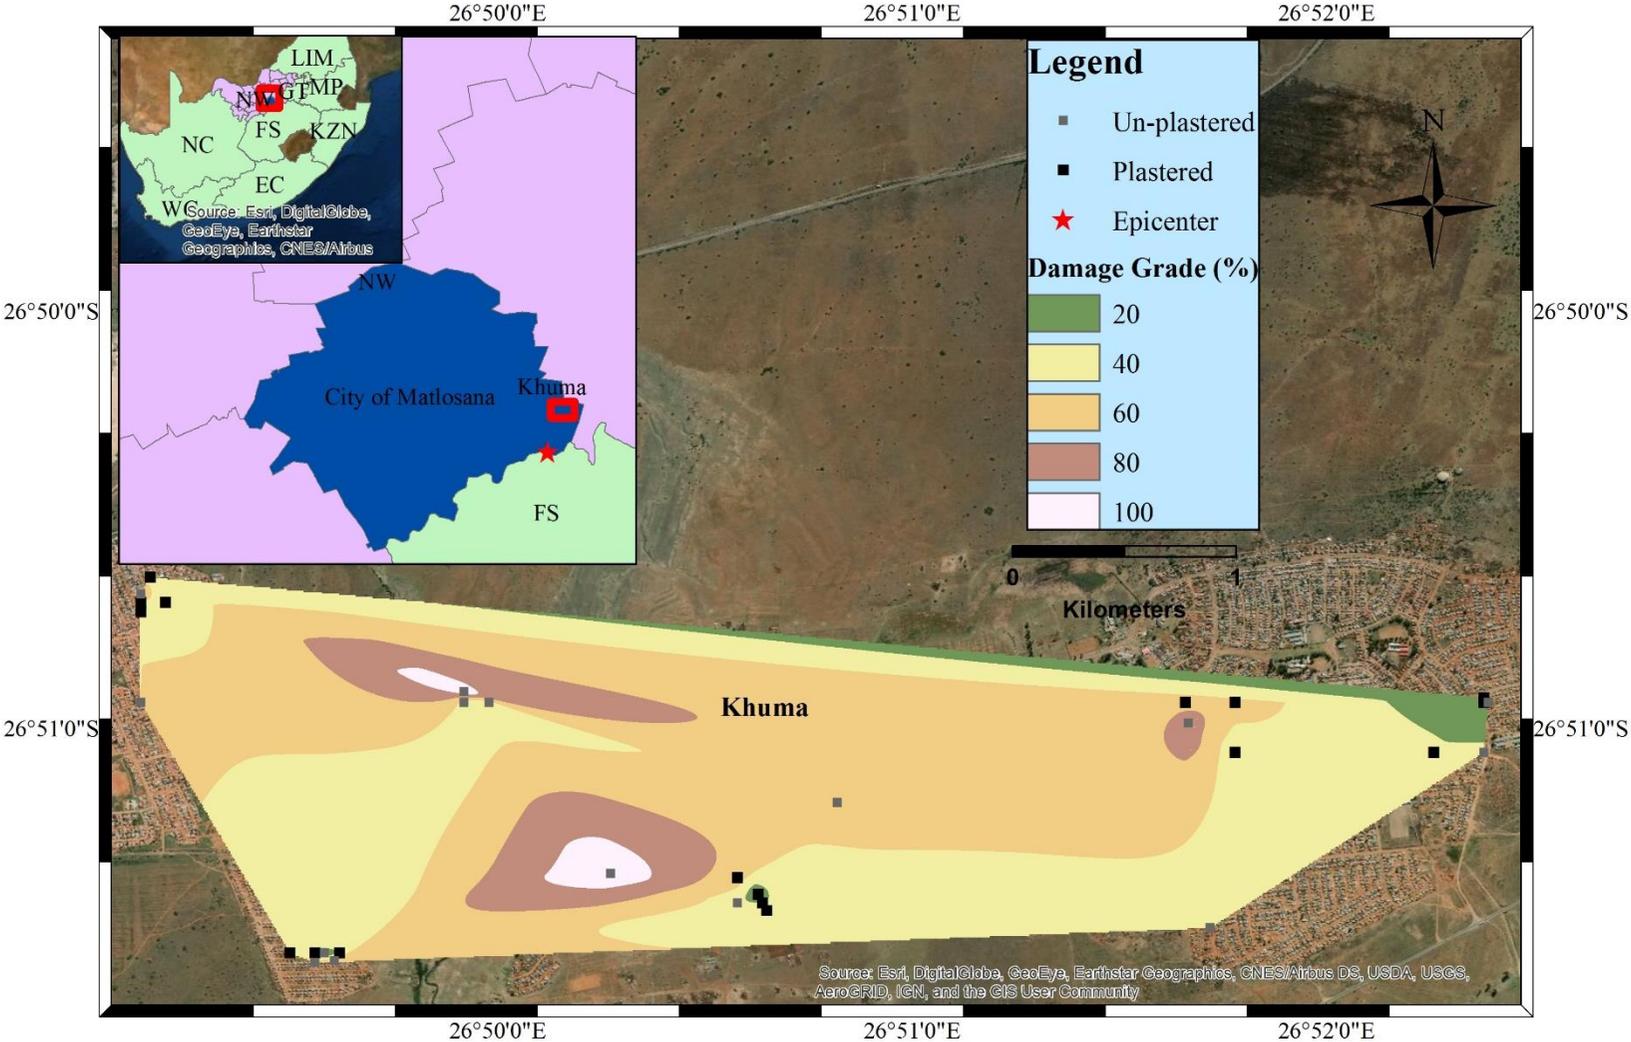
In Khuma, (the most damaged settlement) the damage map (Appendix E, Figure 7-8) shows that the highest number of damaged houses had a plastered finish. However, most damaged un-plastered houses had higher levels of damage grade. From this map three zones of high levels of damage grade are shown. In all three zones these houses were un-plastered. The two damage zones on the west showed damage grades of 100%.

Figure 7-8: Spatial representation of external building finish and damage grade in Khuma

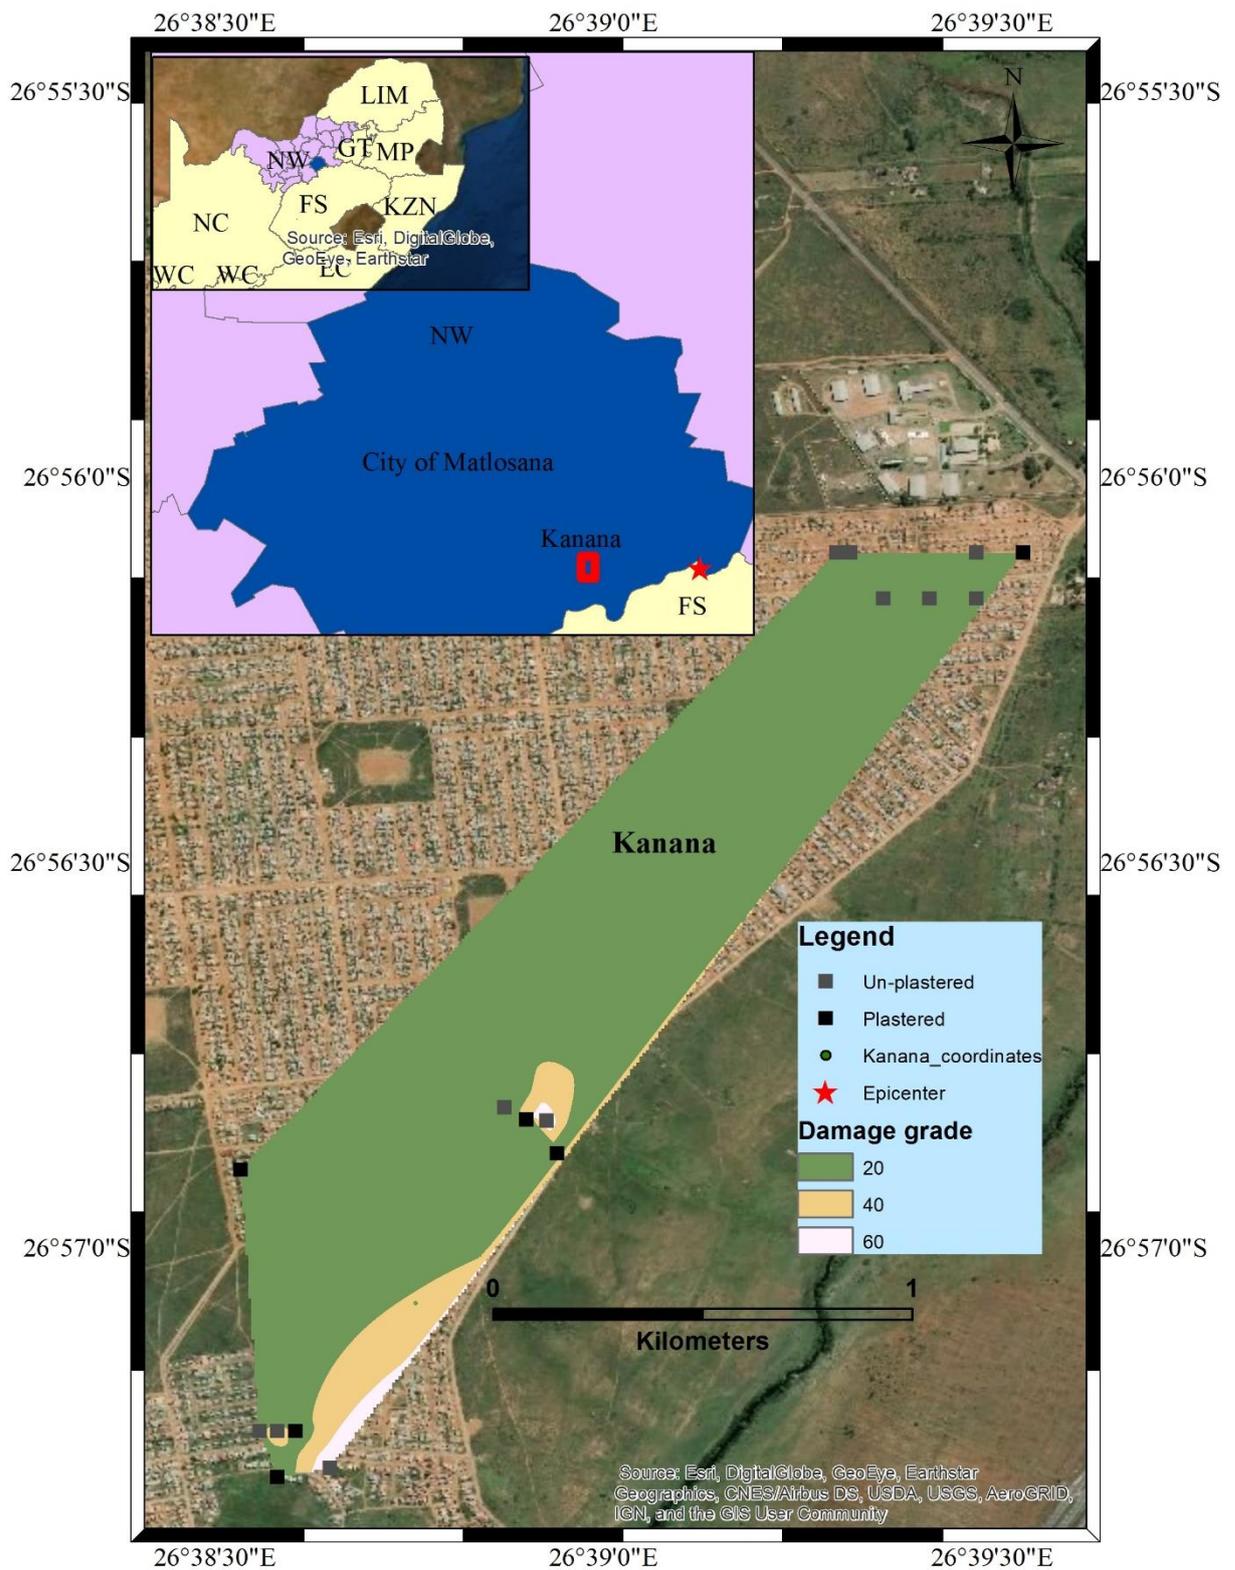
In Kanana (the second most damaged settlement with 17 damaged houses), the damage map (Figure 7-9 in Appendix E) shows that most damaged houses had damage grade 40%. The highest number of damaged houses were un-plastered and there were fewer damaged plastered houses. Most damaged un-plastered houses had damage grade 40% and 60%. This map has two zones of high levels, in both zones the houses were un-plastered. The two damage zones show damage grade of up to 60%.

Figure 7-9: Spatial representation of external building finish and damage grade in Kanana

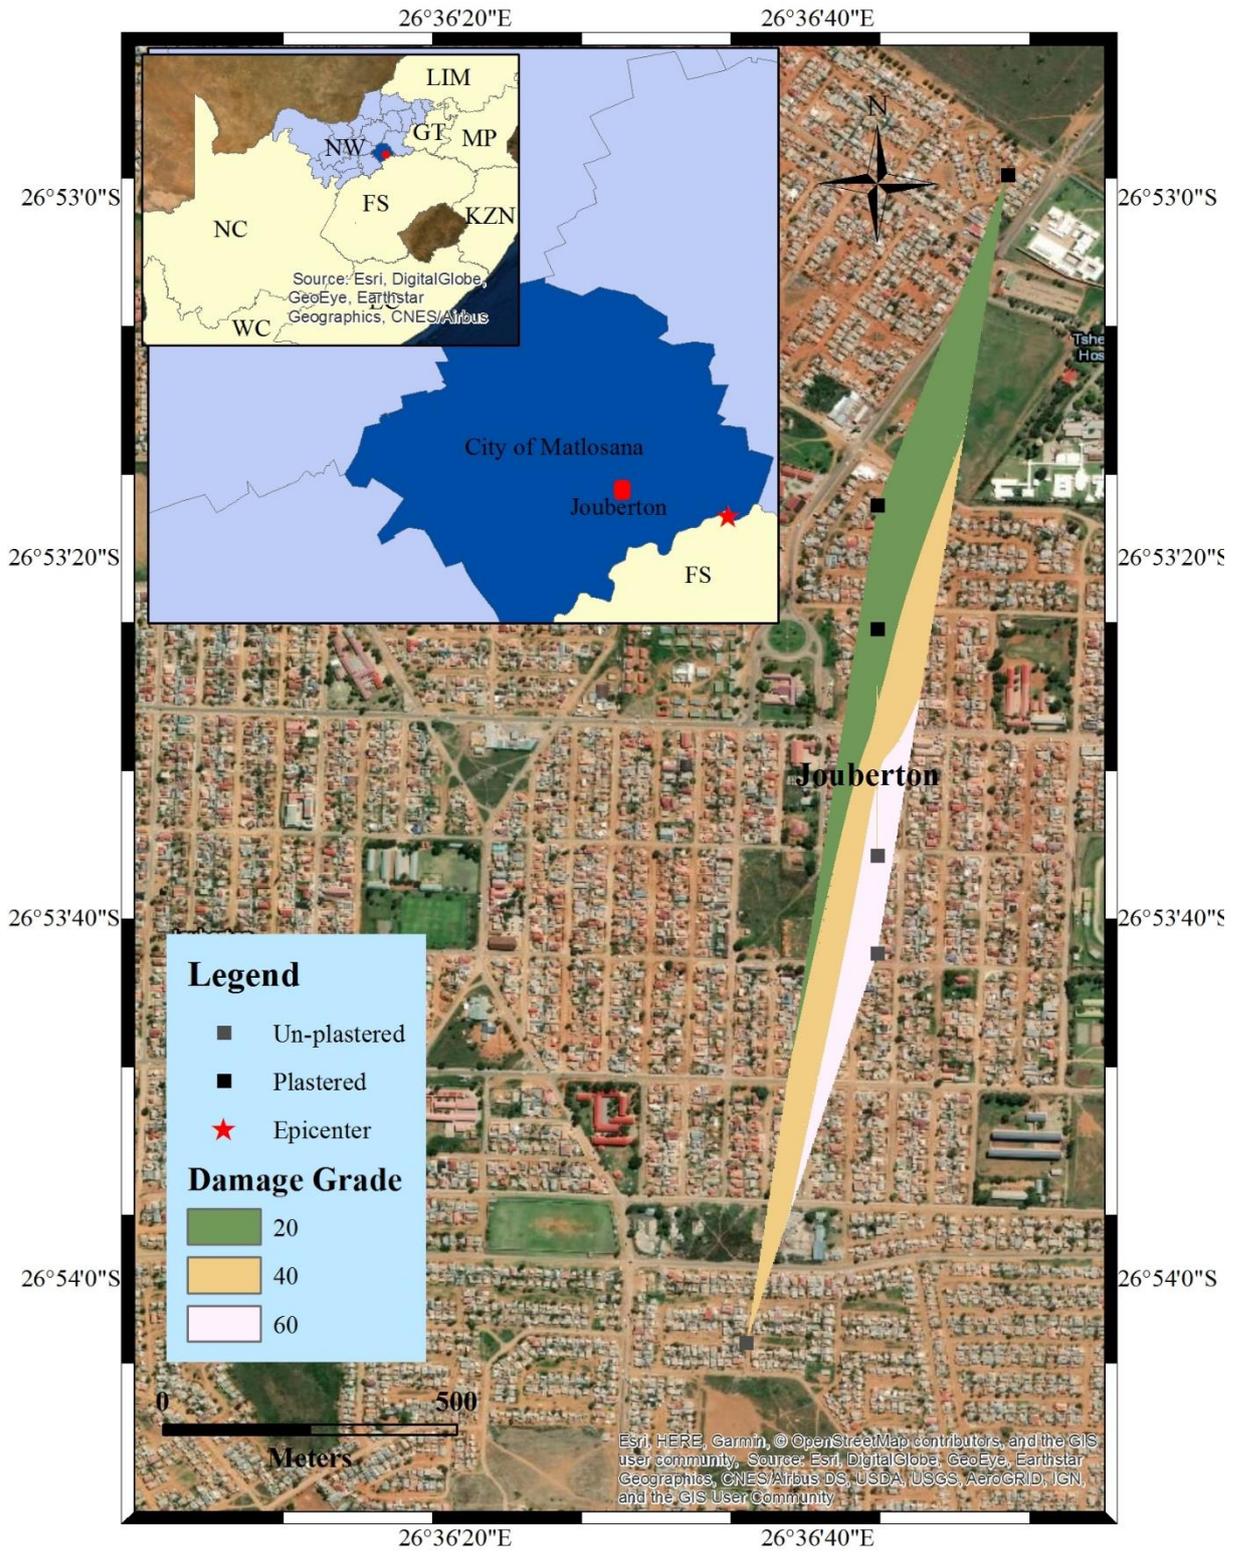
In Jouberton (furthest from the epicentre with only 7 damaged houses), the map (Figure 7-10 in Appendix E) shows that the highest number of damaged houses were plastered. However, there was a higher number of un-plastered houses with damage grade 60%. In the zone of high levels of damage up to 60%, the houses are un-plastered.

Figure 7-10: Spatial representation of external building finish and damage grade in Jouberton.

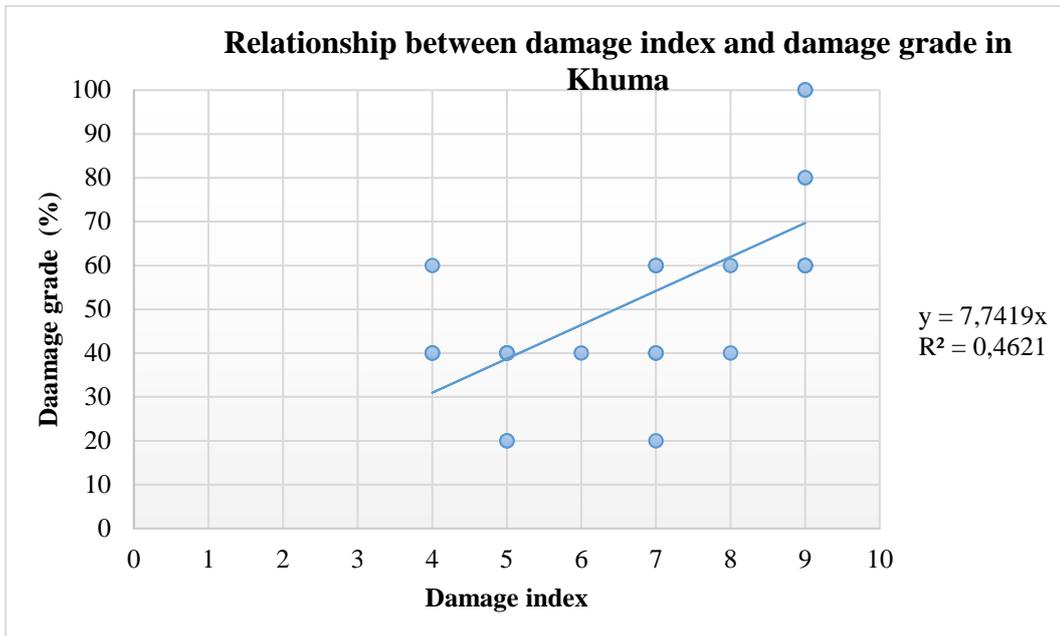
The damage index totals were compared to damage grade recorded by Khoyratty (2016) to determine the accuracy of the damage prediction. This was done using regression analysis. From Figure 7-11 and Figure 7-13 in Appendix G, in Khuma and Jouberton there is a positive correlation between damage index and damage grade and the correlation is negative in Kanana (Figure 7-12 in Appendix G). The correlation between these variables was expected to be positive. R-squared of 0.46 for Khuma (moderate correlation), 0.05 for Kanana (no correlation) and 0.83 for Jouberton (high correlation). These values suggest that the modelling was moderately successful for Khuma and Jouberton and unsuccessful for Kanana. Maybe in Kanana other factors affected the damage grade more than the factors that were considered in this study. This modelling can be improved by including more factors that contribute to the earthquake damage.

Figure 7-11: Correlation of damage index and damage grade in Khuma

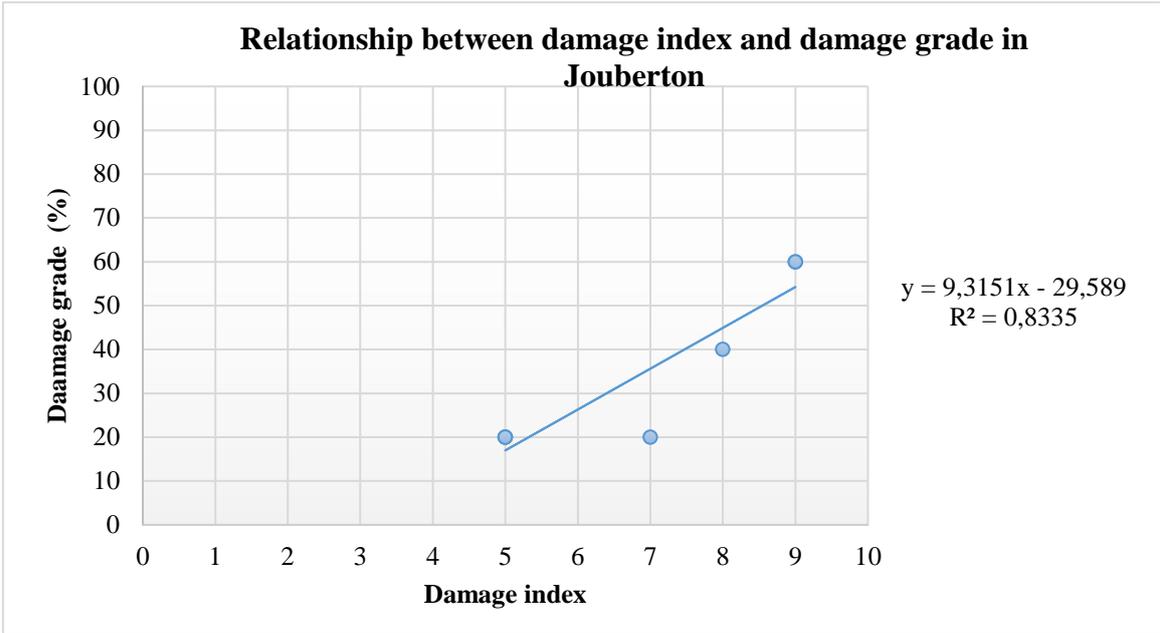
Figure 7-13: Correlation of damage index and damage grade in Jouberton
